**ENVIRONMENTAL INSPECTION REPORT  
(ELECTRONICALLY SUBMITTED)  
FEDERAL ENERGY REGULATORY COMMISSION**

**Date of Inspection:** September 27, 2004

**Name:** Klamath

**Project No.:** 2082

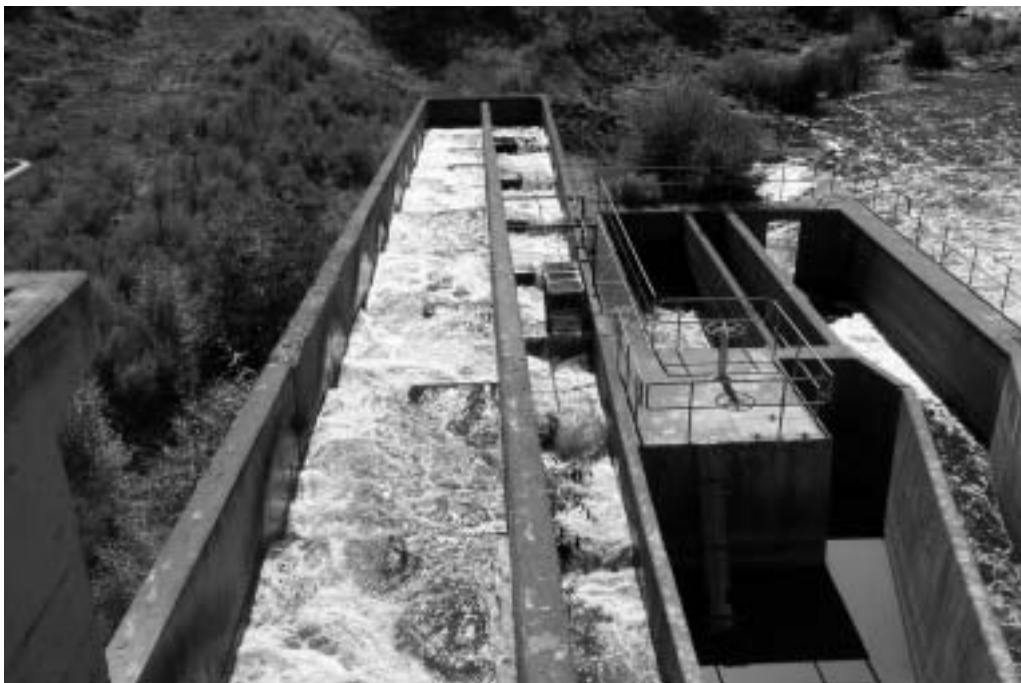
The licensee operates and maintains fish ladders at Keno (Photograph 1) and JC Boyle (Photograph 2) for resident fish passage. Of particular concern are the shortnose suckers, which are listed under the ESA. On the day of the inspection, the Keno ladder was flooded and the JC Boyle ladder had minimal flow over the weirs. According to the licensee, the FWS requested more attraction flow at the Keno ladder; however, the auxiliary water supply system was maxed-out. As a result, the licensee increased ladder flows resulting in poor ladder flow and fish passage conditions. The JC Boyle ladder had minimal flow over the weirs, which could deter passage for those species utilizing the overflow section of the weirs. As a result of unclear ladder operational procedures and criteria, I had a telephone conversation with the licensee's biologist on October 25, 2004. According to the licensee, there has been much confusion and direction from the resource agencies regarding the ladders' operation. He stated that they were in the process of preparing operation plans for the ladders and a draft of the plans was scheduled to be submitted to the resource agencies in November. I requested that a copy of the final plans be sent to me.

Photograph 1: Keno vertical slot fish ladder.

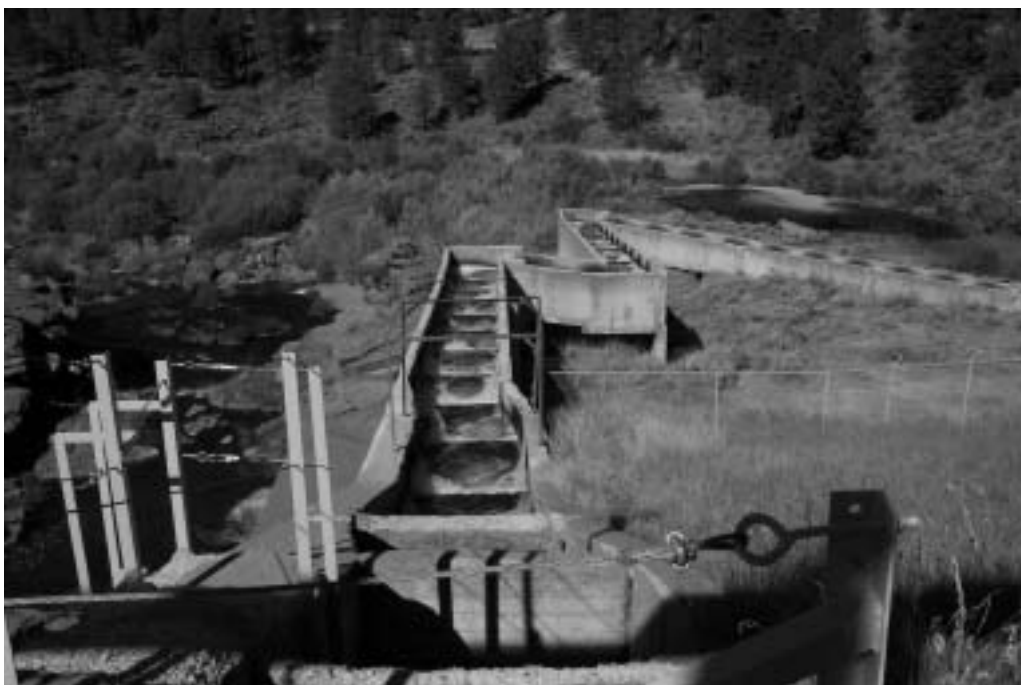
Photograph 2: JC Boyle pool and weir fish ladder.

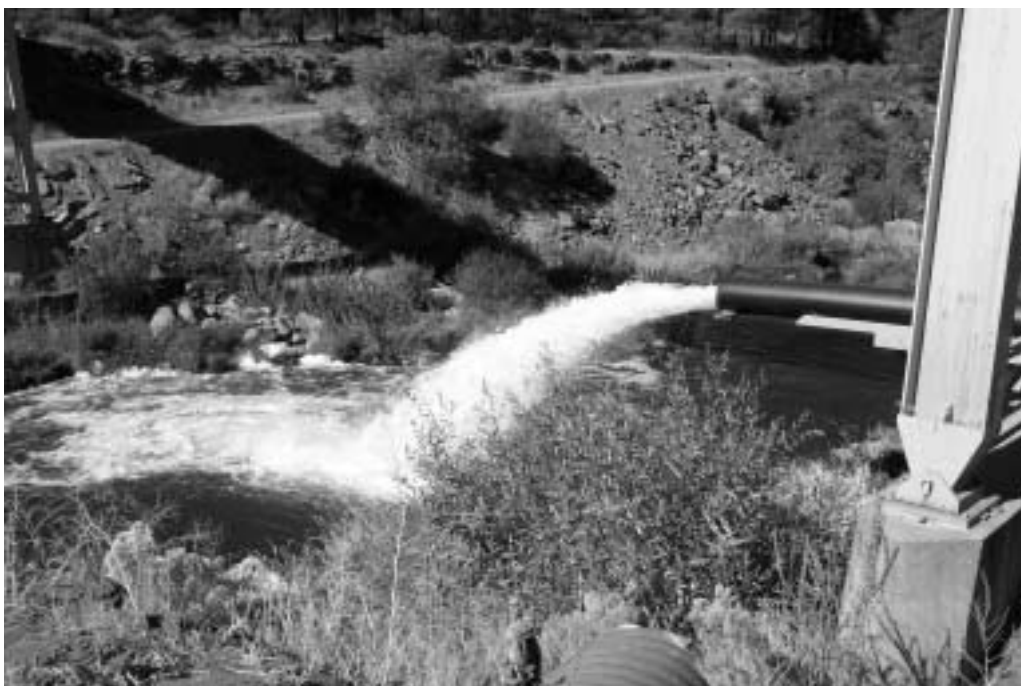
The licensee operates and maintains fish screens at JC Boyle to protect downstream migrants. Fish are diverted to a bypass pipe (Photograph 3), which enters the bypassed reach just downstream of the dam. The outfall pipe was recently extended and the plunge pool was excavated to help protect downstream migrants.

Photograph 3: JC Boyle bypass reach minimum flow and downstream migrant release pipe.

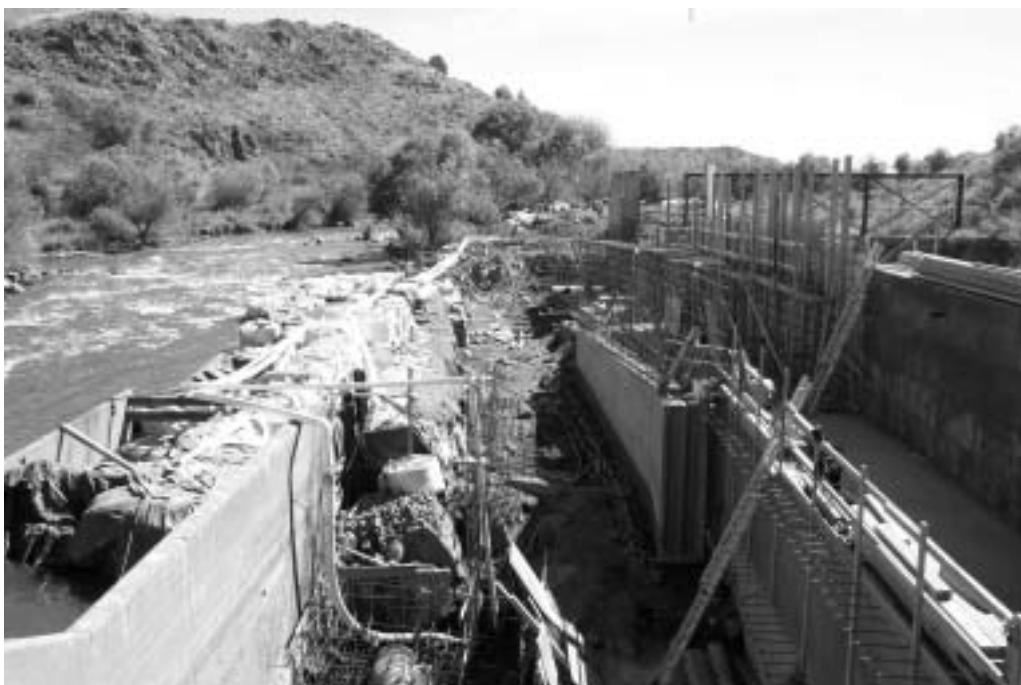
Photograph 4: New fish ladder construction at BOR's Link River Dam.

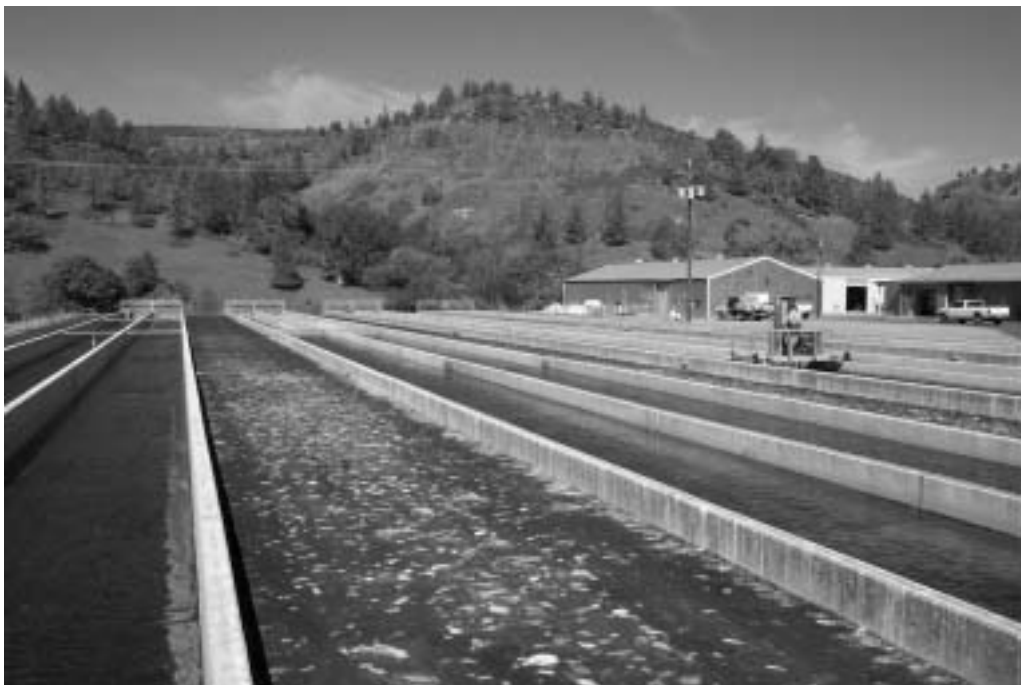
The licensee provides funding to the California Department of Fish and Game for the operation of the Iron Gate Fish Hatchery (Photograph 5). Salmon and steelhead enter the ladder (Photograph 6) at the base of Iron Gate Dam, which directs them to a series of holding ponds (Photograph 7) for collection and transport to the hatchery. The licensee also maintains nesting platforms for osprey at Copco 1 and Iron Gate reservoirs.

Photograph 5: Iron Gate fish hatchery.

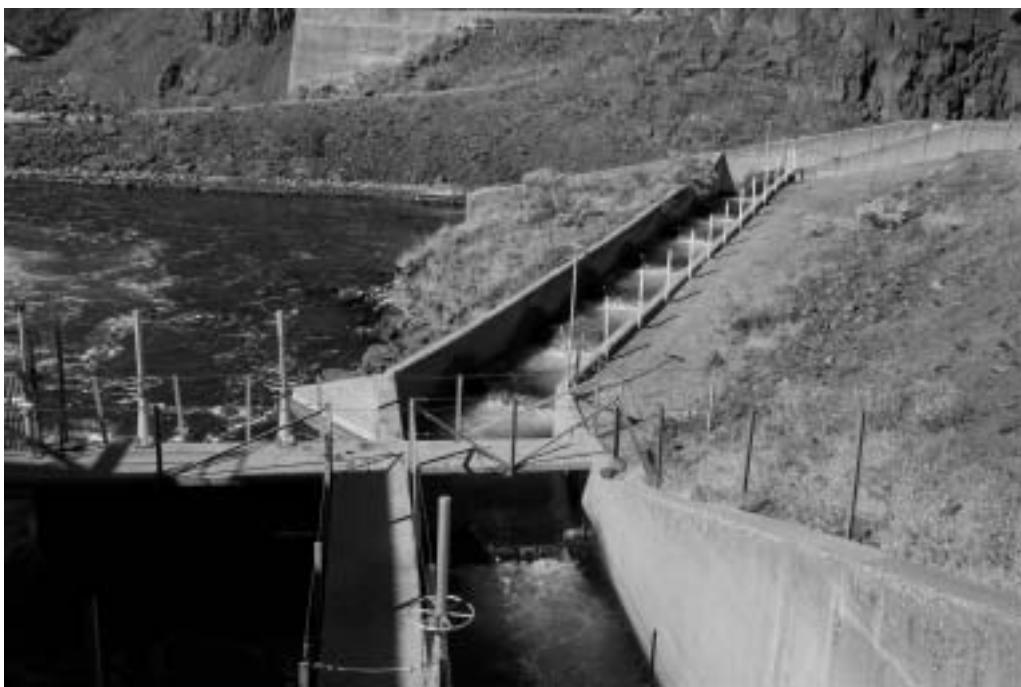
Photograph 6: Iron Gate pool and orifice ladder to fish holding ponds.

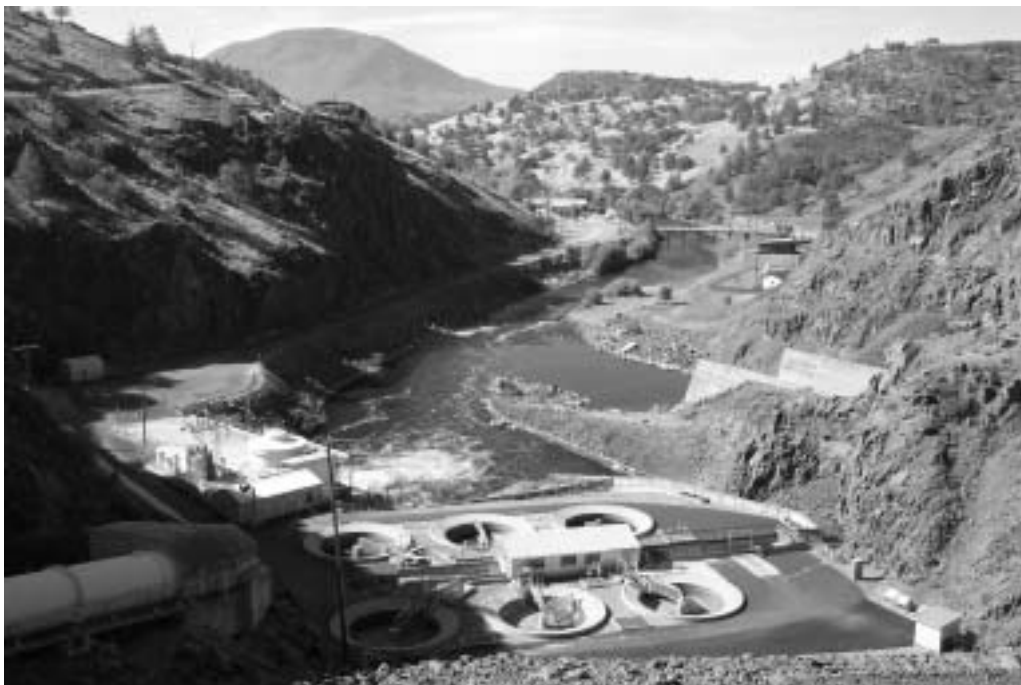
Photograph 7: Fish holding ponds below Iron Gate.

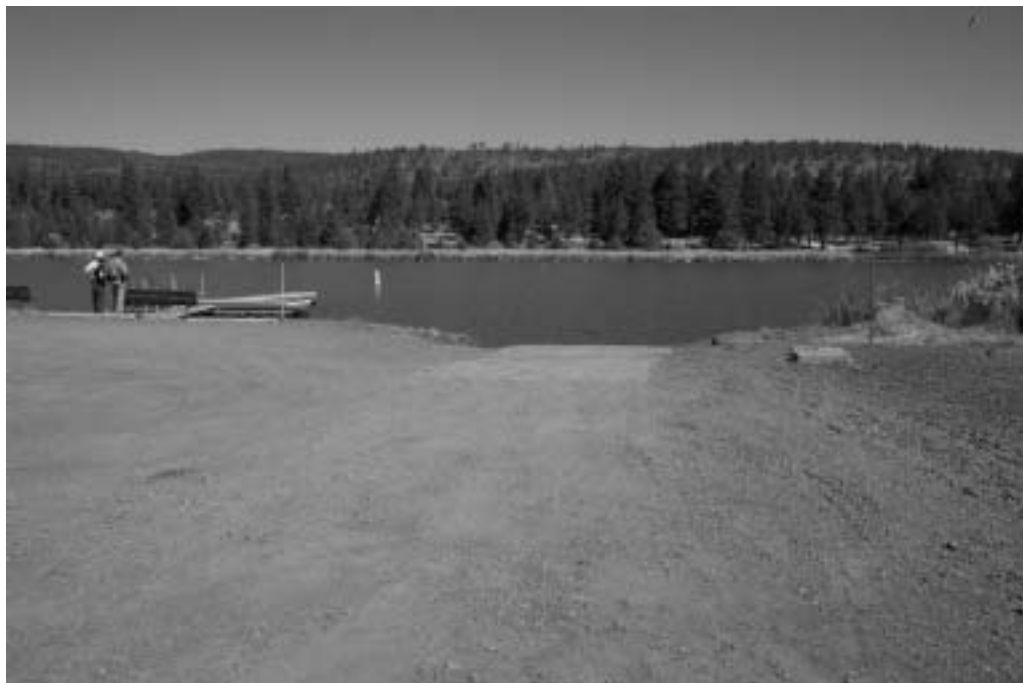
Recreational facilities operated and maintained by the licensee at the project include: a) the Link River Bird Sanctuary and Small Animal Refuge, which includes trails and vault toilets; b) South Bank Recreation Site (Photograph 8), which includes camping, restroom facilities, boat launch and docks (Photograph 9), and a parking lot; c) Pioneer Park, which includes picnic facilities, vault toilets, and boat launch; d) Klamath River fishing access sites, which contain vault toilets at some of the sites; e) Copco Cove, which includes picnic facilities, a portable toilet, and boat launch; f) Mallard Cove (in cooperation with the BLM), which includes a parking lot and boat launch; g) Overlook Park, which includes picnic facilities and fishing access; h) Long Gulch, which includes a campsite and boat launch; i) Iron Gate dam parking lot and boat launch; j) Mirror Cove, which includes camping, vault toilets, and boat launch; k) Juniper Point Camp, which includes camping and a swimming area; and l) Camp Creek, which includes camping (Photograph 10), picnic facilities, and boat launch (Photograph 11). A Part 8 sign is located near the entrance to the Iron Gate Fish Hatchery (Photograph 12) and near the entrances to the other project campgrounds.

Photograph 9: South Bank Recreation Site boat launch.

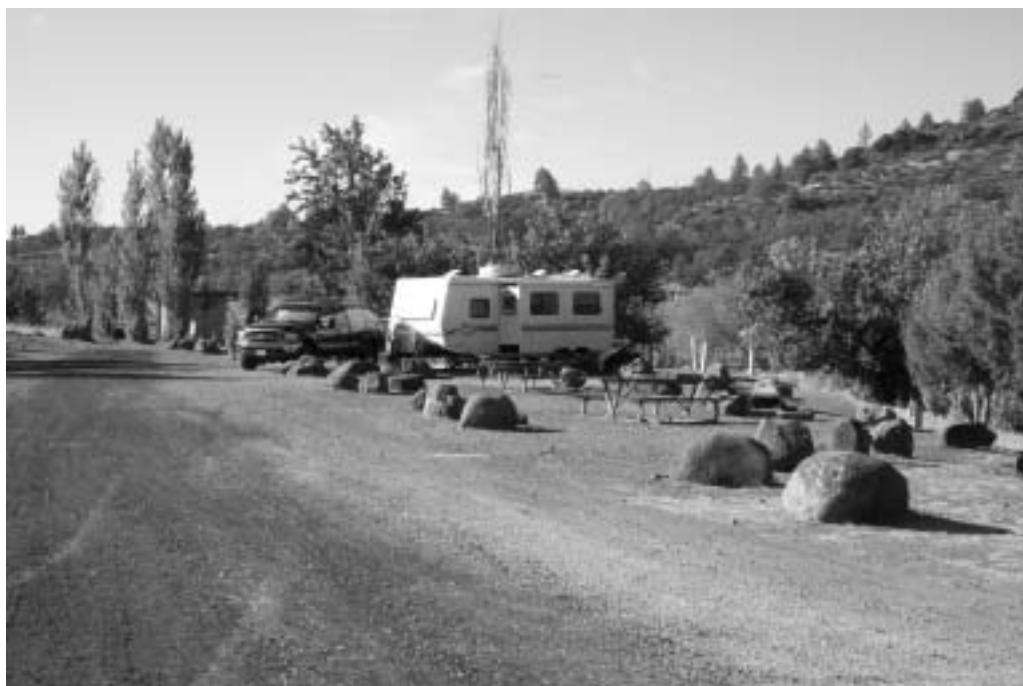
Photograph 10: Camp Creek Campground.

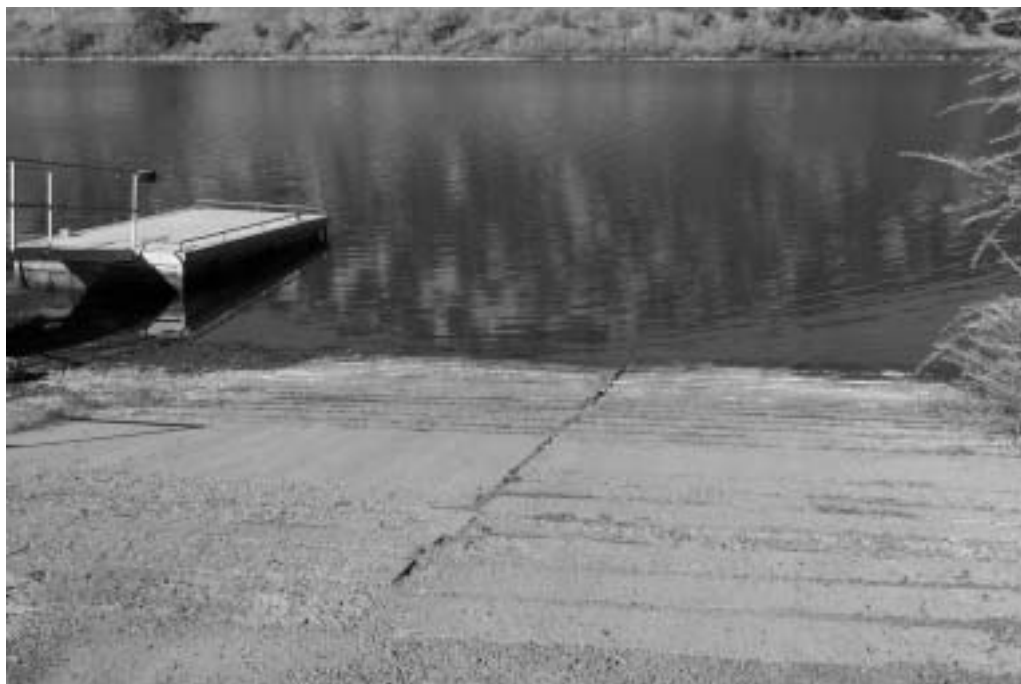
Photograph 11: Camp Creek Campground boat launch.

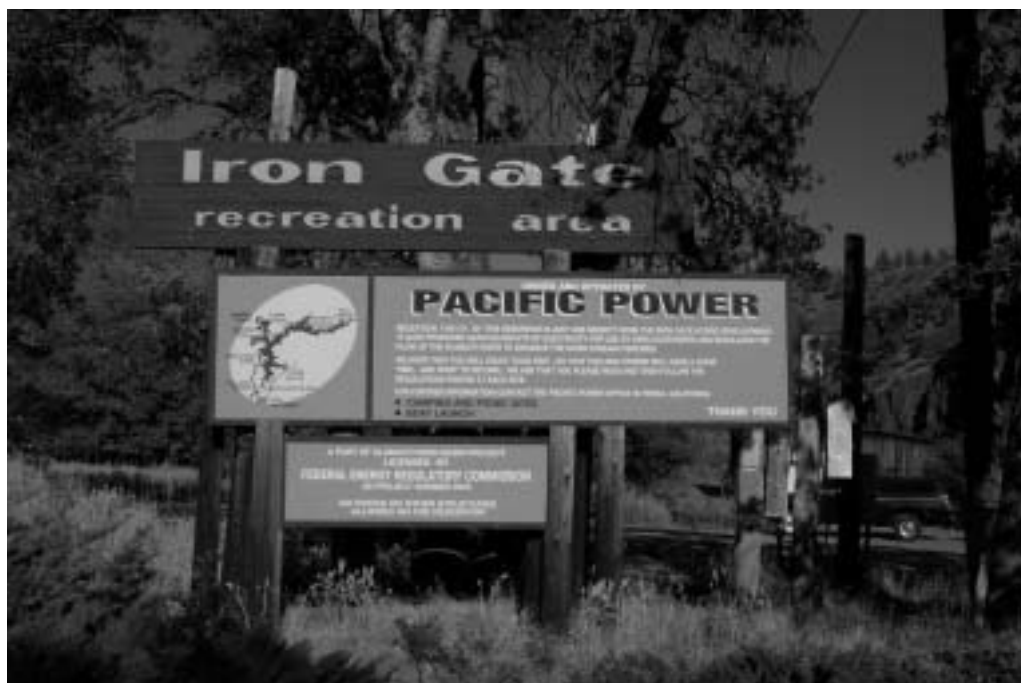
Photograph 12: Part 8 sign at Iron Gate.

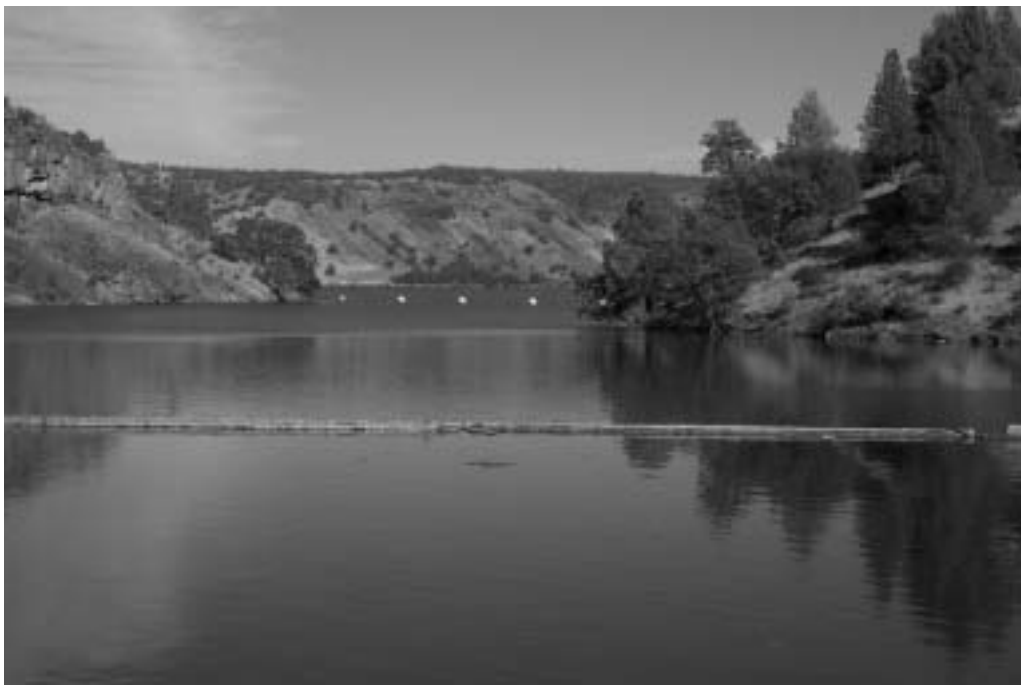
The licensee maintains boat-restraining barriers at each of the project dams (Photograph 13); however boating is prohibited at Copco 2 and Fall Creek so boat barriers are not required. Appropriate fencing and warning signs are also maintained around the project (Photograph 14). All barriers, signage and fencing were in satisfactory condition on the day of the inspection.

Photograph 13: Boat barrier upstream of Copco 1.

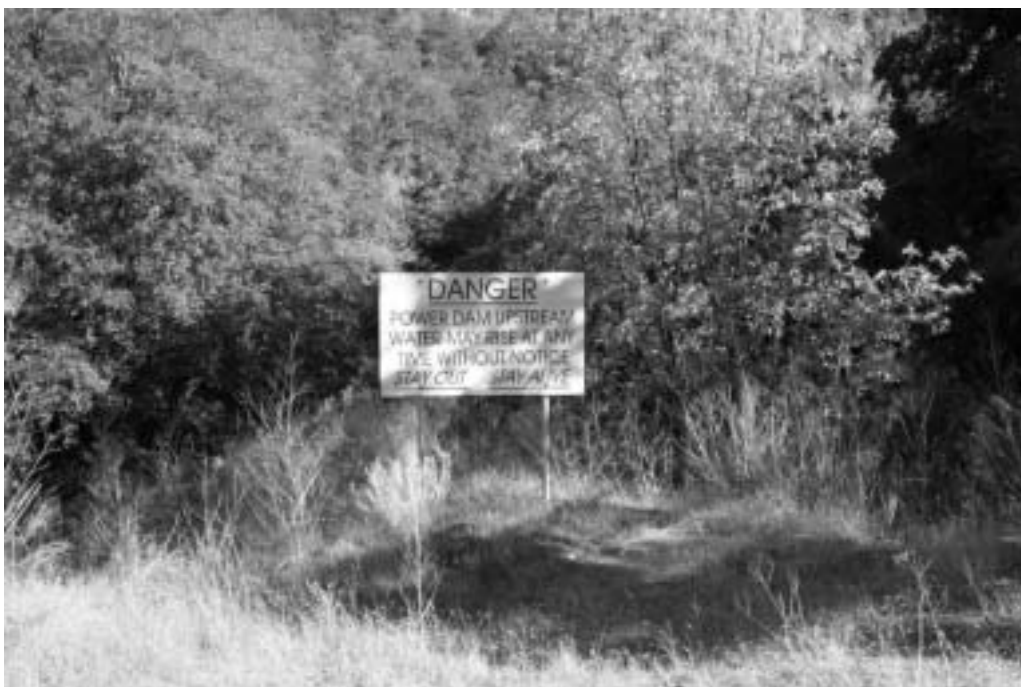
Photograph 14: Warning sign below Copco 2.
