## **GEOPHYSICAL INVESTIGATION REPORT**

**ADOT Project No. 095 LA 158 F0706 01D**

**South of Parker Dam**

**October 2, 2025**

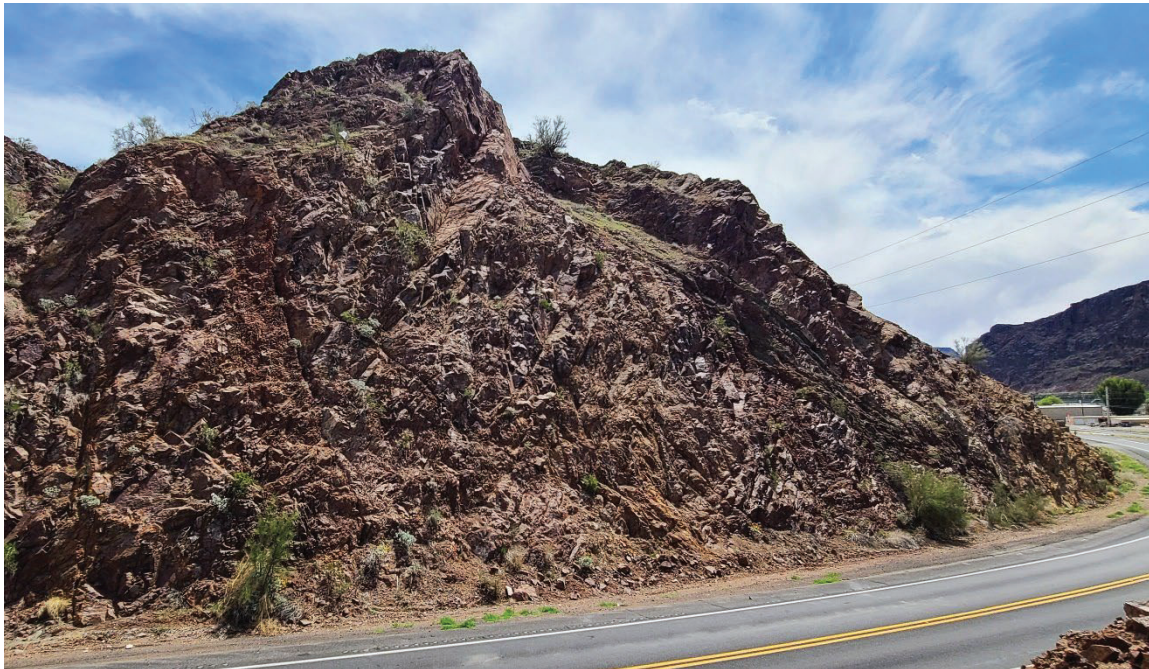
Figure 2: View of the cut slope along NB travel lanes at the location of SL-1

The cut slope at the location of SL-1 where the slope drape is proposed is a fractured and jointed granite and gneiss bedrock. Because the slope was not accessible, the seismic refraction line was conducted along the base of the cut slope.

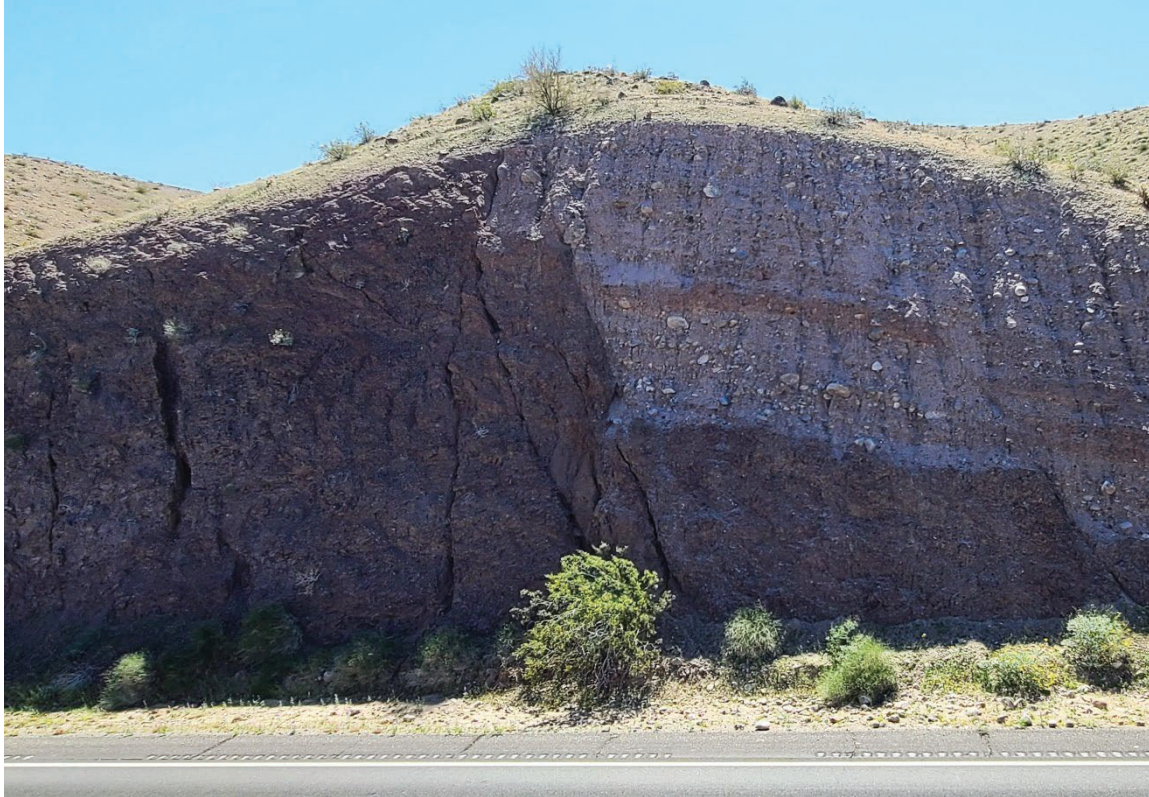
**Figure 3: View of the cut slope along NB travel lanes at the location of SL-2**

The location of the cut slope where SL-2, near the north end of the project, was selected because this cut slope exposed the granite and gneiss bedrock and the alluvial soil overlying the faulted granitic bedrock.

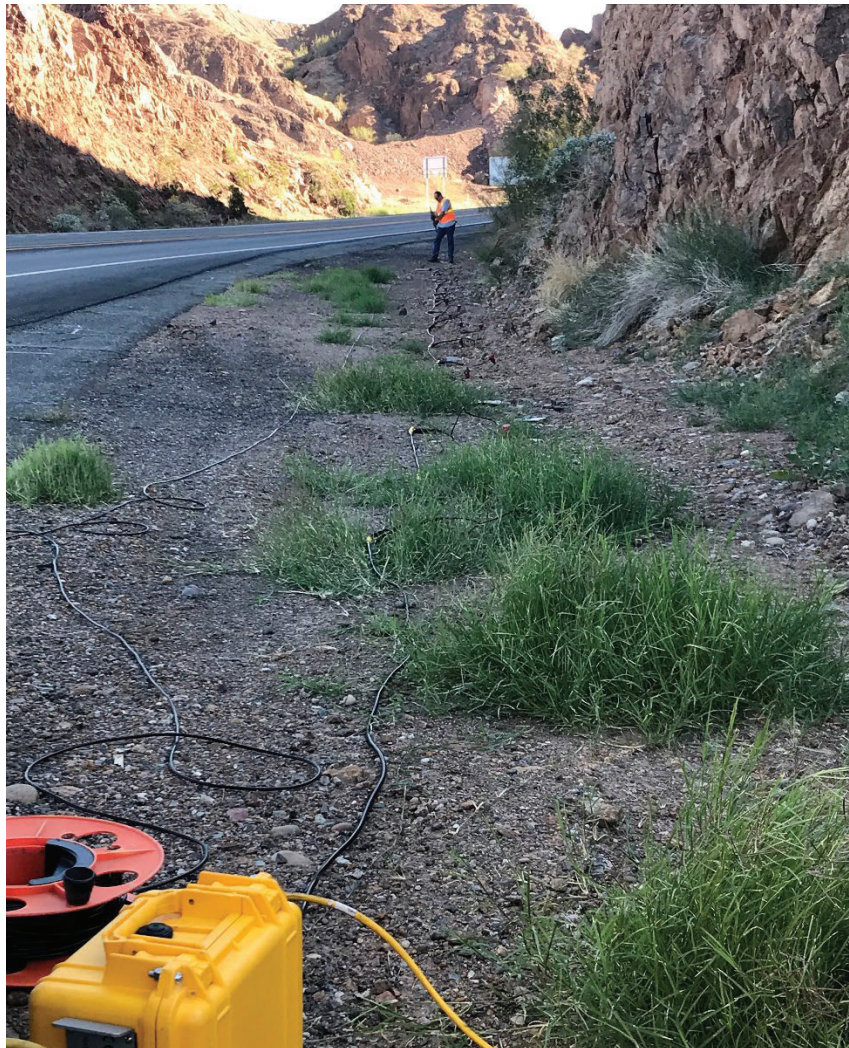
**Figure 4: Seismic Line SL-1 located along the base of the proposed draped slope**

Figure 4 shows the location of seismic survey line SL-1 at the base of the slope where anchored rockfall drape is planned to be installed. The refraction seismic surveys were conducted using a 24-channel, signal enhancement seismograph (Geometrics SmartSeis ST Model SE-24) and a sledgehammer served as the energy source for the survey. The survey line was 120 feet long with geophones placed at 5-foot intervals. Data was retrieved using hammer impacts about 15-foot away from the ends of the seismic line array and a location near the middle of the array. Data from multiple impacts at each impact location are added together to increase signal resolution to obtain the seismic record. The results of the refraction seismic survey provide additional subsurface data to a depth on the order of approximately 30 to 45 feet below the existing grade.

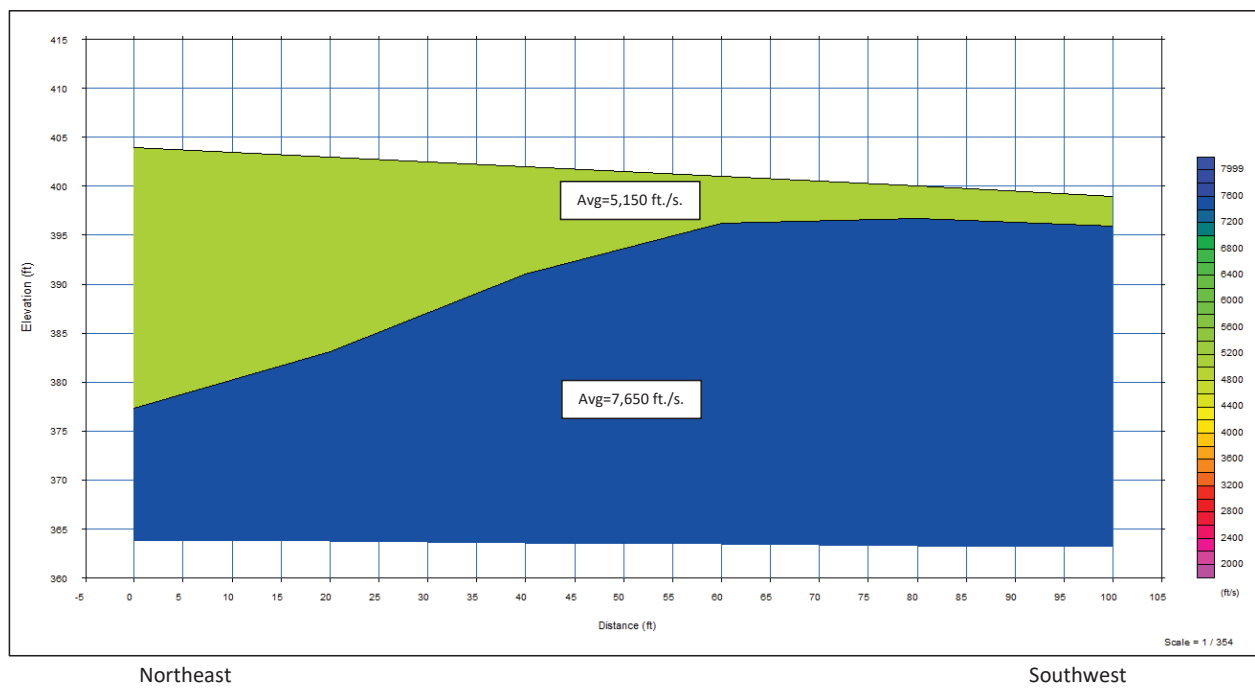
Figure B-2: P-wave Velocity Model for seismic refraction line SL-1

| Survey Lines | Estimated Surface Elevation Range (MSL in ft.) | Layer | Depth Below Surface* (ft.) | Average P-wave Velocity (ft./sec.) |
|---|---|---|---|---|
| SL-1 | 365 to 405 | 1 | 0 to 25 | 5,150 |
| | | 2 | 3 to 40 | 7,650 |

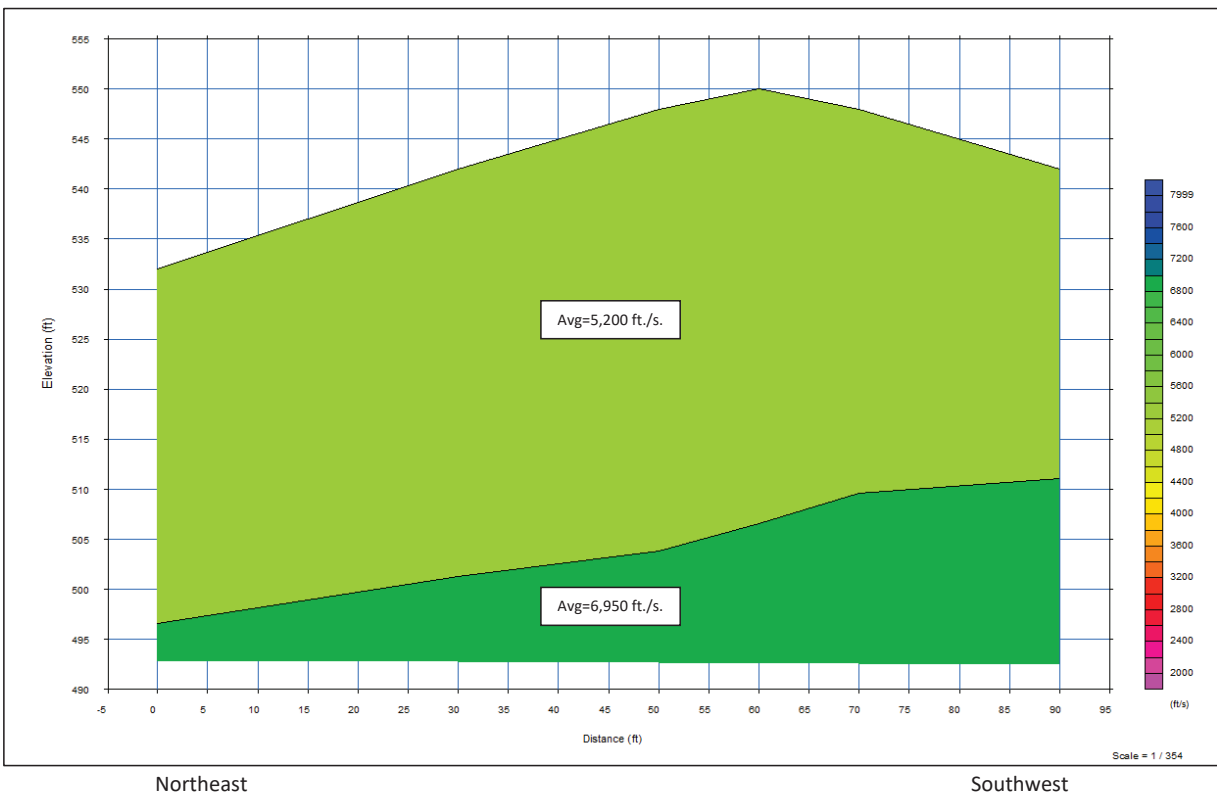
Figure B-3: P-wave Velocity Model for seismic refraction line SL-2

| Survey Lines | Estimated Surface Elevation Range (MSL in ft.) | Layer | Depth Below Surface* (ft.) | Average P-wave Velocity (ft./sec.) |
|---|---|---|---|---|
| SL-2 | 4945 to 550 | 1 | 0 to 45 | 5,280 |
| | | 2 | 35 to 45 | 6,950 |
