# TECHNICAL SERVICE BULLETIN

## 1" Automatic Diesel Nozzle Thread Leaks

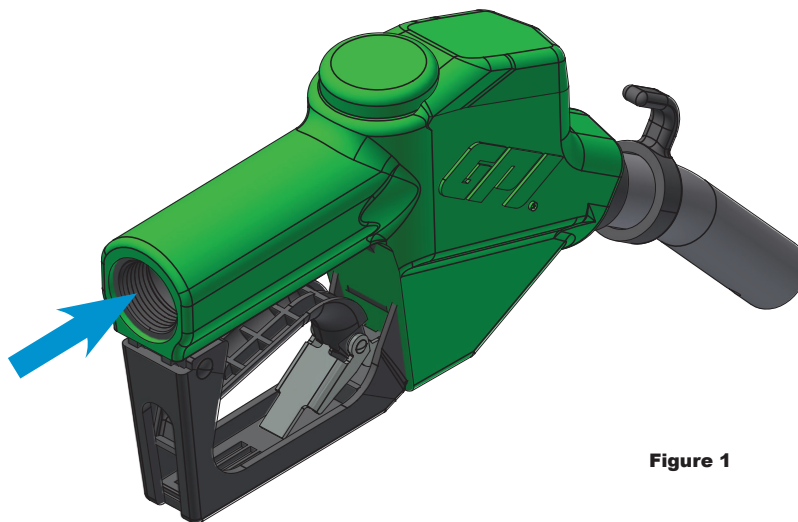
Figure 1

Intermittent tolerance variance on inlet thread of nozzle may result in leaking at hose connection when the nozzle is installed without the use of a pipe thread sealant paste. Nozzles reported with this issue have been evaluated by GPI. The threads of the nozzles were checked with gauges, and it was discovered that we had received nozzles with BSPT threads from our supplier.

GPI has adjusted the tolerance specifications of the nozzle inlet port (see Figure 1) to improve thread engagement with hose end fittings at this connection point.

Contact GPI and request a Return Material Authorization (RMA) to return any leaking nozzles to GPI for evaluation. GPI will ship out replacement nozzles free of charge.
