# Shock and Vibration Summary Test Report

Date creation: October 26<sup>th</sup>, 2003

DOCUMENT REFERENCE										
Project number	ТҮРЕ	FORMAT	PAGE							
D00318	Summary Test Report	Lt	1							
			- REV

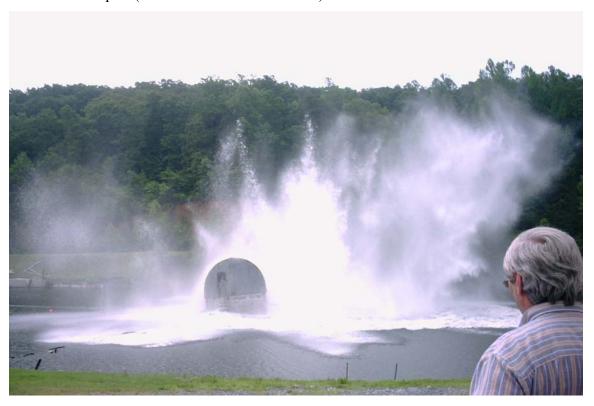
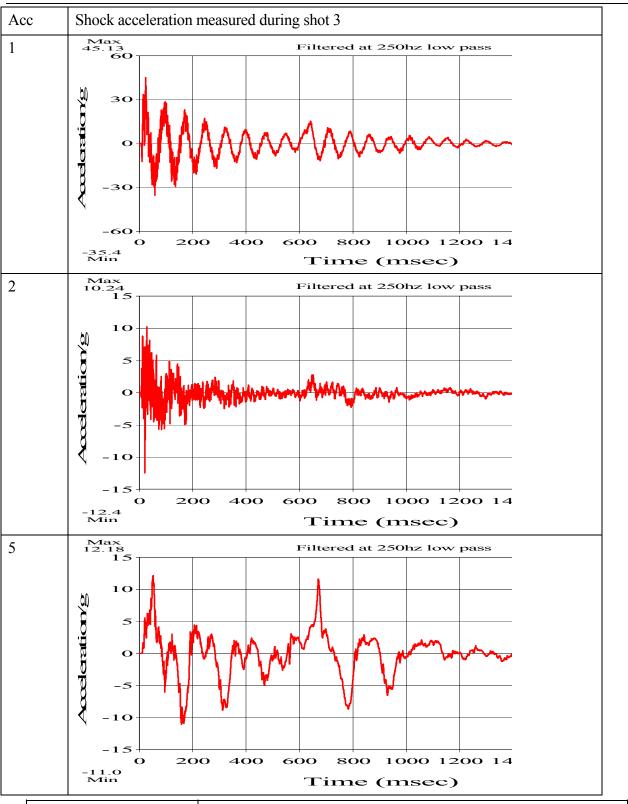
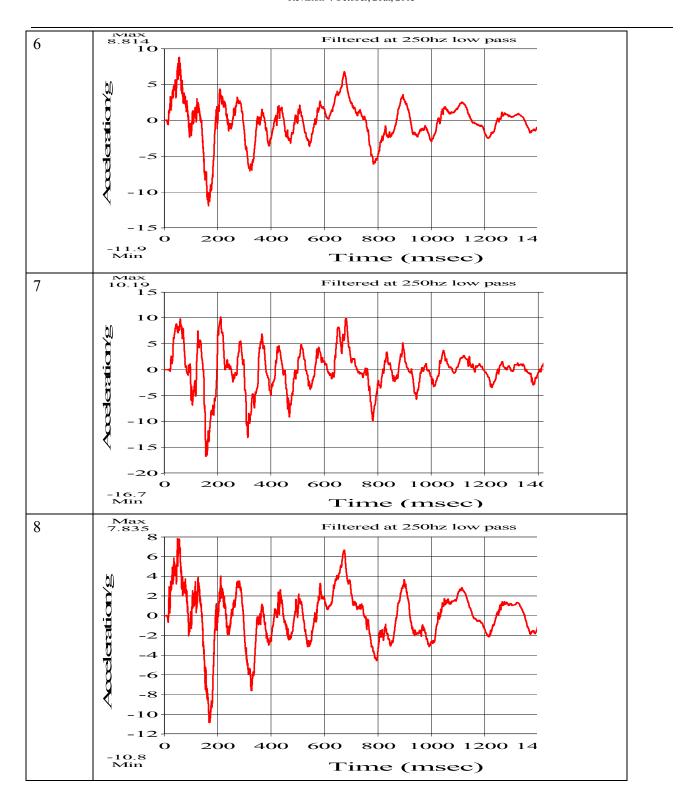
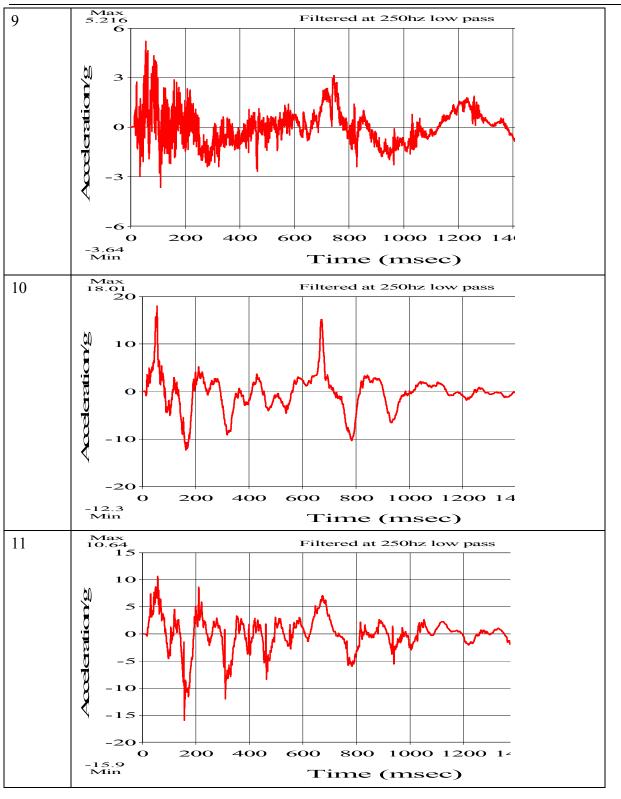
# Shot 3 result summary

Test results have been limited to the most severe and representative test (shot 3 with the 60lbs explosive charge horizontally located at 20 ft from the barge). Other results are fully documented in the shock and vibration test report (DTI document reference 655).

- No defect has been noted on racks (no loose hardware, scratch, dent...)
- The shock isolators did not bottom during the most severe shots (3 and 4).
- Vertical deflection (sway space downward) was measured at 3.5" on clay cone.

- The sway space measured and the level of G response inside the racks is in good accordance with the calculation performed to select the shock mounts. This validates the theoretical model and L/D data used by 901D,LLC to perform barge test shock analysis.

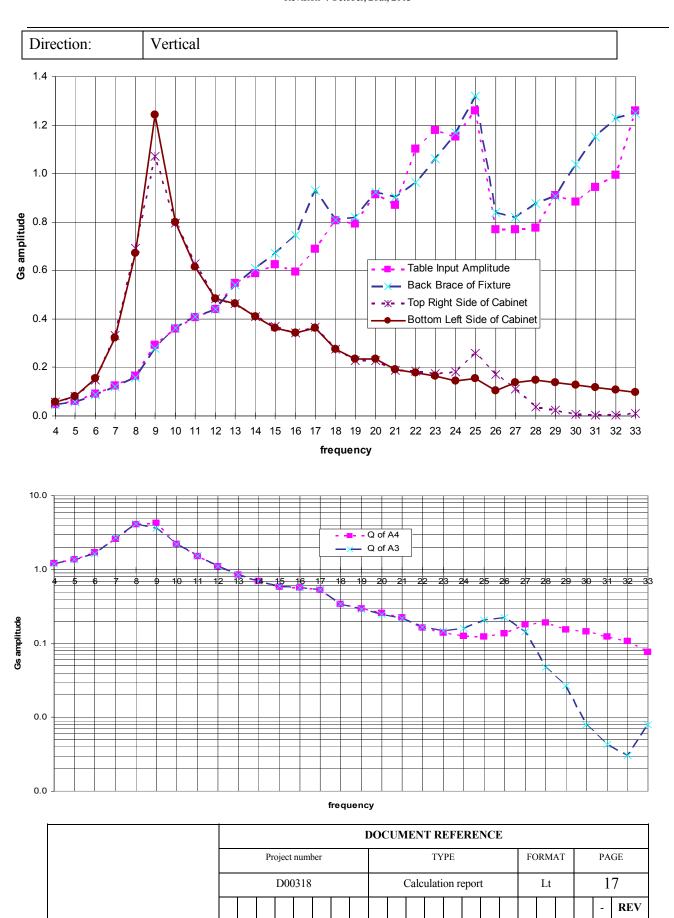
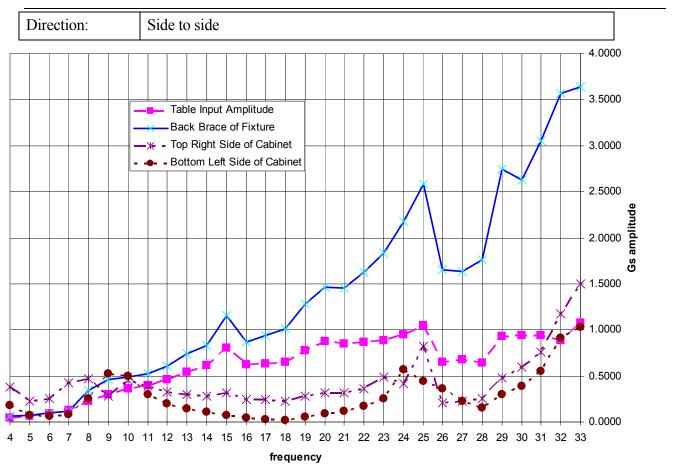
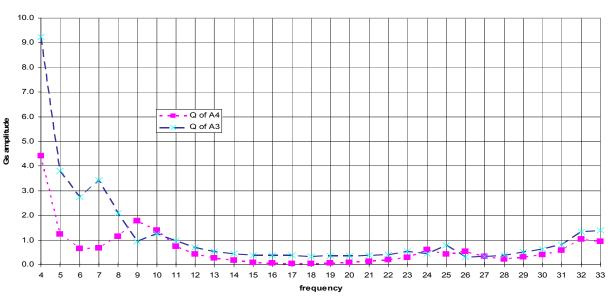
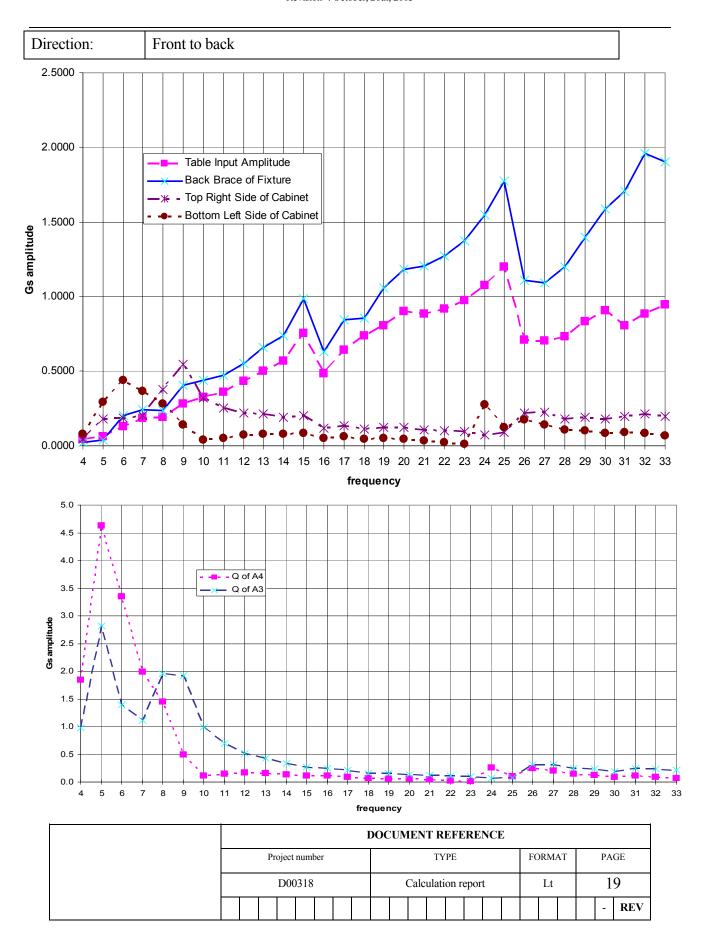
# Vibration result summary

The side to side test has shown an important coupling effect between the vibration table, the test fixture (chassis) and the rack under test. This condition has been generated by the test fixture having a frequency resonance in the side to side axis within the frequency range of the test

This coupling has generated a vibration input at the top of the test fixture well above the MIL STD 167 requirement: 3.7g instead of 1 g.

→ In this configuration, the rack has been over-tested.

Same phenomenon was also noted on the front to back direction, however significantly lower than in previous axis (1.9g instead of 1g).

In both cases, the high damping effect of the shock absorbers has dramatically reduced the level of vibration applied to the rack. The vibration transmitted to the rack was always below 1g for these 2 axes.

The maximum amplitude transmitted to the rack was measured at the resonance in the vertical direction around 1.2g @ 9 Hz.
