ROAD SAFETY AUDIT

Route 20 (Boston Post Road) at Landham Road

Town of Sudbury

June 10, 2015

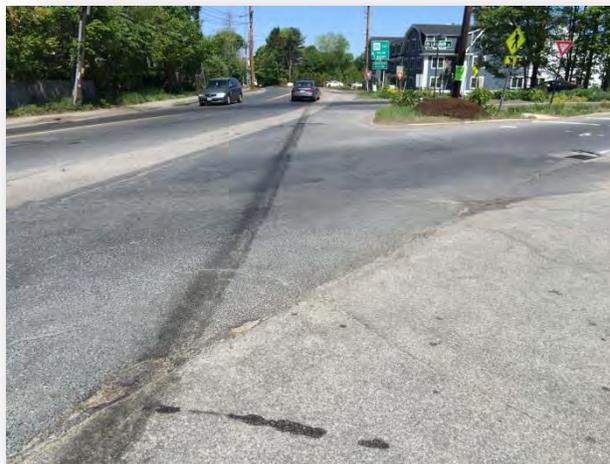
- **Pavement Conditions** – At the time of the audit, high severity cracking on Boston Post Road (Route 20) and within the intersection was observed. Utility maintenance has been performed in the past and therefore, the Boston Post Road (Route 20) has evidence of pavement ‘trenching’ which indicates where access to underground utilities was required. Both approaches of Route 20 have utility trenches where the pavement has settled causing an uneven travel surface for vehicles. This may be a result of poor compaction in the soil beneath the trench asphalt which has since settled and caused the pavement above to do the same. Very slight pavement rutting was noticed at all approaches to the intersection as well. Pavement rutting can promote rear-end crashes as asphalt bleeding usually occurs around the ruts. This issue could have contributed to the numerous rear-end type crashes which

Poor pavement conditions along Boston Post Road.

occurred along all approaches to the intersection. Approximately 31 percent of the total queried crashes at this intersection were rear-end crashes. Additionally, the ruts can collect standing water during rain events/melting snow or be locations with ice in the winter. Town officials reiterated the fact that Boston Post Road (Route 20) at this location has not been re-paved in several years. There are potholes present along both approaches on Boston Post Road (Route 20), causing motorists to essentially “dodge” these hazards to preserve the integrity of their vehicles. This poses a significant safety concern as vehicles may swerve into an opposing traffic lane or off the side of the roadway to avoid these potholes increasing the possibility of a head-on collision or single vehicle collision respectively. Referring to the crash data summary and the collision diagram within the Appendix of this RSA, crashes 54 (a head-on collision) and 20 (a sideswipe, opposite direction) may have resulted from drivers maneuvering around potentially detrimental potholes. Just like all pavement, over time this pavement surface has started to wear down and lose its friction resistance. Poor roadway conditions, especially wet pavement, have been identified by the Federal Highway Administration as a major factor in roadway departure crashes. Approximately 17 percent of collisions to occur at this intersection happened under wet, snowy, or icy pavement surface conditions.

- **Pavement Conditions** – It is recommended that the pavement structure be evaluated and proper measures be taken to rehabilitate pavement to eliminate rutting, settlement, and dangerous potholes. This improvement will provide vehicles with an even travel way and improved friction resistance. This may decrease the potential of rear-end crashes in wet or icy roadway conditions as well as reduce the possibility of a head-on, sideswipe, or single vehicle crash due to vehicles intentionally avoiding dangerous potholes.
- **Pavement Markings** – Markings should be refreshed to be visible, clear and reflective. New retro reflective pavement markings can increase visibility during both daytime and nighttime conditions which can decrease the possibility of a lane departure collision or head-on collision. It should be noted that this can be done prior to the project as a part of maintenance.

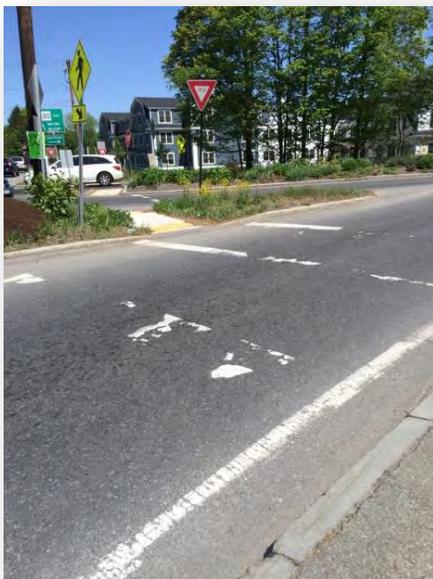
- Pavement Markings – Pavement markings on both Boston Post Road (Route 20) and Landham Road were slightly faded along all approaches of the intersection, with some significant fading in specific areas. The crosswalks across Landham Road were severely faded along with the STOP bar at this approach and the “shark teeth” yield markings along the channelized right turn lanes to and from Landham Road. It should be noted that the crosswalks at this location were the standard parallel crosswalk markings which can often times be confused with the STOP bar. The faded “shark teeth” yield markings, specifically those along the eastbound right turn lane pose a significant safety concern as turning speeds along this approach tend to be higher. Any additional warning of a yield control at this location is necessary and aids in driver yielding rates. It should be noted that there are two sets of “shark teeth” markings on the northbound channelized right turn lane, one before the crosswalk and one beyond the crosswalk. Both sets are faded and in poor condition. In general, pavement markings provide clarity to motorists and assist in the reduction of nighttime crashes of which approximately 15% of the queried crashes were reported to have occurred.

Faded pavement markings along eastbound channelized right turn lane.

The refreshment of the yield markings on both slip lanes will provide more awareness to the driver of the yield condition which may decrease the possibility of a rear-end or angle type collision.

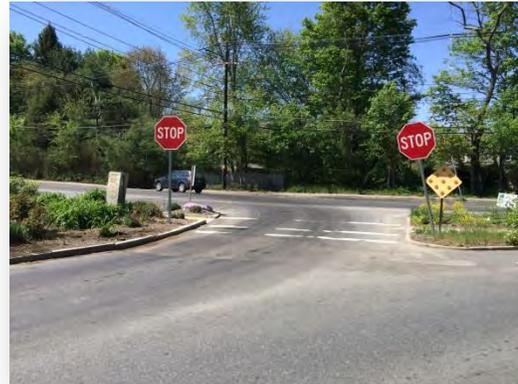
- **Signage** – The STOP sign on the right side of the northbound approach on Landham Road has been hit and is tilted over to the left side.

Typically, the visibility of a traffic sign will diminish if not vertically straight. Since the sign is leaning in towards the roadway, it puts the sign in jeopardy of being hit again and causing property damage to a vehicle since the lateral clearance is no longer sufficient.

STOP sign on the right has been hit and it tilting into the roadway.

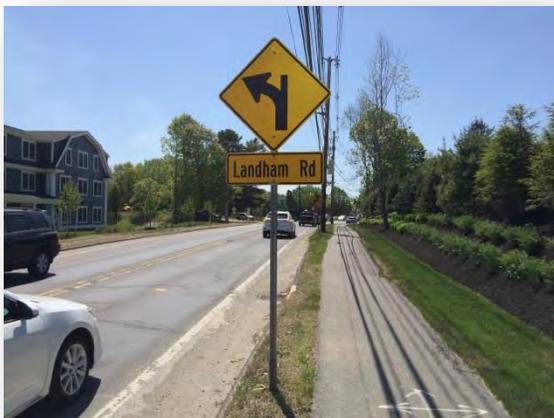
Existing W1-10b sign along westbound approach that does not properly portray horizontal alignment of roadway.

The intersection warning signs (W1-10b) with supplemental road name plaques (W16-8P) located on both the eastbound and westbound approaches do not properly reflect the horizontal curvature of the roadway on Boston Post Road (Route 20). These signs indicate that the thinner section extending straight is Landham Road. These signs should be updated to properly reflect the intersection geometry.

The intersection warning signs (W1-10B) with supplemental (W16-8P) road name plaques located on both the eastbound and westbound approaches should be replaced with W1-10 signs which better depict the actual horizontal alignment. The supplemental road name plaques should remain at these locations for advanced warning to approaching vehicles on Boston Post Road (Route 20).

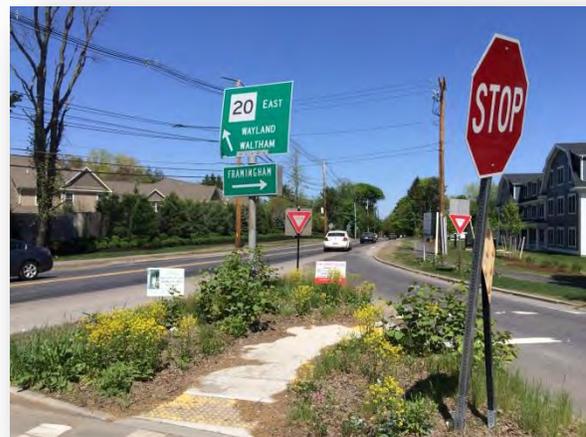
It was also observed during the field visit that the green destination signs located in the most eastern center island median are incorrectly located due to the existing intersection geometry. These signs direct drivers to either continue on Boston Post Road (Route 20) or take Landham Road towards Framingham. Generally, signs are located immediately after the required turn. However, the location of this sign promotes vehicles unfamiliar with the intersection to enter Landham Road at the wrong opening. Therefore, vehicles traveling

Green destination sign currently located in the eastern most island falsely directs motorists to enter Landham Road at wrong opening.

westbound on Boston Post Road (Route 20) may be misled and access Landham Road via the northbound channelized right turn lane while vehicles traveling eastbound on Boston Post Road (Route 20) may enter Landham Road via the northbound left turn lane on Landham Road rather than utilizing the channelized right turn lane on Boston Post Road (Route 20). The latter of these two actually occurred during the site visit on May 21st in which an eastbound motorist entered Landham Road via the northbound left turn lane and continued on Landham Road the wrong way. This occurrence is exacerbated due to the lack of do not enter signs to prohibit vehicles on Boston Post Road (Route 20) from entering the northbound left turn approach lane on Landham Road. Referring to the collision summary and the collision diagram included within the Appendix of this RSA, collision 26 involved a westbound motorist on Boston Post Road (Route 20) who executed a left turn onto Landham Road and entered via the northbound left turn lane resulting in a head on collision.

The placement of the green destination signs located within the most eastern median should be revisited. Destination signs for both eastbound and westbound approaches should be relocated to the most western island. This will ensure that the arrow directing vehicles to Framingham points will guide vehicles to the correct entry way onto Landham Road. This will reduce the possibility of a head on collisions caused by drivers unfamiliar with the intersection entering the wrong way on Landham Road.

Do Not Enter (R2-1) signs should also be installed at the northbound left turn lane to inform vehicles on Boston Post Road (Route 20) that they should not enter Landham Road at this location? This too will reduce the possibility of a head on collision caused by drivers unfamiliar with the intersection entering the wrong way on Landham Road.

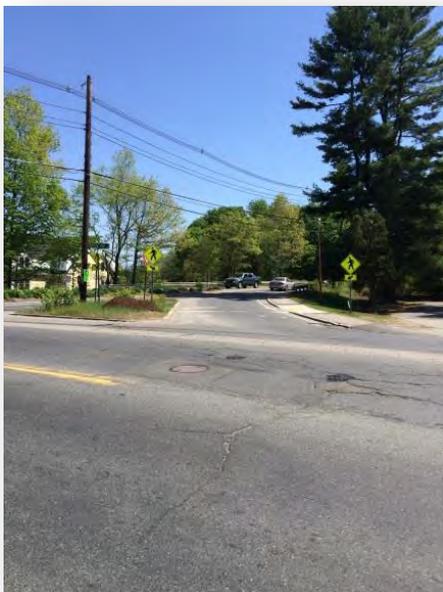
There is only one yield sign present for eastbound right turn lane which is typically a fast turning movement.

Audit team members also pointed out that there is only one YIELD sign present for the eastbound right turn lane on Boston Post Road (Route 20), located on the left side of the roadway. Typically, YIELD signs would be located on the right side of the roadway. Since this is such a heavy conflict point, consideration should be made to install retro-reflective YIELD signs on both sides of the roadway to increase driver awareness.

It was observed that only one YIELD sign is installed for the eastbound right turn lane and is located on the left side of the road. Audit team members suggest that an additional YIELD sign be installed on the right side of the roadway to increase driver awareness of the YIELD control at this location. This may reduce the potential of an angle or rear-end type collision at this conflict point.

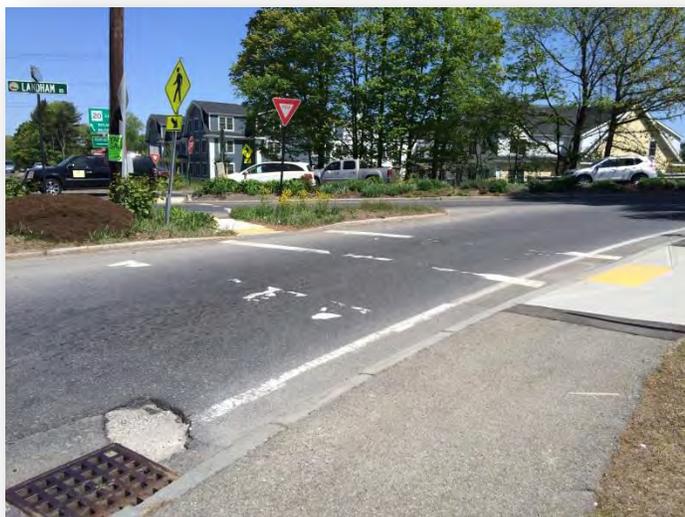
- Intersection Geometry – As mentioned previously, Landham Road intersects Boston Post Road (Route 20) from the south to form a “T” intersection. There are three center island medians which separate northbound vehicles on Landham Road wishing to execute a left turn onto Boston Post Road (Route 20) westbound and westbound left turning vehicles on Boston Post Road (Route 20) wishing to continue onto Landham Road. As previously mentioned, the destination signs located at the intersection could confuse motorists unfamiliar with the intersection and they may enter Landham Road via the wrong entrance. These islands also create slip lanes for both northbound and eastbound right turning vehicles. Slip lanes are generally designed with very large corner radii that put an emphasis on easy and fast vehicle travel. This can have a negative effect for pedestrians, especially at slip lanes controlled by a YIELD sign rather than a signal or STOP sign. Since motorists tend to focus more so on merging with oncoming traffic, they may not see pedestrians entering the crosswalk. For pedestrians waiting to cross at the southeastern side of the intersection, sight distance is a concern because of the large radii and is compounded by the overgrown vegetation along the western side of Landham Road. It is also common at YIELD controlled slip lanes for vehicles to already be looking left for oncoming traffic and accidentally rear-end the driver in front of them when they think there is an adequate gap. Referring to the collision summary and collision diagram included within the Appendix of this RSA, collisions 42 and 52 can be attributed to this common tendency.

Slip lanes generally promote high speed turns which pose significant conflicts for pedestrians waiting to cross at these locations.

Vehicles traveling eastbound on Boston Post Road (Route 20) and turning right onto Landham Road via the slip lane tend to travel at a higher rate of speed because they are coming from a free flowing roadway. These vehicles must then yield to westbound left turning vehicles from Boston Post Road (Route 20). Although the collision diagram does not show many collisions at this

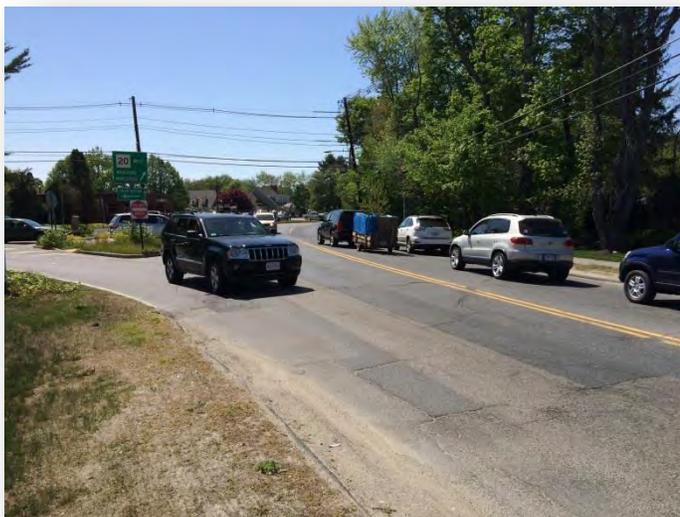
- Excessive Queuing – The intersection of Boston Post Road (Route 20) and Landham Road experiences heavy congestion especially during the peak commuter periods. As the traffic counts indicate, there are heavy left turn volumes on both the northbound and westbound approaches to the intersection. There is also heavy through movement volume on the eastbound approach which makes it difficult for left turning vehicles to find adequate gaps in traffic to execute a safe left turn maneuver. This results in significant queuing on both the northbound and westbound approaches. The lack of sufficient gaps in traffic on Boston

Queues develop along westbound approach on Route 20 as a result of left turning vehicle waiting for adequate gap in opposing traffic.

Post Road (Route 20) increases the potential for aggressive and distracted driving. It was also suggested that eastbound mainline motorists on Boston Post Road (Route 20) stop to let vehicles turn left into and out of Landham Road. However, this ‘courtesy’ gap often increases backups on Boston Post Road (Route 20) eastbound and is also a safety hazard for people using the intersection, resulting in potential rear-end collisions. Referring to the collision summary and diagram included within the Appendix of this RSA, a total of four rear-end collisions (33, 39, 41, and 45) occurred on the eastbound approach to the intersection.

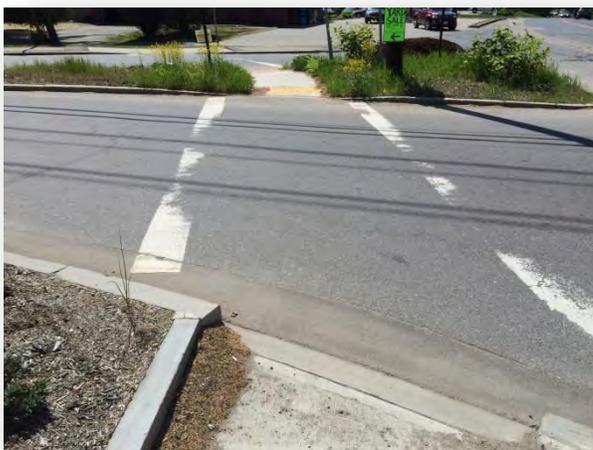
- Pedestrian Accommodations – Currently sidewalk is present along the northern side of Boston Post Road (Route 20) and is in fair condition west of the intersection but in good condition east of the intersection. A new hot mix asphalt sidewalk was installed with the construction of the restricted senior living residential development. This sidewalk is in good condition and is present along the southern side of Boston Post Road (Route 20) east of the intersection and terminates at the senior residential development. There is also a sidewalk along the western side of Landham Road in good condition. There is a crosswalk available across Landham Road at the intersection and is broken up by three center island medians which all provide pedestrian refuge. At the time of the audit,

Crosswalks are significantly faded and debris is present within pedestrian refuge islands.

there was significant debris located within the walkways at these locations making it difficult to navigate through the intersection as a pedestrian. ADA compliance is satisfied at each of the crossing locations which are equipped with cement concrete wheelchair ramps and associated detectable warning panels. It was suggested that crosswalks are fading and not visible, presenting safety concerns for pedestrians. These crosswalks are also parallel marking crosswalks which can often times be confused with the STOP bar. Pedestrian crossing assemblies (W11-2 in conjunction with W16-7P supplemental arrow plaques) are located at the Landham Road crosswalk informing vehicles traveling on Boston Post Road (Route 20) of the pedestrian crossing.

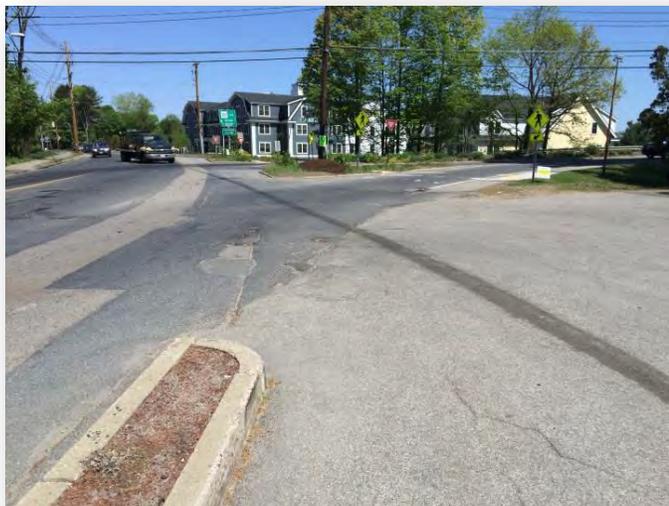
- Access Management – Sudbury Automotive, Inc. located in the southwest corner of the intersection has two wide and undefined driveways on Boston Post Road (Route 20). These wide curb cuts may be crossed by pedestrians, causing a longer period in which pedestrian/vehicle conflicts could occur. The close proximity of the driveways to the intersection creates conflicts with the Boston Post Road (Route 20) eastbound queues. Referring to the collision summary and diagram included within the Appendix of this report, there were four angle collisions involving vehicles entering and exiting the eastern driveway. This driveway is located very close to the eastbound right turn slip lane. Vehicles exiting the driveway may not expect vehicles to travel around the queue to the right which can increase the possibility of an angle type collision at this location. The close proximity of this driveway may also be confusing for westbound left turning vehicles on Boston Post Road (Route 20) if they see a right blinker indication because they may be unsure as to whether that eastbound vehicle is going to continue onto Landham Road or turn right into the gas station.

The wide and vague eastern driveway of Sudbury Auto. Inc. is located close to intersection adding additional conflict points.

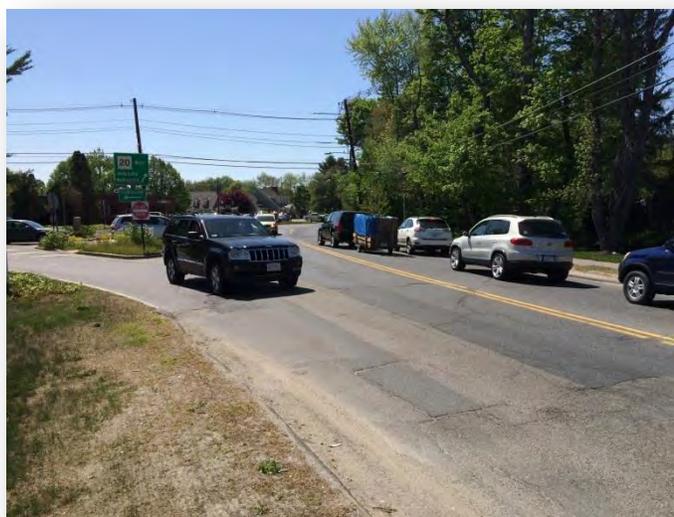
- Intersection Control - Route 20 (Boston Post Road) and Landham Road intersect to form a three-way unsignalized intersection. The Route 20 (Boston Post Road) westbound approach provides a single general purpose travel lane operating under free-flowing conditions. This approach does not efficiently serve the heavy volume of left turning vehicle at this approach. Since the lane is fairly narrow, vehicles try to pass left turning vehicles on the right which may result in a sideswipe collision. Referring to the collision summary and diagram

Westbound vehicles trying to pass left turning vehicles on the right which is very narrow and may result in a sideswipe collision.

included within the Appendix of this report, collision number 18 was a sideswipe collision in which a westbound through moving vehicle tried to pass a westbound left turning vehicle on the right and did not have enough room resulting in the collision. During heavy peak periods, left turning westbound vehicles queue which may promote rear-end collisions on this approach as following motorists may not be paying attention to the sudden stops in traffic. Referring to the collision summary and diagram included within the Appendix of this report, there were eight rear-end collisions along the westbound approach. The Route 20 (Boston Post Road) eastbound approach provides a through travel lane operating under free-flowing conditions as well as a channelized right run lane onto Landham Road that is under YIELD control. As mentioned previously, vehicles in this eastbound right turn slip lane must yield to westbound a left turning vehicle, which creates a conflict point. Since there are significant eastbound right turn volumes, if a vehicle is yielding to a westbound left turning vehicle, a following vehicle may not expect a sudden stop, resulting in a rear-end collision.

- Intersection Control – Given the congestion that exists at this intersection, a detailed analysis of traffic volumes should be conducted to determine the best control at this location. The Corridor study prepared by VHB provided such recommendations and MassDOT will re-evaluate as part of an independent final design project. Traffic signal control or a roundabout configuration will both provide more safe operations. With improved safety, there is potential to have a tradeoff in capacity. For instance, Boston Post Road (Route 20) currently has the right-of way throughout the day relative to Landham Road. A traffic signal will require stops in the Boston Post Road (Route 20) traffic which may aggravate drivers. This could result in cut-through traffic seeking another route which may be viewed as a benefit to the Town and abutters. As long term intersection control is evaluated, the pedestrian accommodations will need to be seriously considered given the new developments in close proximity and the planned multi-use path construction project.
