Fire Department Station 1

Town of Sudbury ADA Transition Plan

October 2020

**Town of Sudbury
Fire Department Station 1**

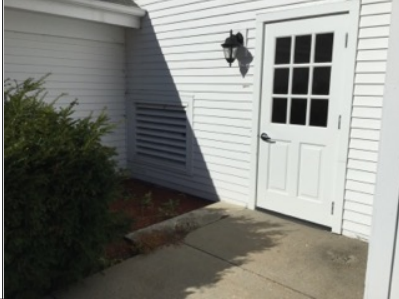
Surface not stable, firm, and slip-resistant at entrance	-	Remove the weeds from the door maneuvering clearance area.	1	Labor	\$0
Emergency Exit												
2	Main Entrance	1		Emergency Exit	N/A

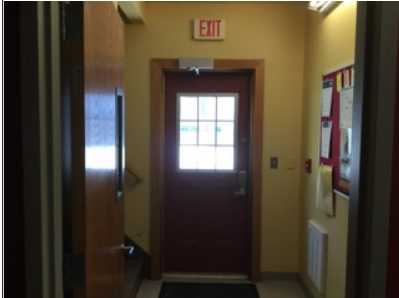
Tactile sign not provided at exit Illuminated Int. Symbol of Acc. not provided (MAAB)	- -	Provide tactile exit signs with raised characters and braille at exit doors. Mount signs between 48"- 60" above the finished floor located on the latch side of the door. Provide an illuminated sign with the International Symbol of Accessibility.	1	432	\$432
3	Apparatus Room, South Side Exit	LL		Emergency Exit	N/A

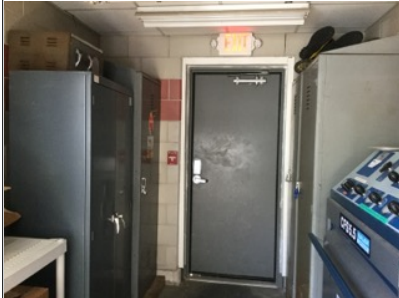
Tactile sign not provided at exit Illuminated Int. Symbol of Acc. not provided (MAAB)	- -	Provide tactile exit signs with raised characters and braille at exit doors. Mount signs between 48"- 60" above the finished floor located on the latch side of the door. Provide an illuminated sign with the International Symbol of Accessibility.	1	432	\$432

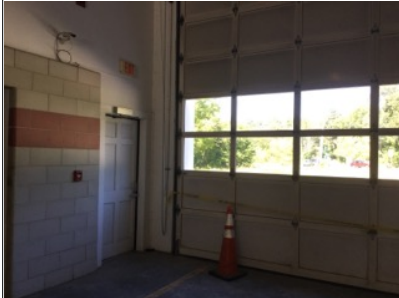
4	Apparatus Room, North Side Exit (Front)	LL		Emergency Exit	N/A

Tactile sign not provided at exit Illuminated Int. Symbol of Acc. not provided (MAAB)	- -	Provide tactile exit signs with raised characters and braille at exit doors. Mount signs between 48"- 60" above the finished floor located on the latch side of the door. Provide an illuminated sign with the International Symbol of Accessibility.	1	432	\$432
5	Secondary Entrance on South	1		Emergency Exit	N/A

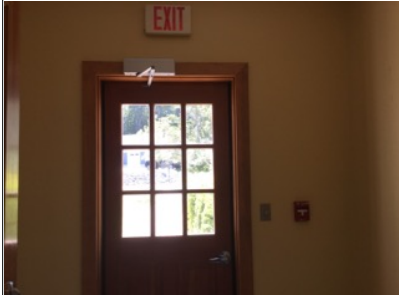
Tactile sign not provided at exit Illuminated Int. Symbol of Acc. not provided (MAAB) Door requires > 15 lbs. of force to open	- - 17 lbs	Provide tactile exit signs with raised characters and braille at exit doors. Mount signs between 48"- 60" above the finished floor located on the latch side of the door. Provide an illuminated sign with the International Symbol of Accessibility. Adjust closers of exterior doors so doors do not require more than 15 pounds of force.	1	432 Labor	\$432

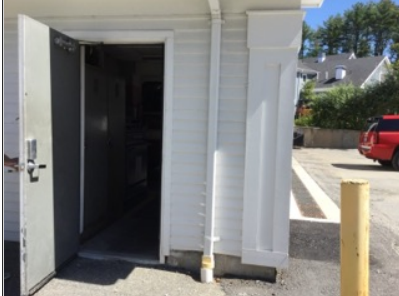
Threshold > 1/2" high	2.5"	Alter the threshold to be 1/2" high max.	1	150	\$150
7	Apparatus Room, North Side Exit (Front)	Ext.		Emergency Exit	N/A

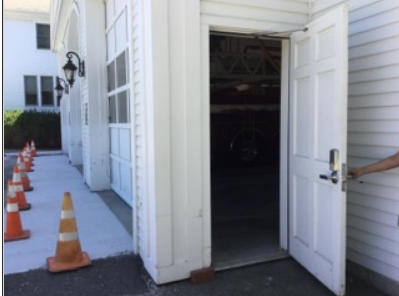
Threshold > 1/2" high	2.5"	Alter the threshold to be 1/2" high max.	1	150	\$150
Access to Goods and Services												
Doors, Doorways, & Gates												
8	Conference Room	1		Doors, Doorways, & Gates	Meeting Room

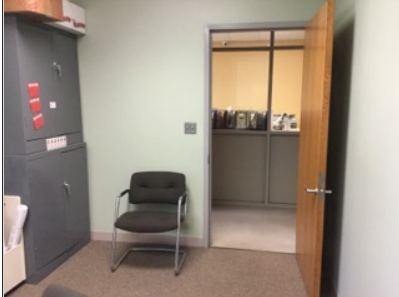
Maneuvering clearance(s) not provided	-	Relocate the chair to ensure that there is 18" clear on the latch side of the door.	1	Labor	\$0
9	Men's Toilet Room	1		Doors, Doorways, & Gates	Toilet Room

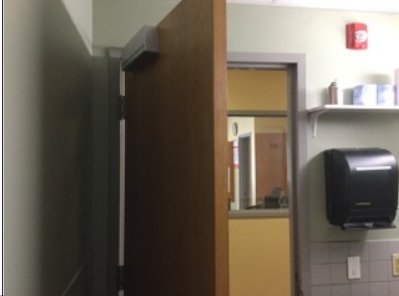
Maneuvering clearance(s) not provided	-	Provide an automatic door opener.	1	3060	\$3060
10	Secondary Entrance/ Egress	1		Doors, Doorways, & Gates	Circulation

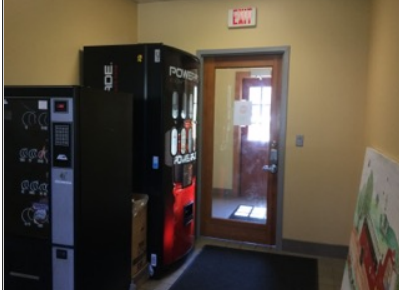
Maneuvering clearance(s) not provided	-	Ensure that vending machine is placed so that it does not affect clear width or maneuvering clearance at the door.	1	Labor	\$0

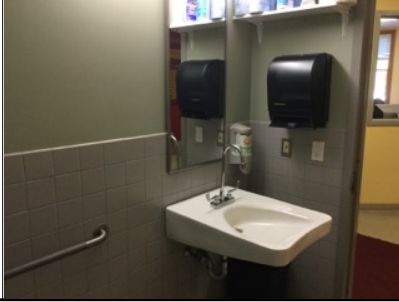
Maneuvering clearance(s) not provided	2"	Provide an automatic door opener.	1	3060	\$3060
Signage												
12	Shift Commander's Office	1		Signage

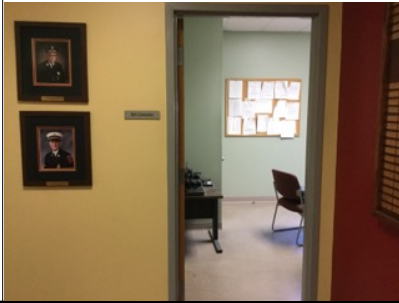
Raised characters not provided on sign Braille not provided on sign Sign not located on the latch side of the door	- - -	Provide text with raised characters duplicated in braille on sign. Locate sign at permanent rooms alongside the door on the latch side.	1	232	\$232
Service Counter												
13	Reception/Chief's Secretary	1		Service Counter	N/A

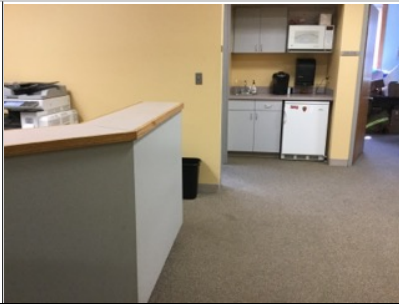
Counter > 36" high	42.25"	Provide a counter that is 36" max. above the ground or finished floor.	1	880	\$880
Toilet & Bathing Rooms												
Overall Access												
14	Apparatus Room	LL		Overall Access	Toilet Room

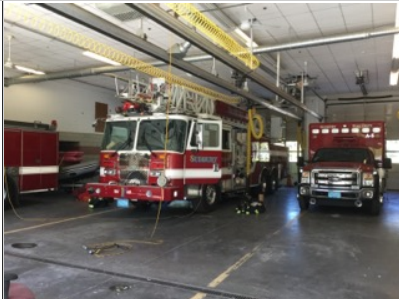
Not on an accessible route	-	There is no accessible route (only stairs) between the apparatus room and the toilet rooms. It may be technically infeasible to create an accessible route.	1	-	\$0

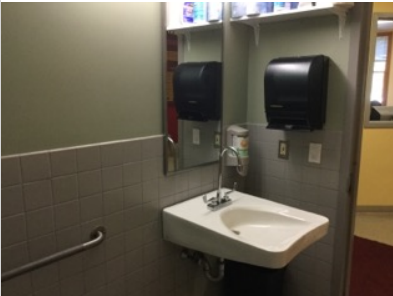
Toe or knee clearances not provided Plumbing underneath is exposed Dispensers not within reach range	25.75" - 48"	Provide at least one lavatory with knee and toe clearance positioned for a forward approach. Insulate or otherwise configure pipes to prevent contact at the lavatory. Lower the paper towel dispenser to 42" max. above the floor.	1	2131	\$2131
16	Men's Toilet Room	1		Lavatory	N/A

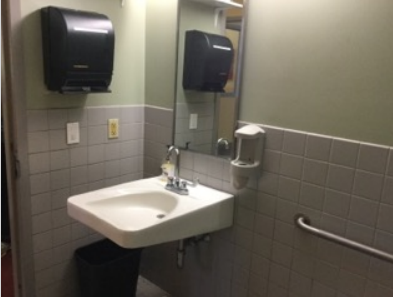
Toe or knee clearances not provided Plumbing underneath is exposed Dispensers not within reach range	25.75" - 51.25"	Provide at least one lavatory with knee and toe clearance positioned for a forward approach. Insulate or otherwise configure pipes to prevent contact at the lavatory. Lower the paper towel dispenser to 42" max. above the floor.	1	2131	\$2131

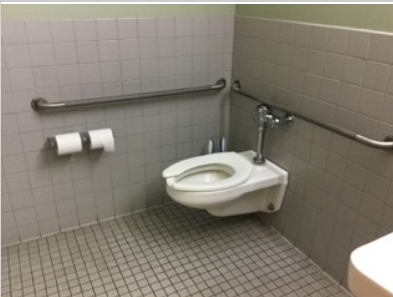
Flush control not on open side	-	Relocate the flush control to the open side.	1	374	\$374
18	Women's Toilet Room	1		Single-User Toilet

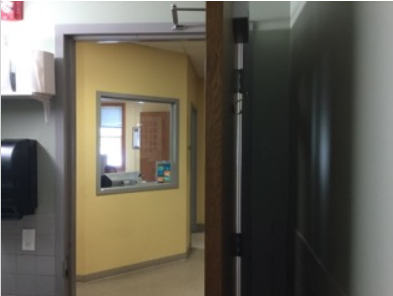
Hook located > 48" high	68"	Locate hook no higher than 48" above the finished floor.	1	150	\$150
Additional Access

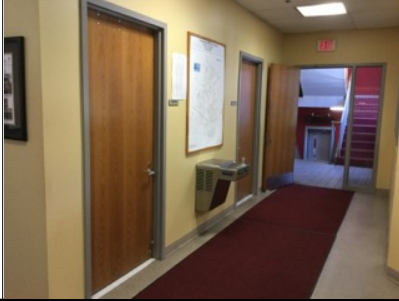
No drinking fountain provided for standing users	-	Install a Hi-Lo drinking fountain.	1	4216	\$4216
Best Practice												
20	Conference Room	1

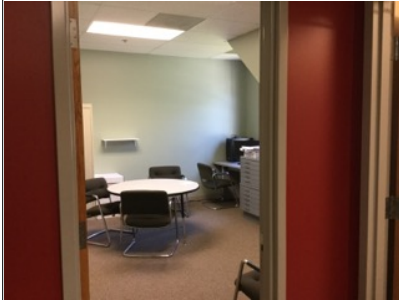
Signage is not provided	-	Recommend providing designation signage with raised characters and braille at all permanent rooms where signage is not provided.	1	-	\$0
21	Reception/ Chief's Secretary	1

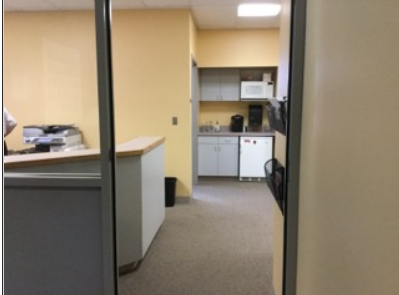
Signage is not provided		Recommend providing designation signage with raised characters and braille at all permanent rooms where signage is not provided.	1	-	\$0
