BAY
PROPERTY INSPECTIONS
Standard Building Report

For The Property Located At
11 Selkirk Street, Winston Hills, NSW 2153

Inspected for Phillip Dobson on August 27, 2020

Standard Building Report

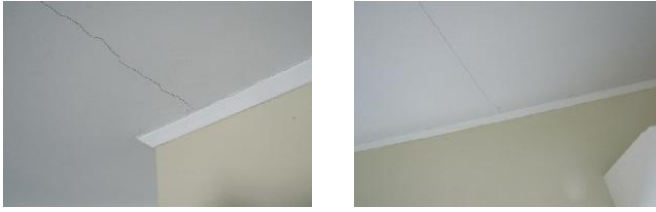
3.13 - MAINTENANCE:

Minor movement cracks noted in ceiling sheet joins.
Recommend cracks be repaired and repainted.

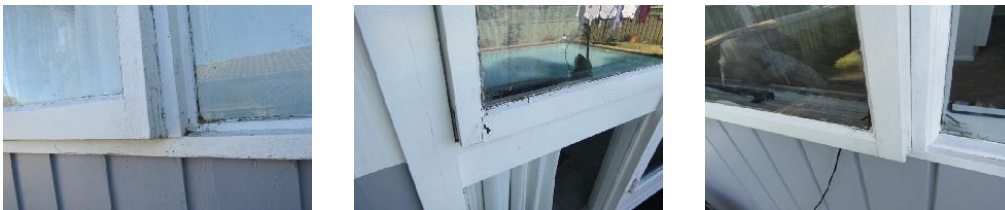
Windows are awning design.

Recommend servicing of windows to improve functionality.
