## DROP DEAD PEST CONTROL

### Visual Timber Pest Inspection & Report in accordance with AS 4349.3-2010

**11 Selkirk Street, Winston Hills NSW 2153**

Inspection Date: 26<sup>th</sup> August 2020

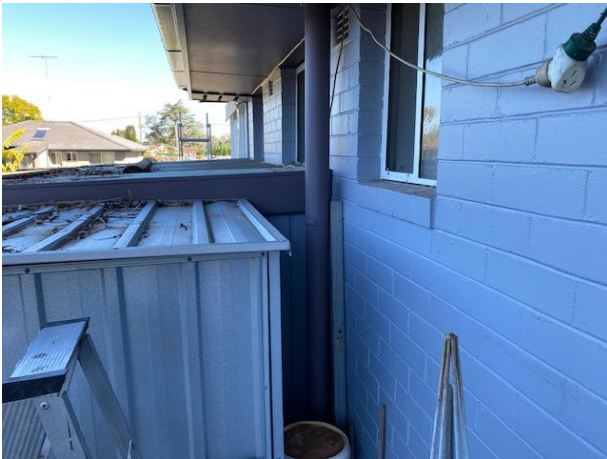
No inspection of the wall was possible behind the shed

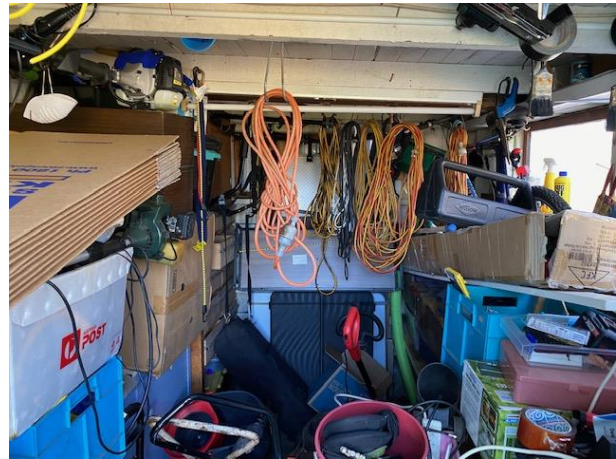
Stored items in the shed obstructed inspection

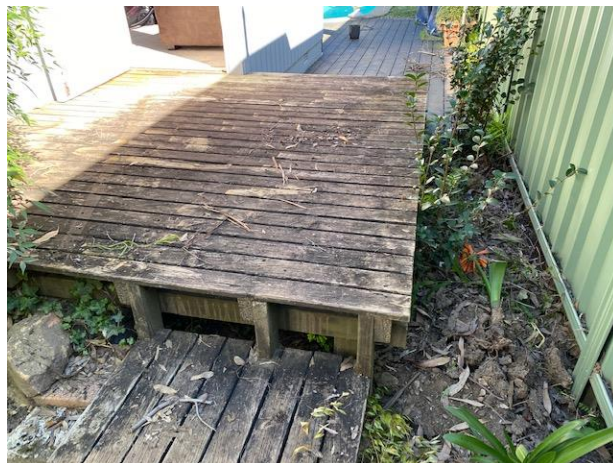
No access below deck for inspection

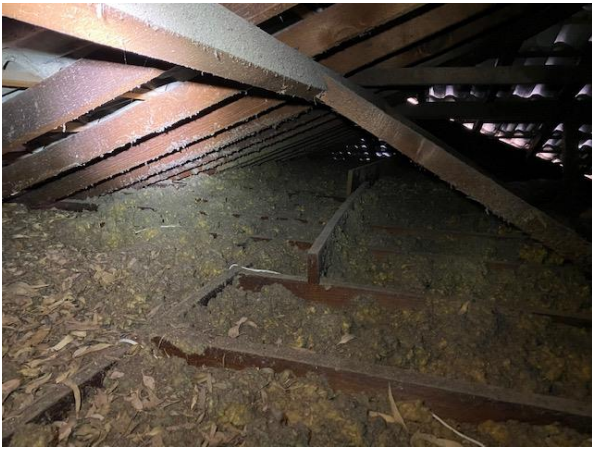
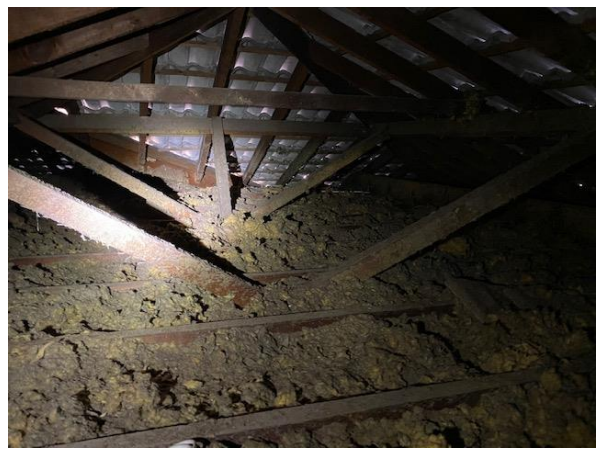
Insulation in roof void restriction inspection

**1.6** The following further inspections are recommended for the areas described above: Further Inspection is recommended once insulation in roof void is lifted.

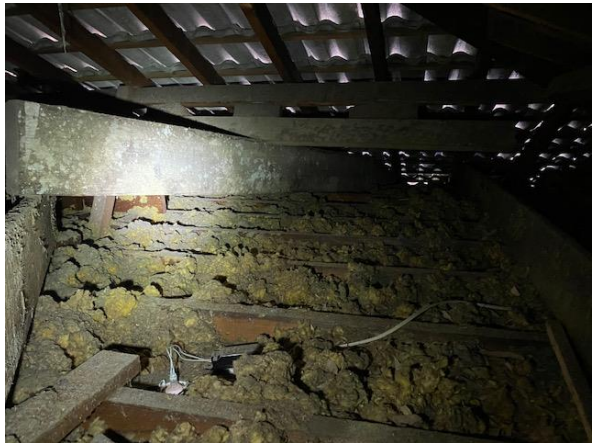
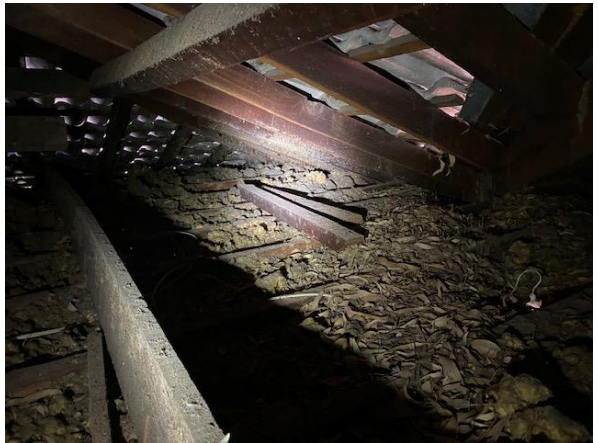
Insulation in roof void restriction inspection

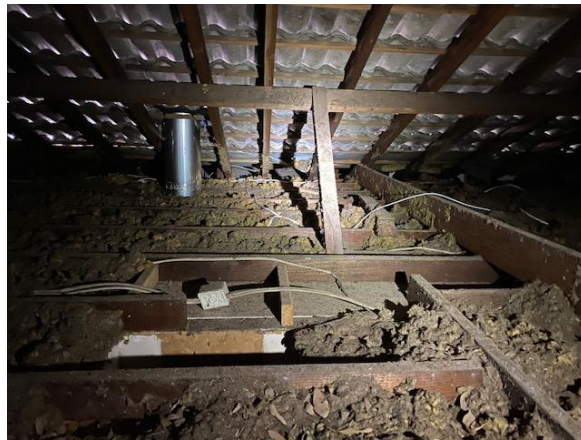
Insulation in roof void restriction inspection

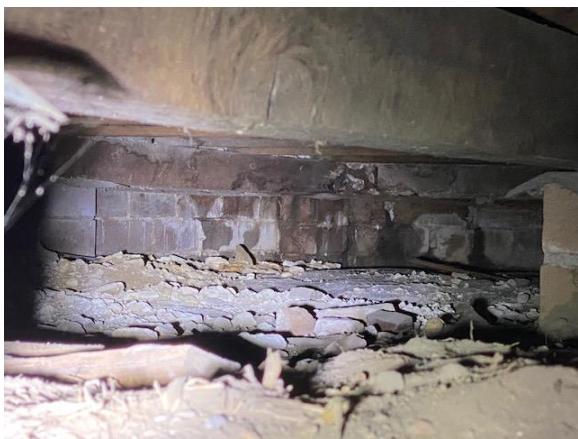
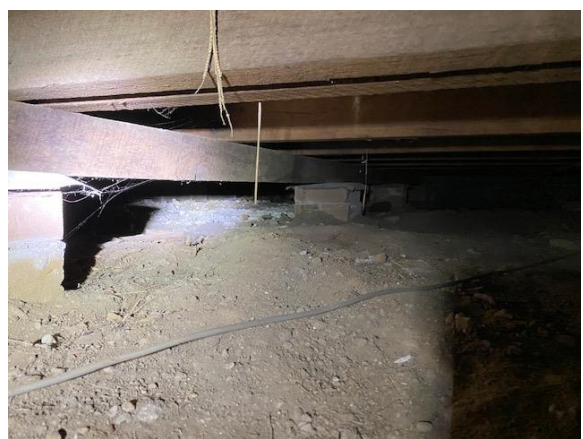
Limited inspection due to height of subfloor

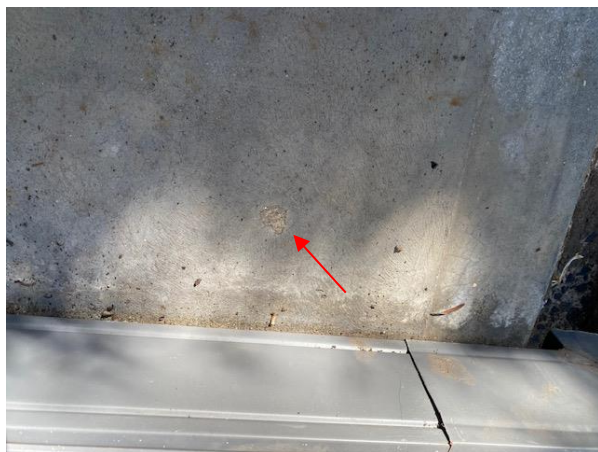
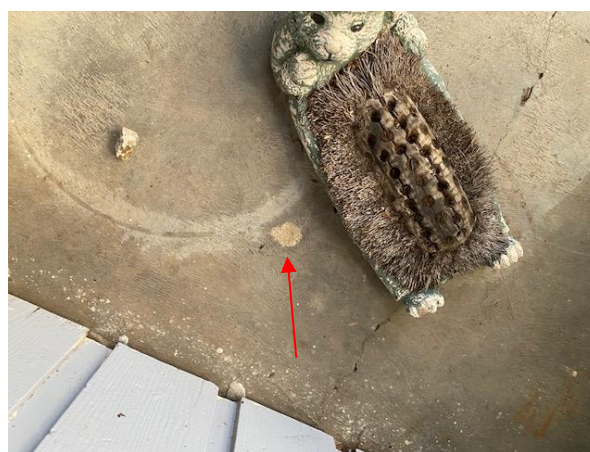
**2.5** Evidence of a possible previous termite treatment was located. Drill holes were located in the front veranda.

Drill holes in front veranda indicating possible previous termite treatment

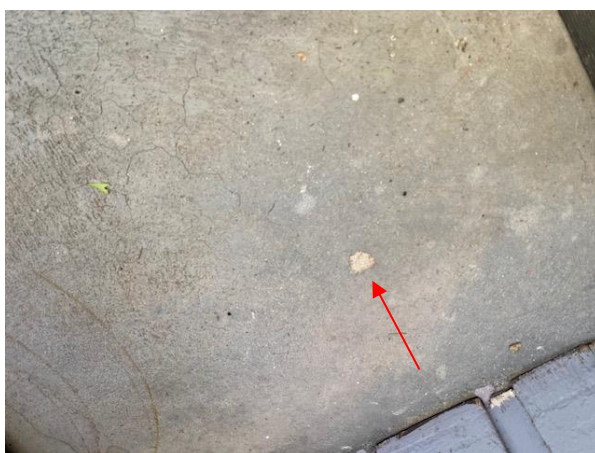
Drill holes in front veranda indicating possible previous termite treatment

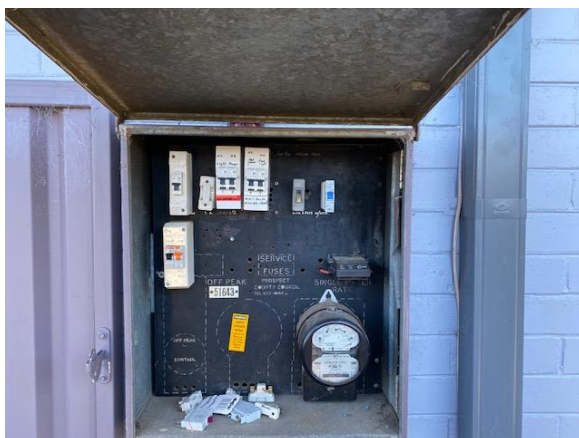
**2.6 Durable Notice (Termite Management Notice)** A durable notice was not located and there was no evidence suggesting it may have been removed.

No durable notice present in the meter box

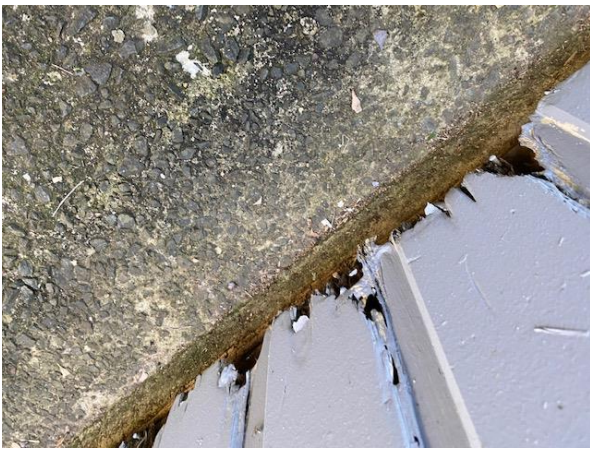
**4.1 Was evidence of wood decay fungi (wood rot) found?** Yes, located in the external timber cladding around the house, carport timbers and in the rear windowsill. Defibration was not present.

Wood rot in timber cladding

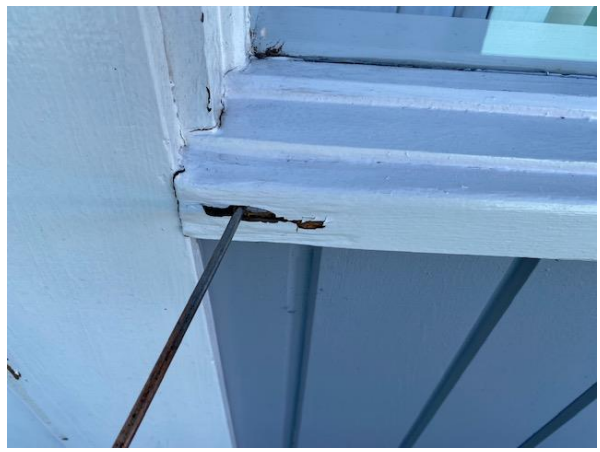
Wood rot in windowsill

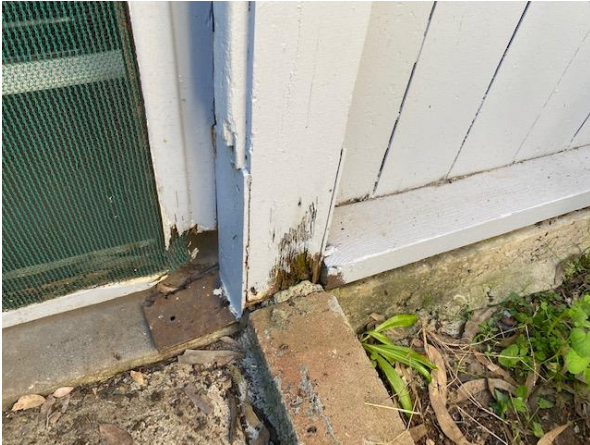
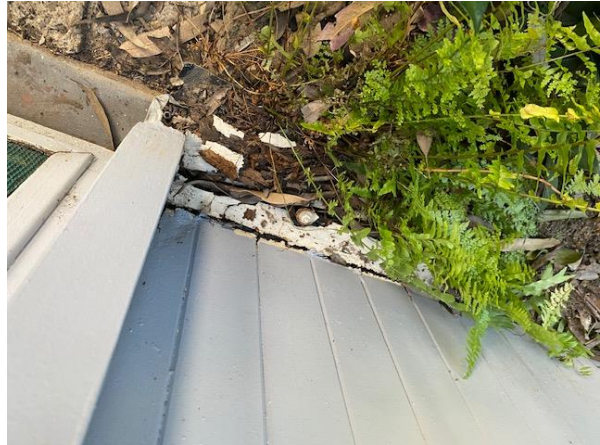
Wood rot present in carport timbers and around the property

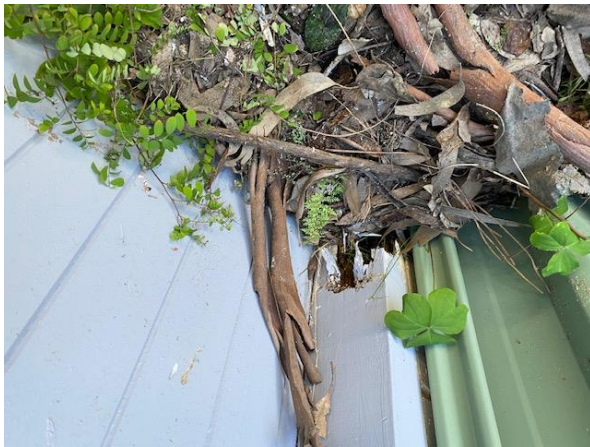
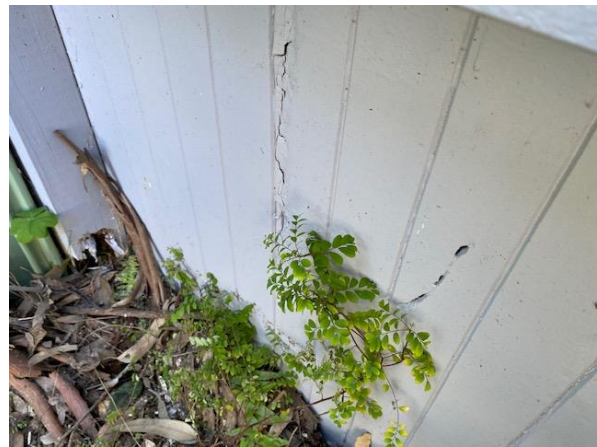
Wood rot present in carport timbers and around the property

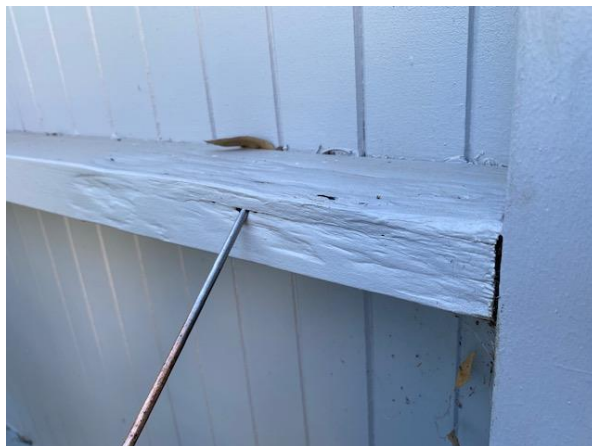
Wood rot present around the property

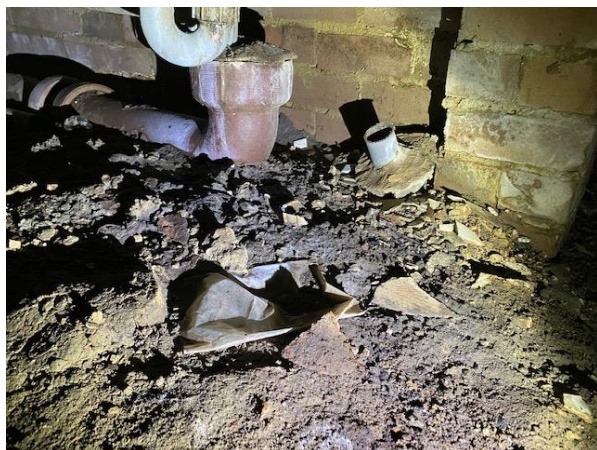
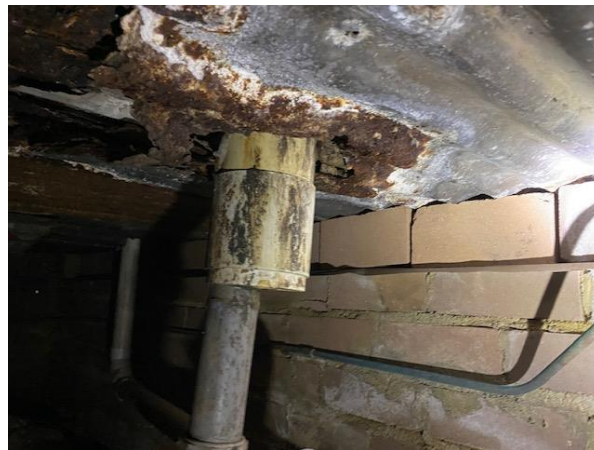
**5.1** At the time of the inspection, a **water leak was located** in the main shower recess and laundry tub water pipe.

Leaking shower floor waste in subfloor

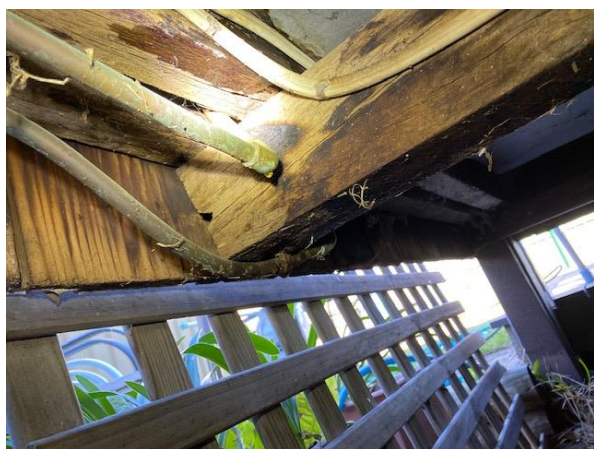
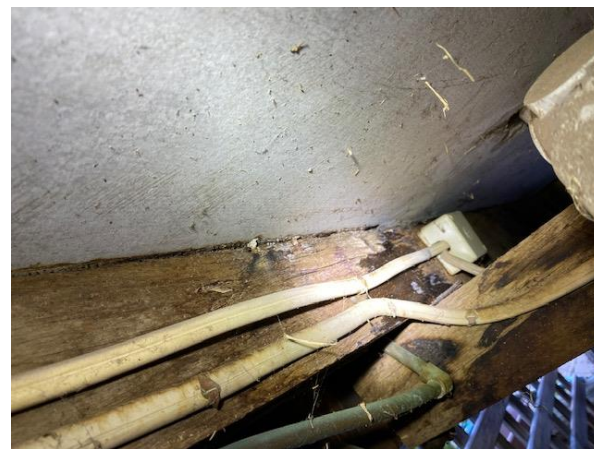
Leaking laundry tub below laundry in subfloor

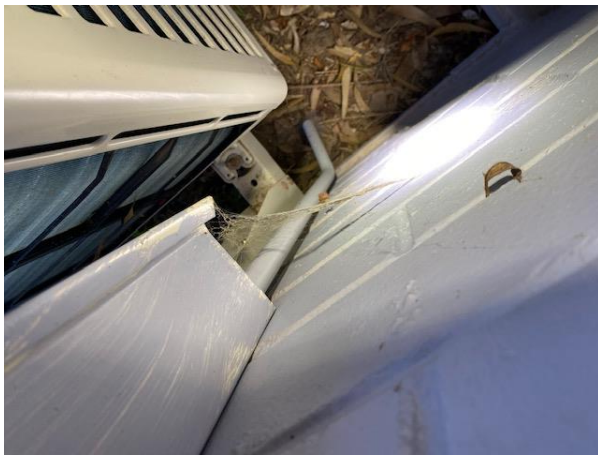
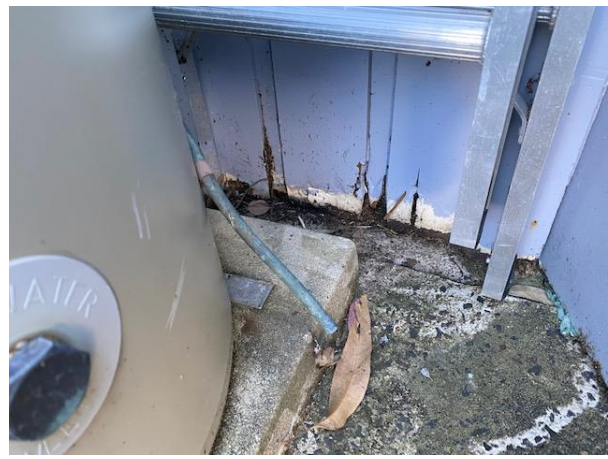
**5.2 Is there a need for this work to be carried out?** Yes, hot water and air conditioning services overflow pipe need to be correctly drained away from the home into a drain.

Air conditioning and hot water overflow need to be correctly piped to a drain

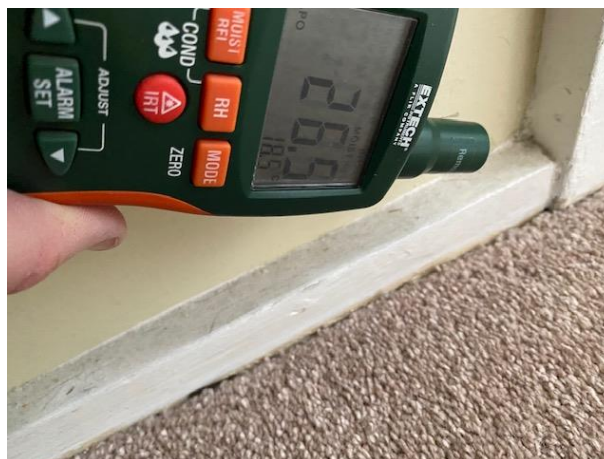
**5.4** At the time of the inspection **elevated moisture readings were detected** at a reading of **26.5%** in the wall behind the main shower recess.

26.5% moisture detected behind shower recess

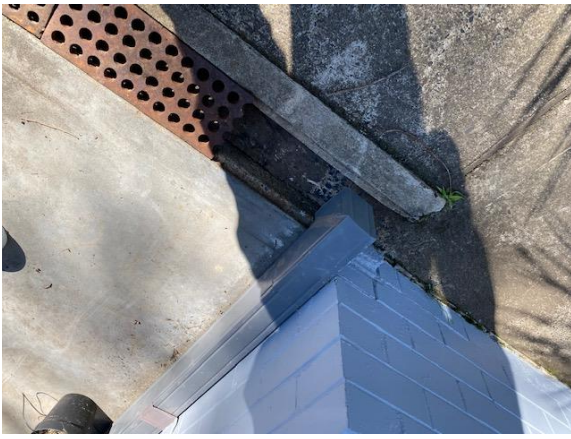
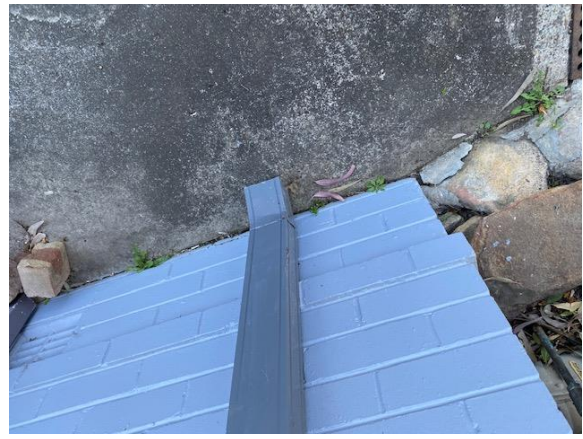
**5.6** We claim no expertise in plumbing and drainage, however in our opinion, **subfloor drainage is inadequate**. Stormwater downpipes need to be connected to the correct drainage.

Stormwater downpipes need to be connected to the correct drainage

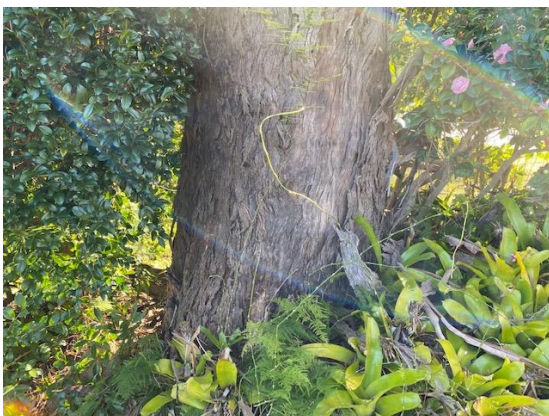
Tree should be drilled and inspected (front yard)

**Trees and Stumps:** Should be drilled and inspected.

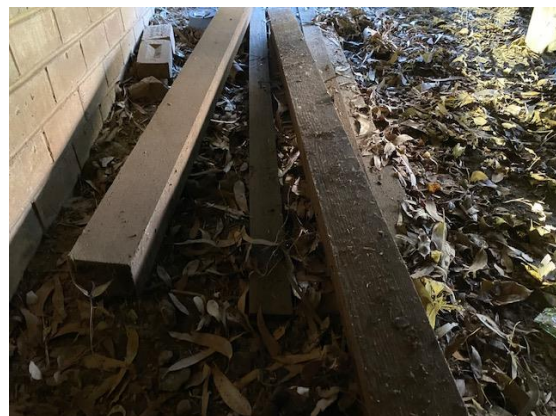
Loose timber in subfloor should be removed

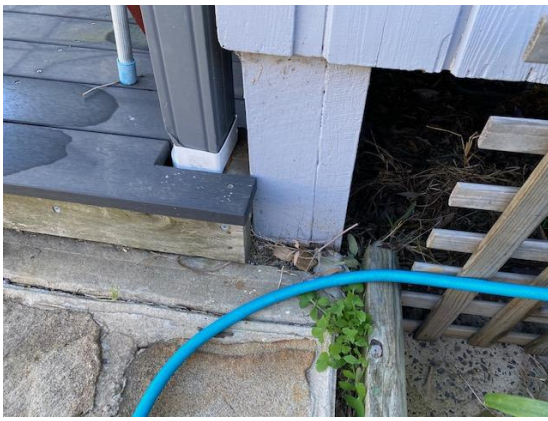
Timber piers in ground contact

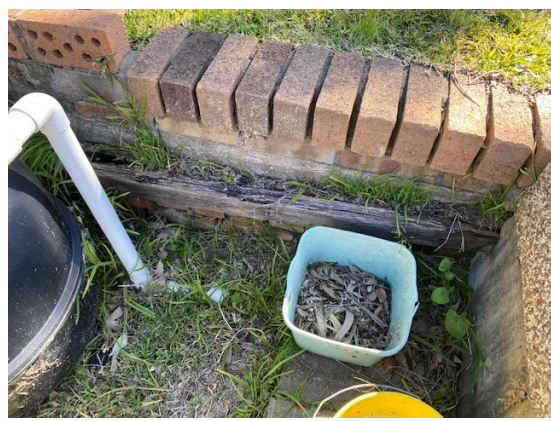
Landscaping timbers should be removed

**Landscaping Timbers:** Should be removed and replaced with a non-susceptible material.

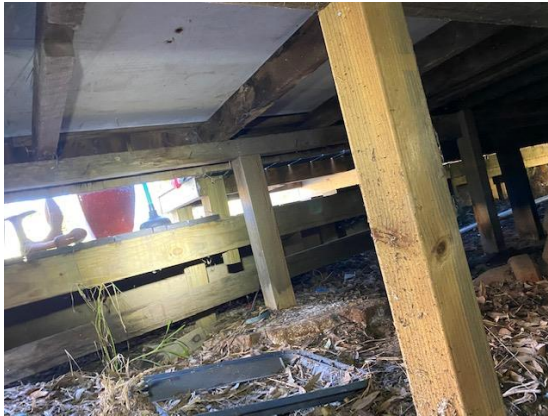
Timber piers in ground contact

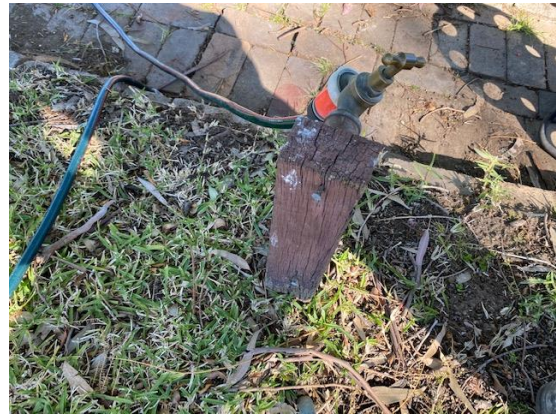
Timber tap post should be removed & replaced

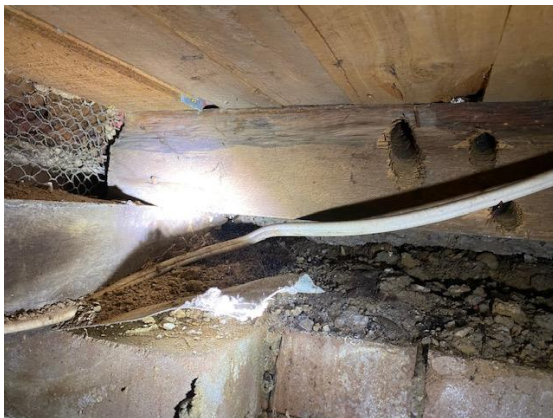
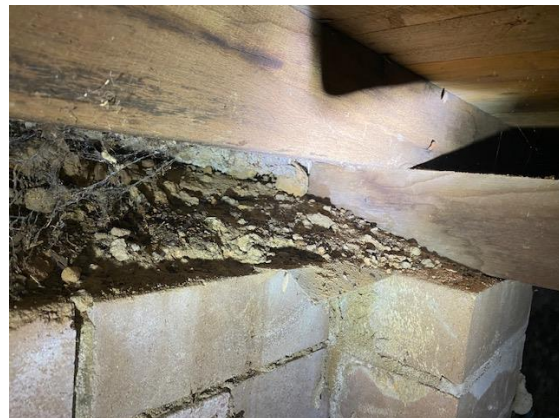
Timber Bearers in ground contact – inadequate termite protection
