### Visual Timber Pest Inspection & Report in accordance with AS 4349.3-2010

**14 Torumba Close, Bangor NSW 2234**

Inspection Date: 07.04.21

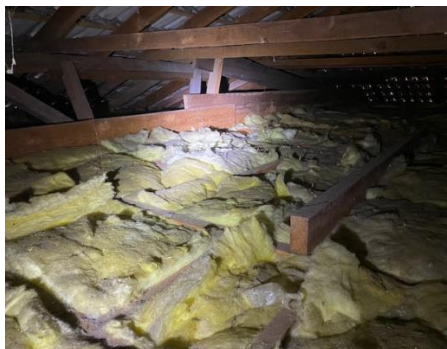
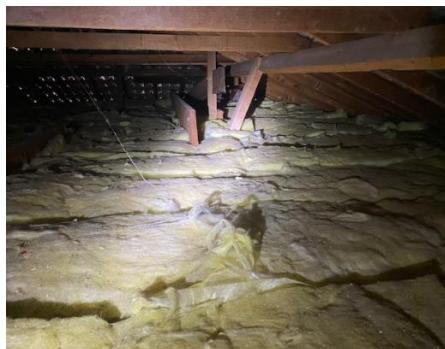
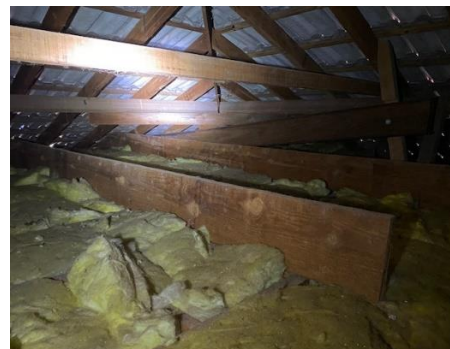
Insulation in roof void obstructing inspection zone

**Further inspection is recommended when** insulation is lifted in the roof void and stored items are removed from the garage to gain access and carry out an invasive inspection.

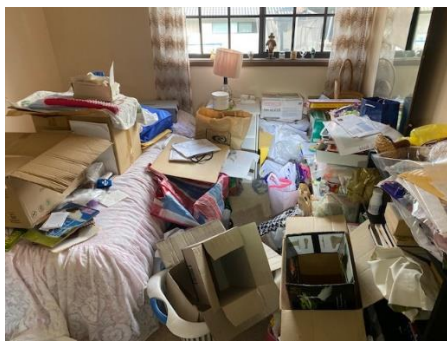
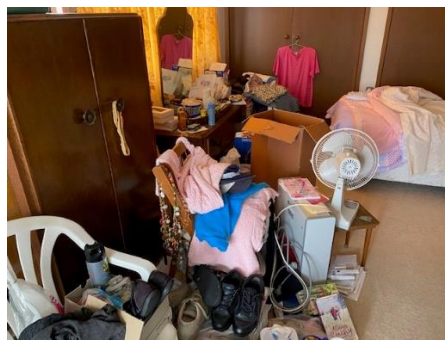
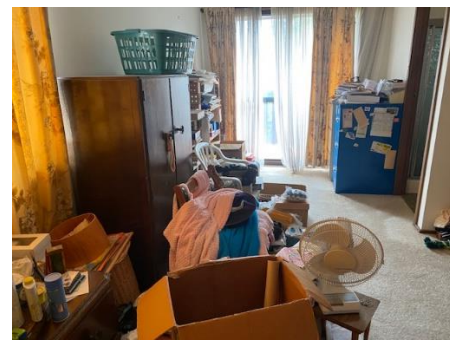
Stored items obstructing inspection zone

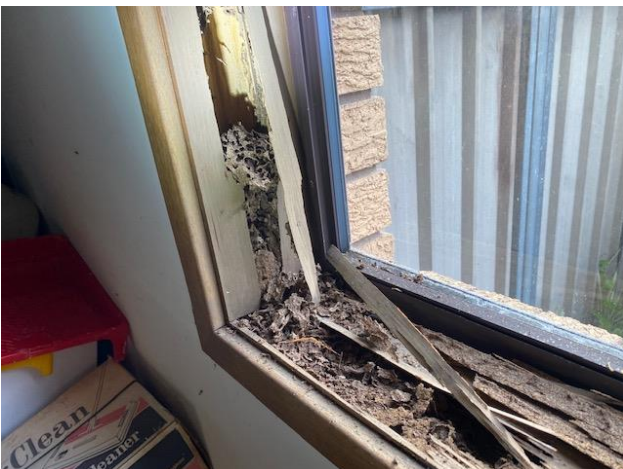
**2.3 Extensive visible evidence of subterranean termite workings and/or damage was found located in the garage windowsill and a termite lead was found to the garage floor.**

Termite damage located to garage windowsill

**8.2 SUBTERRANEAN TERMITE TREATMENT RECOMMENDATION:** A management program in accord with AS 3660-2000 to protect against subterranean termites is considered to be strongly recommended. A Termite Chemical Treatment would be recommended for this property to assist in protecting the property against termite entry. A proposal is not attached however this is available from our inspector on request.

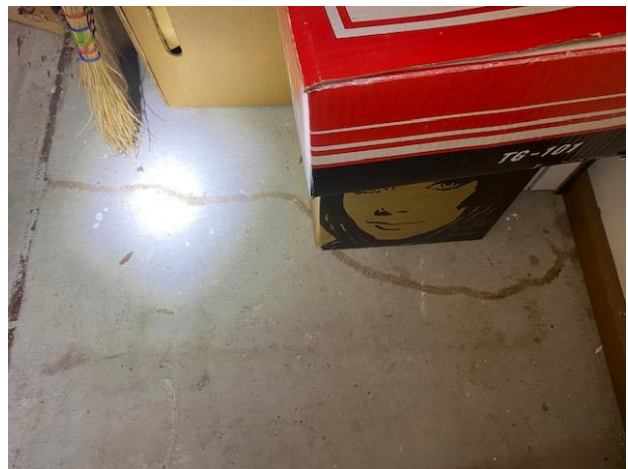
Termite Lead located in the garage

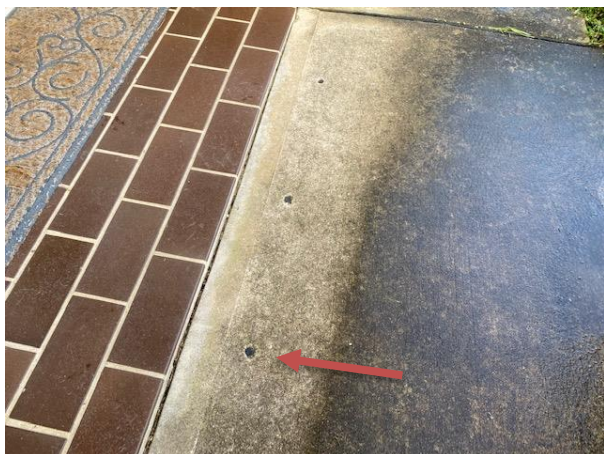
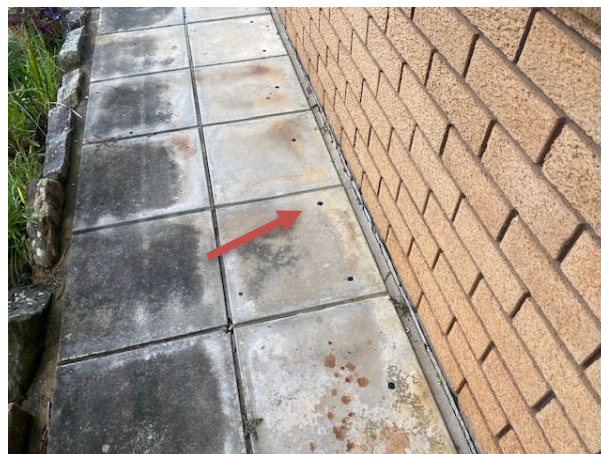
**2.5** Drill holes located to the perimeter of the home suggesting a previous termite treatment has been installed.

Drill holes located to the perimeter of the house

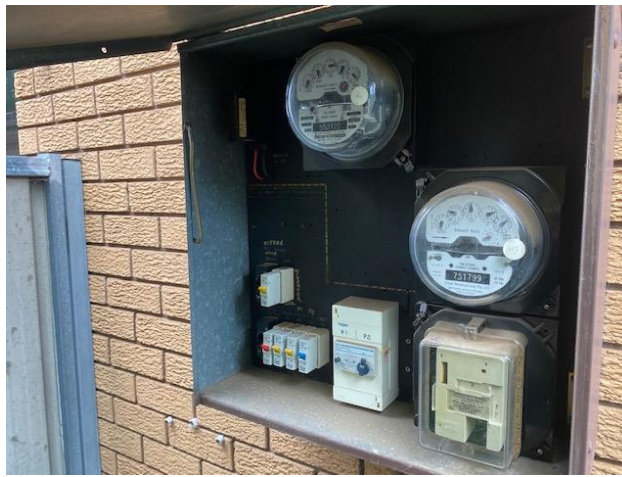
**2.6** Durable Notice (Termite Management Notice) A durable notice was not located in the meter box and there was no evidence to suggest that one had been removed.

No Durable Notice was located in the meter box

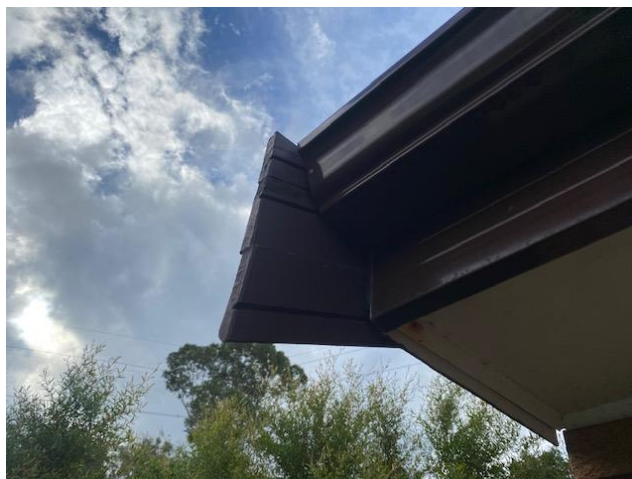
4.1 Was evidence of wood decay fungi (wood rot) found? Yes, Localised minor wood rot located to barge board timber.

Minor wood rot located to barge board timber

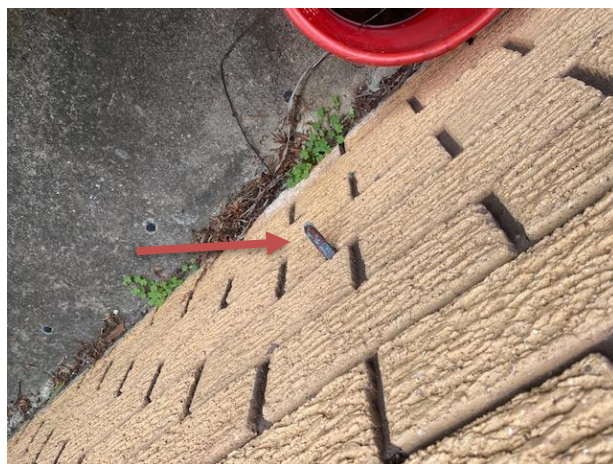
Hot water service overflow pipe should be piped away to a drain or downpipe

5.2 Is there a need for this work to be carried out? Yes, redirect the hot water service overflow pipe to a drain or downpipe

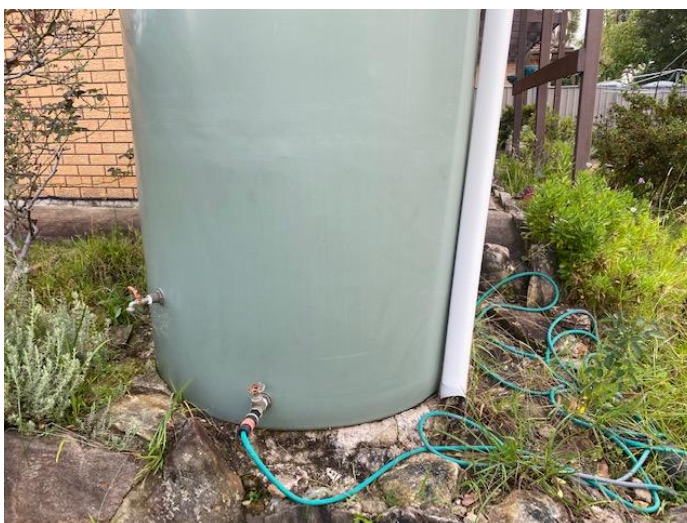
Water Tank overflow outlet should be drained away correctly

**5.3** Is there a water tank present? Yes, which should be drained away correctly

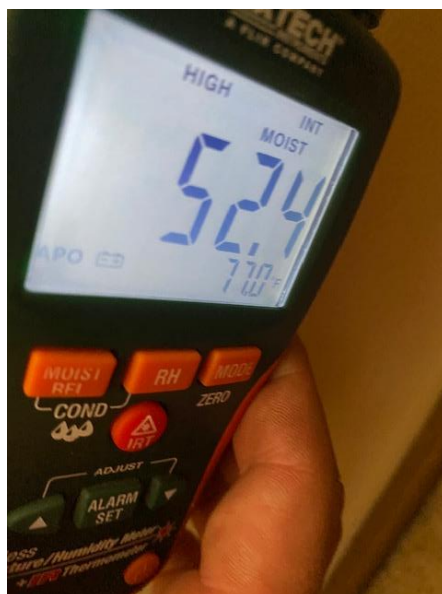
**5.4** At the time of the inspection moisture readings were high reading 52.4% located below the upstairs window in the front bedroom. The bedroom is located above the garage.

High moisture reading of 52.4% located under window in front bedroom

If high moisture was reported then you must have a building expert investigate the moisture and its cause and determine the full extent of damage and the estimated cost of repairs.

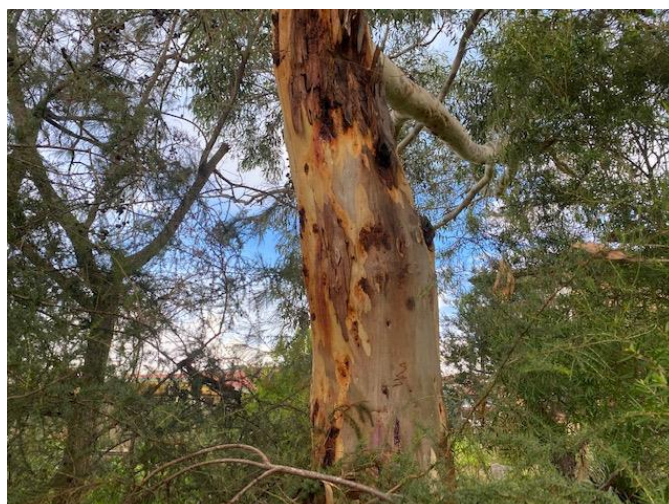
**Trees and Stumps:** Rear large tree should be drilled and treated.

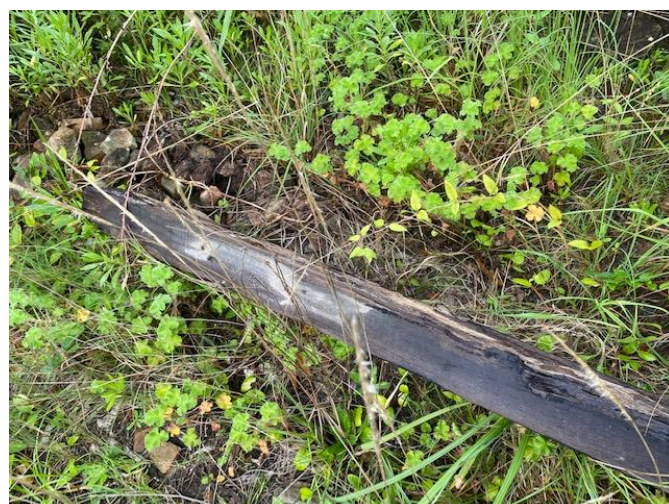
**Timber in ground contact:** Timber sleeper in rear yard should be removed.

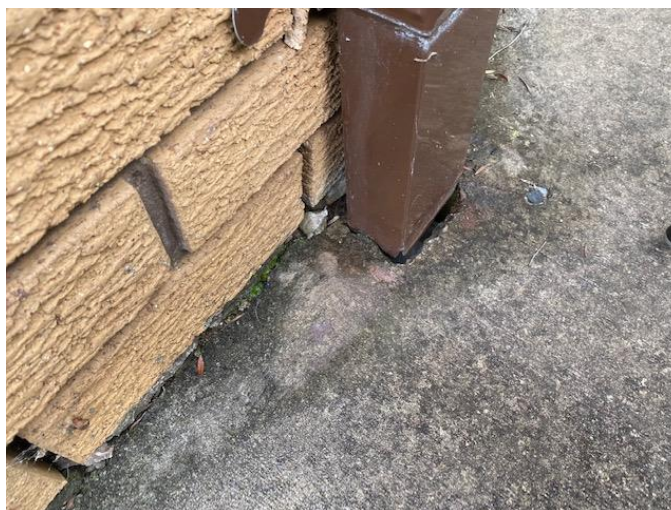
**5.11 Comments on other conditions conducive to Timber Pest infestation:** Downpipe should be connected correctly to allow water to drain away correctly.

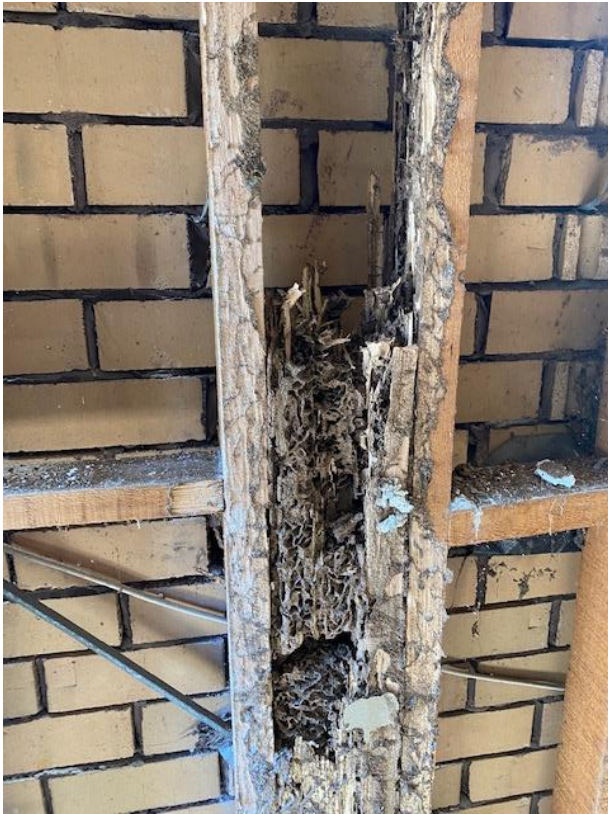
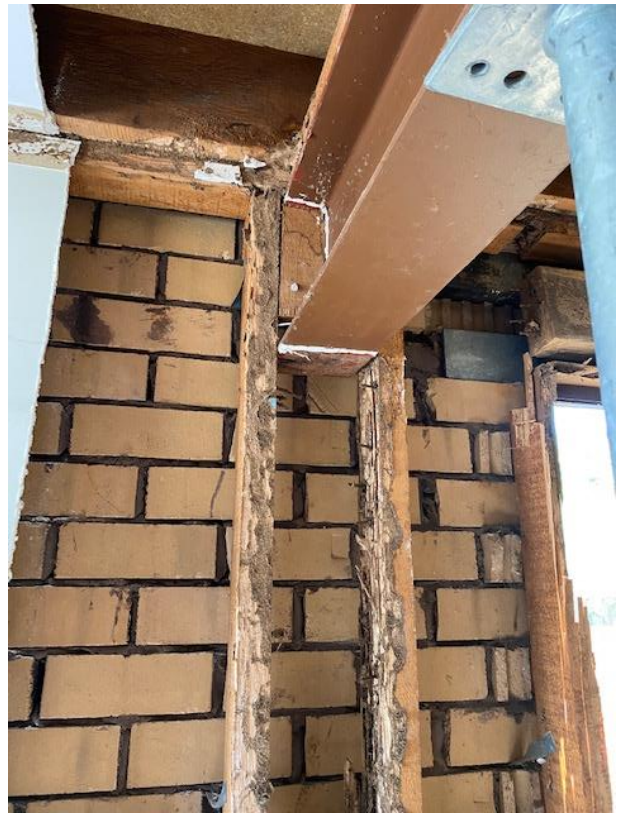
**Previous Termite Damage at the time of Inspection.**
