Standard Building Report

Prepared For Exclusive Use By
Jean Moss

For The Property Located At
14 Torumba Close, Bangor, NSW 2234

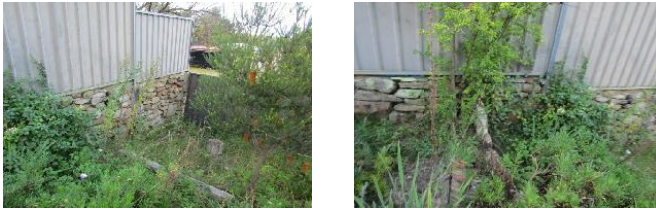
7.2 - COMMENTS: The sandstone retaining walls are functional.

7.3 - DEFERRED:

Evaluation of retaining wall strength, adequacy, and drainage falls outside the scope of this property inspection.
