## 24 Heathglen Ave, Parklands

Clear Engineering Services.  
Civil and Structural Engineers

Hawkins Construction Ltd (Hawkins) has engaged Clear Engineering Services Ltd (Clear Engineering Services) to provide an engineer's report and repair strategy, if repairable, based on the current condition of the dwelling located at 24 Heathglen Avenue, Parklands, Christchurch (the site). The dwelling was damaged as a result of the sequence of earthquakes that commenced in the Canterbury region on 4 September 2010.

FIL Engineers NZ Ltd. has been engaged by W2NZ Ltd to carry out the final inspection of the dwelling following the completion of the earthquake-related repairs. The following documents have been sighted as part of this report.

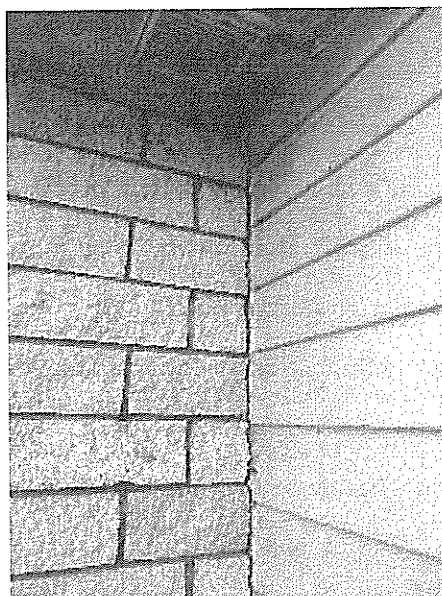
The Summerhill Stone cladding was observed as loose on all elevation with diagonal cracks up to a maximum of 4 mm wide evident. The cracks were initiating of window and door frames.

The extension onto the north eastern corner of the dwelling is clad on two sides with horizontal plastic boards. Separation has occurred at the joint between the Summerhill Stone and the plastic boards. Refer Picture 2 below.

Picture 2: Separation between Summerhill Stone and plastic cladding

The external cladding has failed on all elevation. Further unseen damage such as sheared wall ties may be present. It is recommended that the external cladding is completely removed and replaced with a cladding of equal or lesser weight per m<sup>2</sup>.

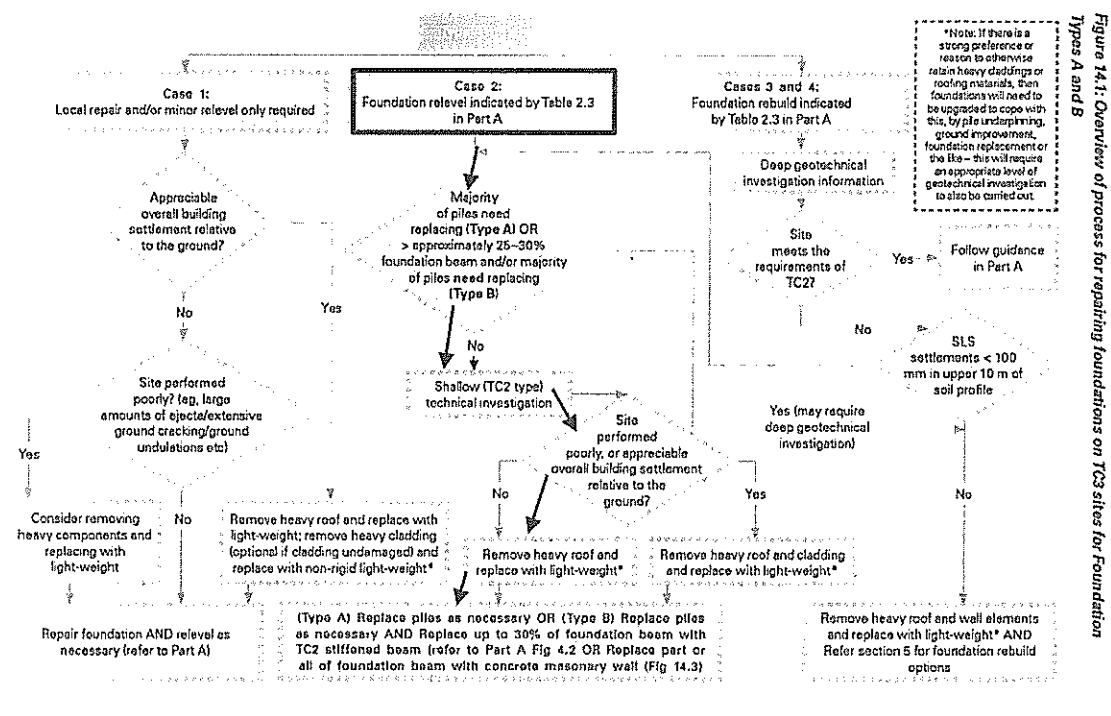
Table 2.3: Indicator criteria for floor/foundation releval or rebuild (see also Figure 2.2)

Since this vertical settlement over the building's footprint is greater than 50 mm and less than 100mm, in accordance with Table 2.3 of the MBIE "Guidance - Repairing and Rebuilding Houses Affected by the Canterbury Earthquakes – Version 3 (December 2012)", a foundation releval is indicated to return the dwelling to an acceptable floor level standard.

The perimeter footing should be underpinned as required to lift the perimeter of the flooring to the required level. The results of the geotechnical investigation should be made available to the repairs contractor to determine founding depths of the temporary lifting jacks.

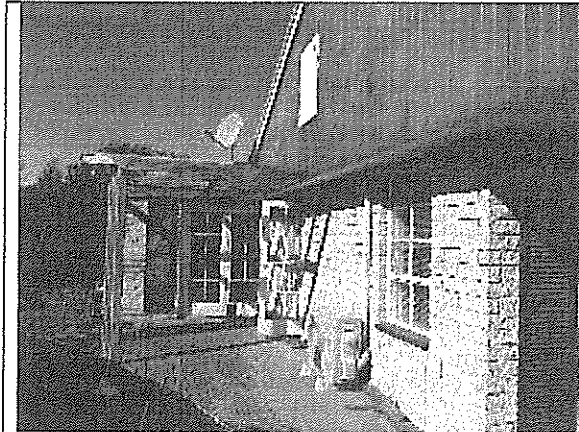
Photo 1: Timber deck with extension to background	Photo 2: Cladding damage

The timber deck along the northern elevation will need to be disengaged from the dwelling to allow the releveling works, modifying to suit the revised height. The concrete patio is recommended to be demolished and replaced with a timber deck also.

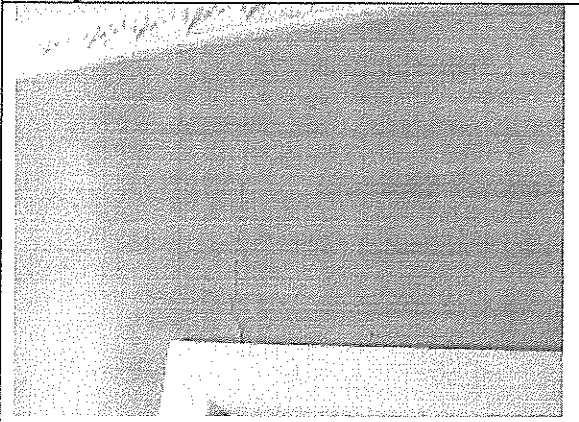
Minor damage was observed to plasterboard wall linings, with maximum cracking of 1 mm wide recorded in all internal rooms. The cracks initiated off window and door frames

Photo 3: Typical internal lining damage	Photo 4: Subfloor

Plasterboard linings have incurred minor cracking damage around re-entrant corners. The dwellings bracing function is not thought to have been compromised. Cosmetic repairs only will be required.

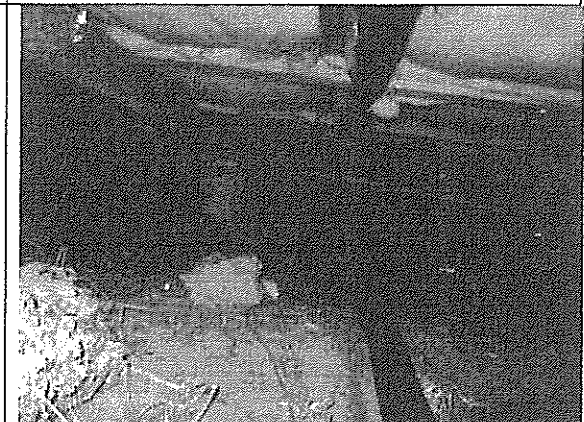
No damage was observed in the subfloor however our inspection was limited due to access safety concerns.
