2/46 Aldwins Road, Phillipstown

Attic

Exterior

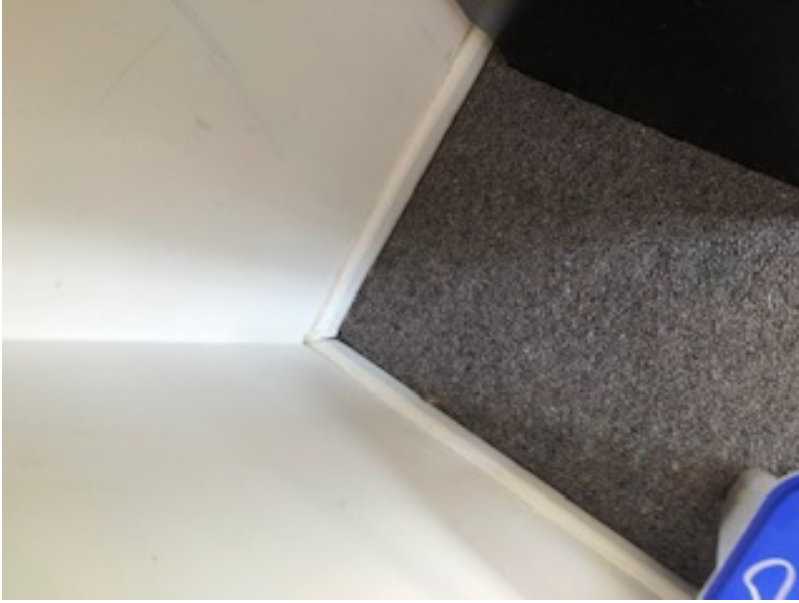
Living Room Skirting

Floor	Carpet over Timber Floor
Walls	Gib - Painted
Ceiling	Gib - Painted
Doors	Timber Veneer to Hallway
Windows	SG Aluminium Slider in Working order and Window to South Elevation in Fair Condition
Other Comments	Skirting has been removed and reinstalled at some stage. Poor Carpentry - Will require filling and painting again at some stage

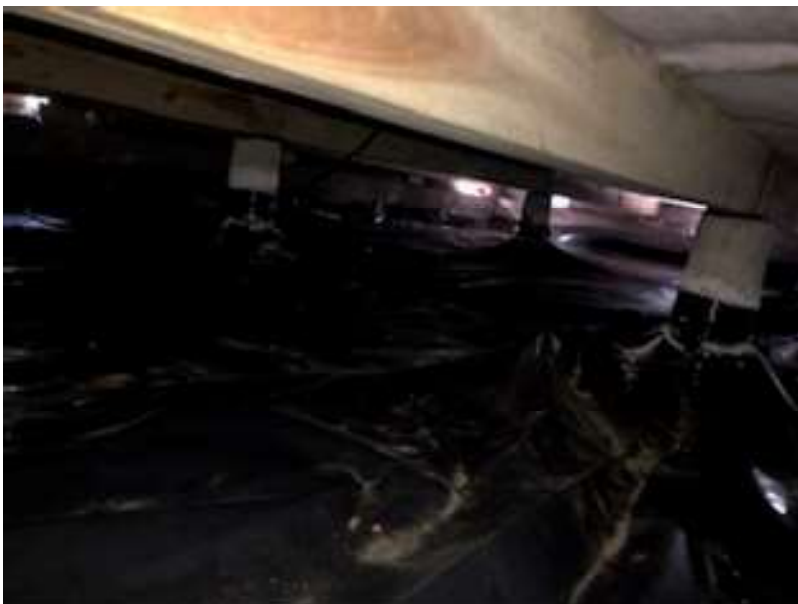
Underfloor – Plastic and Insulation in place

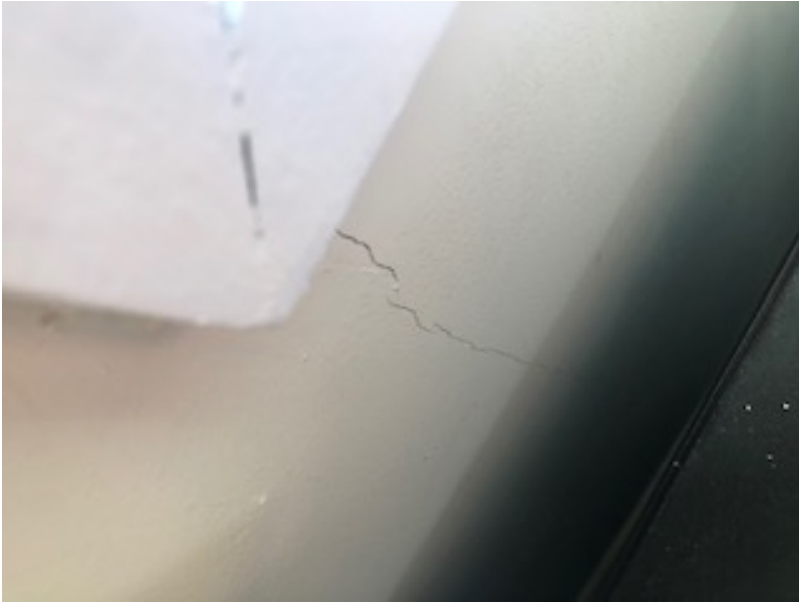
Floor	Carpet over Timber Floor
Walls	Gib – Painted –Cracking evident below window on left hand side. Probable EQ damage, will require minor repairs
Ceiling	Stipple Finish, Painted – Probable Asbestos
Doors	Timber Veneer IWO
Windows	SG Aluminium IGC
Wardrobe	Painted Timber Doors need adjustment
Other Comments	Underfloor Access in Wardrobe

Cracks visible under window- staircase cracking visible outside in this location as well

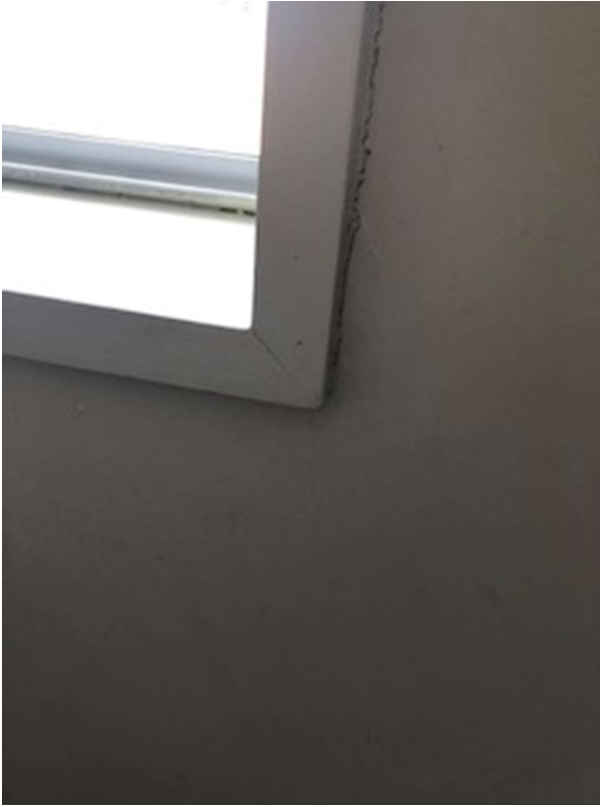
Floor	Carpet over Timber Floor
Walls	Gib, Painted – Cracking visible at top of window. Minor Repairs Required
Ceiling	Stipple, Painted – Probable asbestos
Doors	Timber Veneer IWO
Windows	SG Aluminium
Wardrobe	Timber Painted Door with Hanging Rail
Other Comments

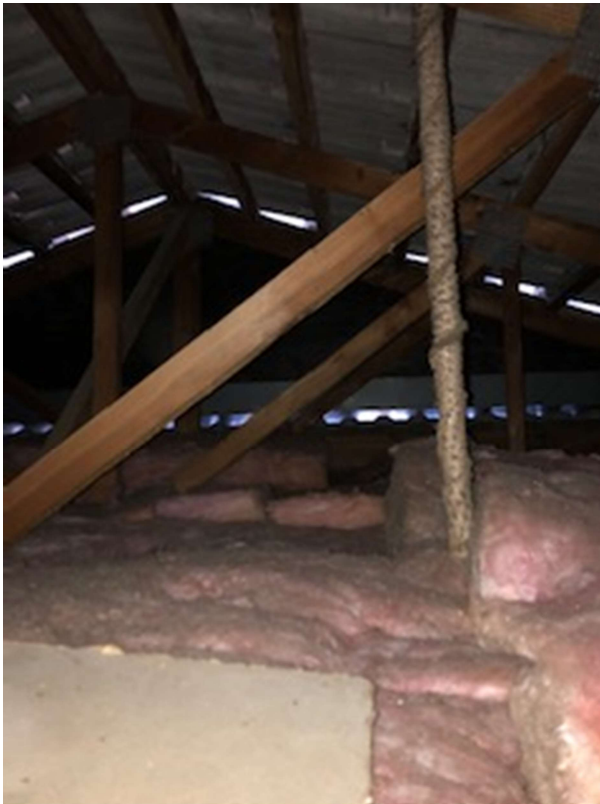
Framing/ Trusses	Heavy Concrete Tile over Truss In Fair Condition for age of building
HWC	N/A
Sarking	Nil
Insulation	In place
Other Comments

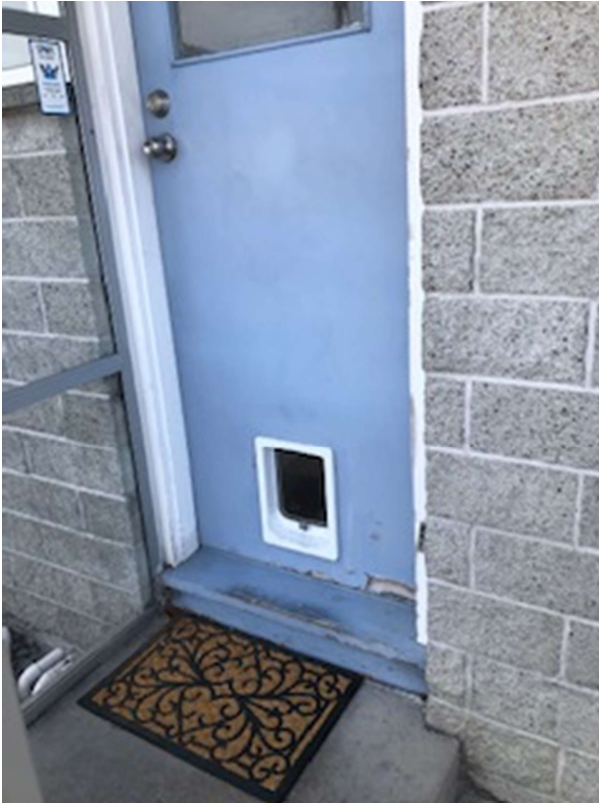
Door Requires Paint

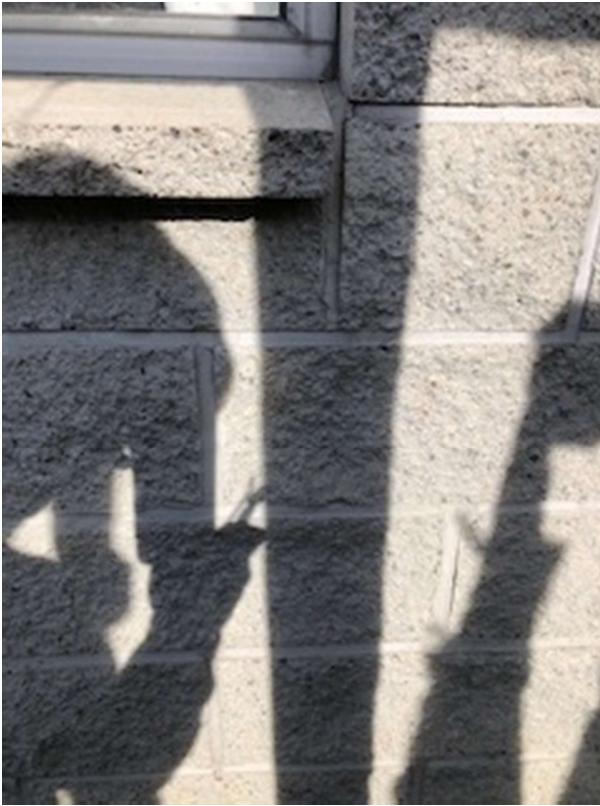
Minor Staircase Cracking

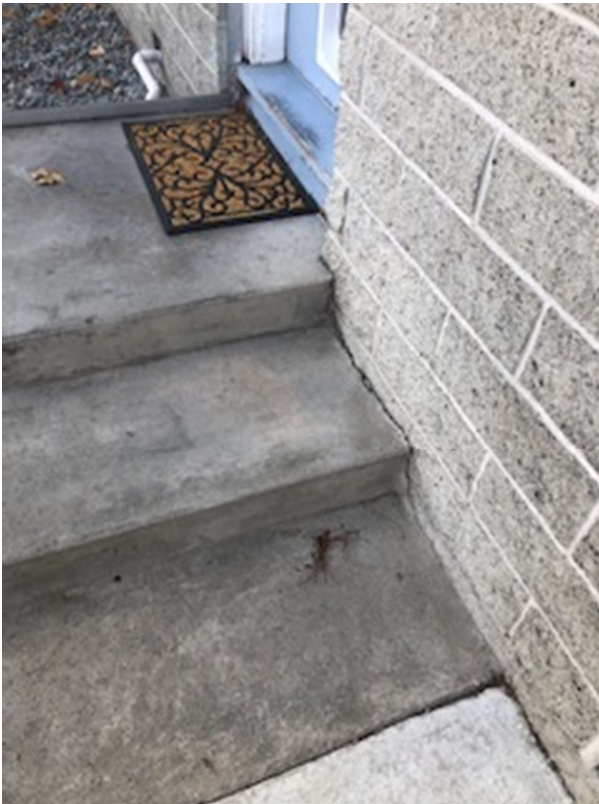
Front step

Stairs coming away from Foundation
