02 November 2017

Job No: 17-536

**RE: STRUCTURAL ASSESSMENT – 46 CHARLES STREET, WALTHAM, CHRISTCHURCH 8011.**

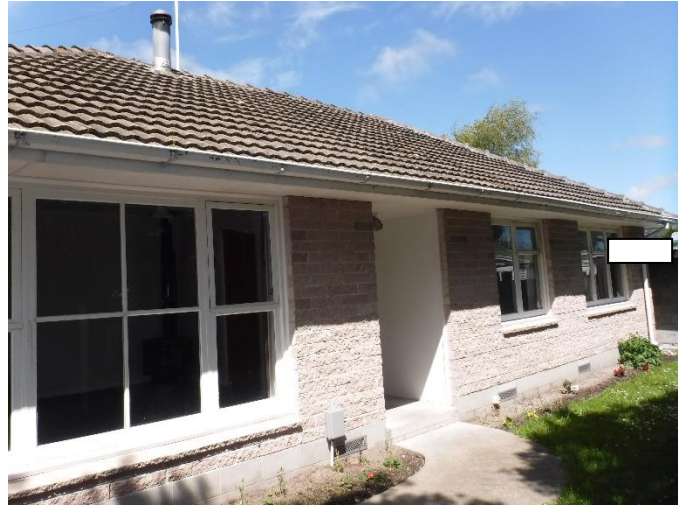
Photo 2. Northwest elevation.

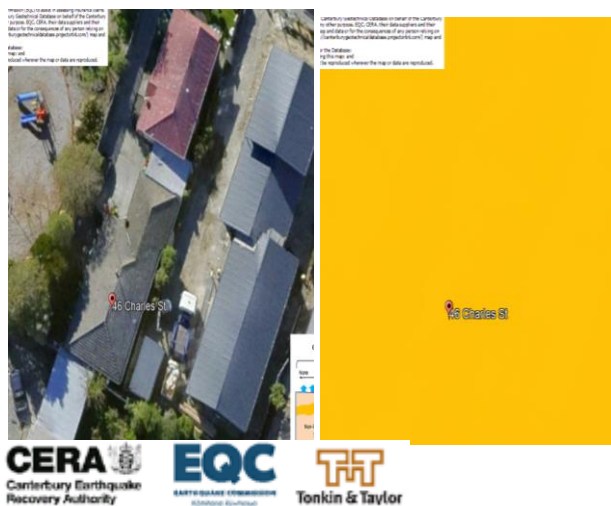
EQC liquefaction and lateral spreading observations show “no observation” in the area after September 2010 and “no lateral spreading but minor to moderate quantities of ejected material” in the area after February 2011 earthquake event. No site specific geotechnical investigation was undertaken as part of this assessment.

Photo 3. EQC liquefaction and lateral spreading observations show “no observation” in the area after September 2010 and “no lateral spreading but minor to moderate quantities of ejected material” in the area after February 2011 earthquake event.

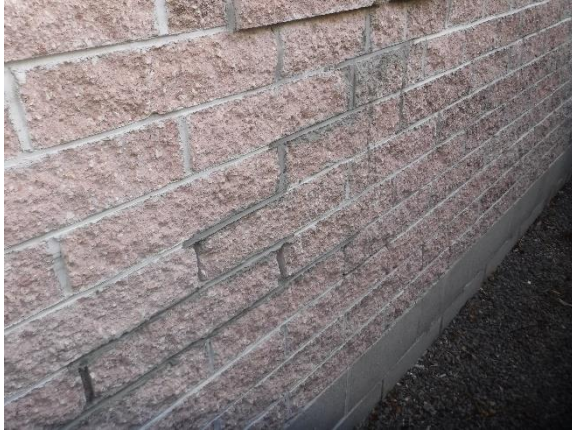
Moderate mortar step cracks to the Summer hill stone veneer at southeast corner of the dwelling were observed. Except this, minor mortar step cracks to the Summer hill stone veneer were identified at a few locations around the dwelling. A single moderate separation in between concrete blocks of perimeter foundation wall was observed at southeast side of the building.

Photo 4. Moderate mortar step cracks to the Summer hill stone veneer at south east corner of the dwelling

- As Summerhill stones veneer was moderately damaged, it is recommended to take them down and re-clad with appropriate fixing to timber walls where required.

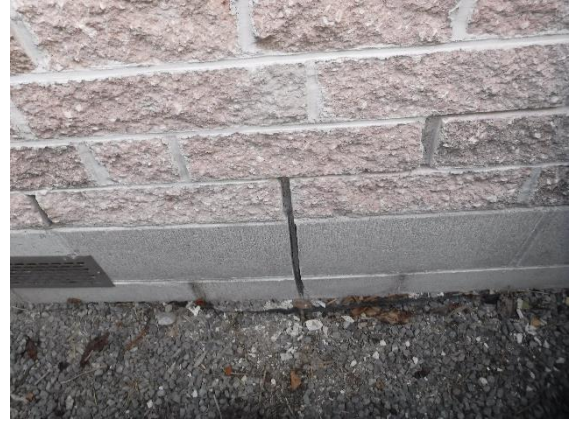
Photo 5. Moderate separation in between the concrete blocks of perimeter foundation wall.

- Rake out mortar along the moderate crack or missing mortar of perimeter foundation block wall, and repointing with appropriate fixing to timber walls where required. Locally remove broken bricks and replace with new bricks.

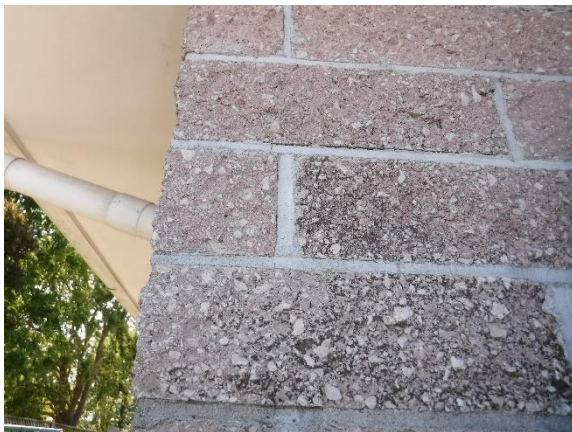
Photo 6. Minor mortar step cracks around the dwelling.

- Rake out mortar along the minor crack lines of dwelling Summer hill stones veneer, and repointing with appropriate fixing to timber walls where required. Locally remove broken bricks and replace with new bricks.

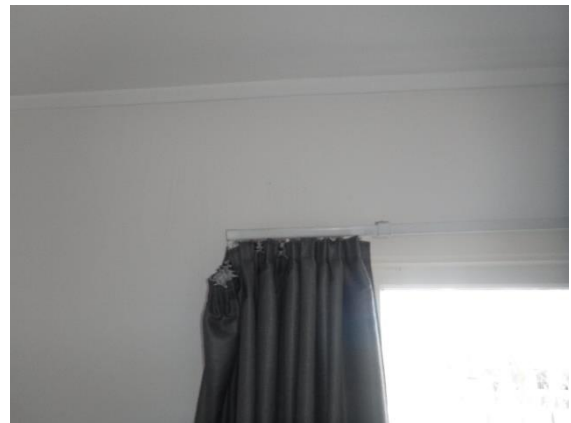
Photo 7. Dwelling wall lining

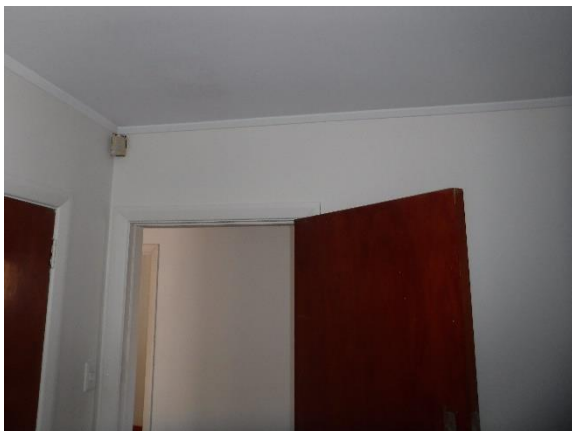
Photo 8. Dwelling wall lining and ceiling

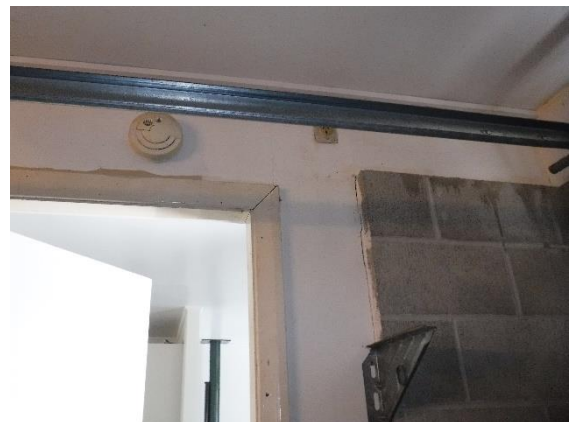
No apparent damages to the dwelling wall lining and ceiling were identified during our inspection. However, minor vertical sheet separations at corner of openings were observed at attached garage wall linings.

Photo 9. Minor vertical sheet separation at corner of opening to garage wall lining.

- (Post re-level) Where diagonal cracks from corners of openings are less than 50mm long and cracks or separations are typically along sheet joints, re-stop to wall (Fibafuse) and ceiling plasterboard.

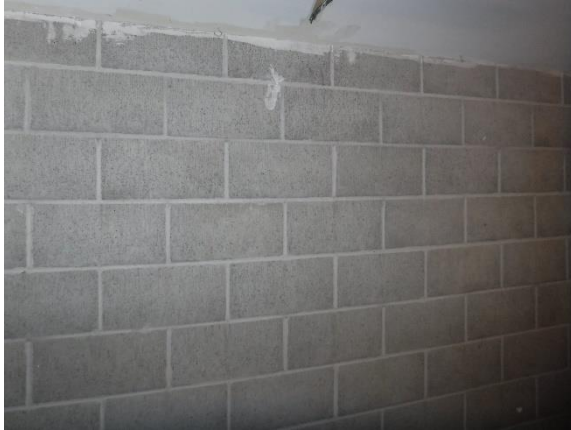
Photo 10. Garage concrete block wall from interior view.

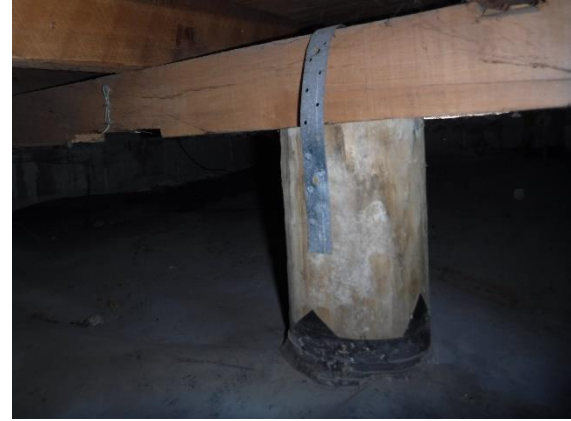
Photo 11. Sub floor space (View 1)

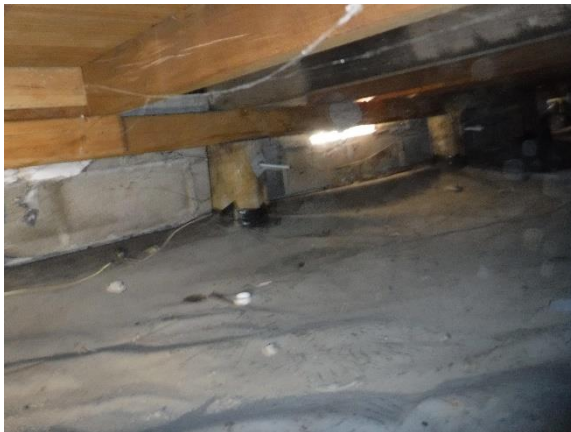
Photo 12. Sub floor space (View 2)

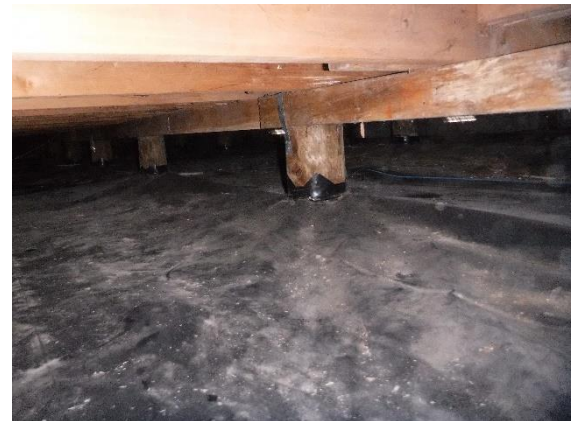
Access to subfloor was limited at the time of inspection. The subfloors had a standard timber floor on timber piles with perimeter concrete block wall. There were steel strap connections identified at the pile-to-bearer interface. The timber internal piles appear to have performed well and have retained its structural integrity. No piles were observed to be leaning, and appeared to provide adequate support for the floor above.

Photo 13. Sub floor space (View 3)

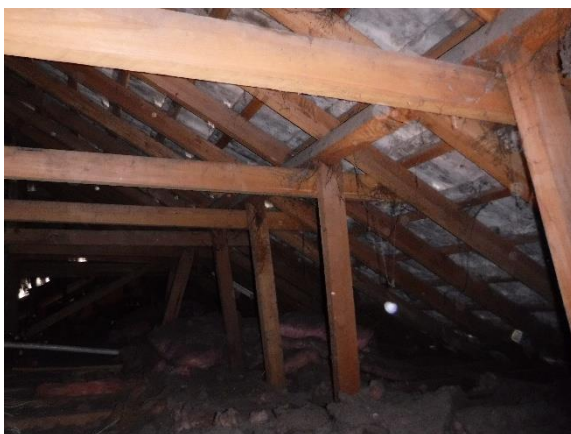
Photo 14. Roof space (View1)

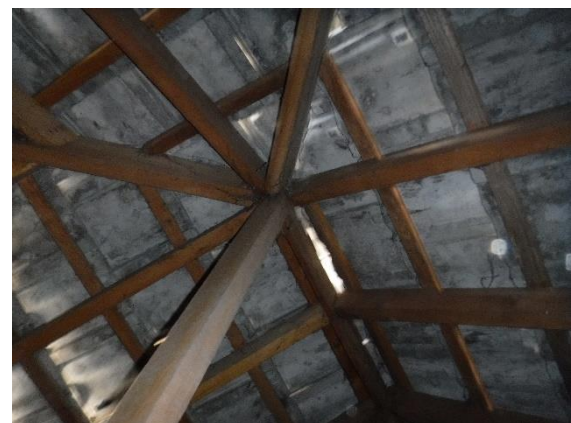
A visual assessment of the roof was carried out from the exterior of the building. The roof appears to have no structural damages, including deflection of the ridge, valley and hip lines. Roof cavity was accessed through an access panel and visibility was limited through this. No apparent damages were observed to timber members and connections.

Photo 15. Roof space (View2)

- (Post re-level) Inspection of roof structure to be carried out by suitable qualified builder. Satisfactory evidences of roof structural integrity (Photos) to be provided to structural engineer for their review.

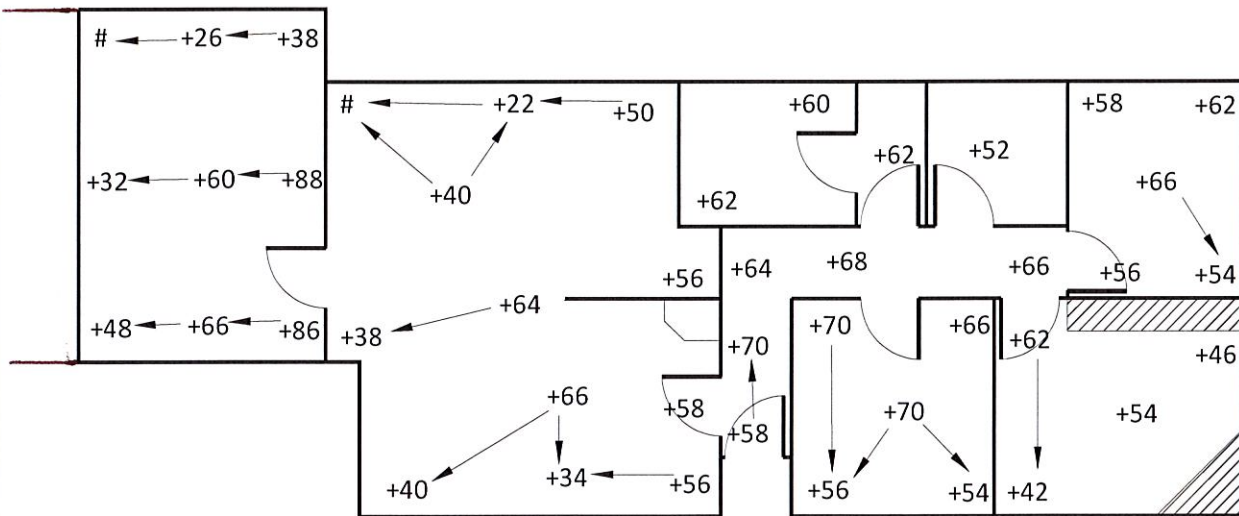
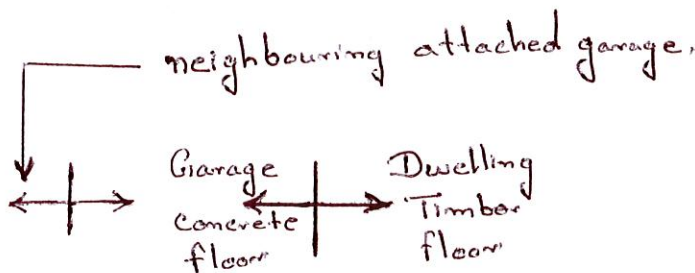
DWELLING: FLOOR LEVEL PLAN

The overall floor level variations were measured to be approximately 70mm for dwelling timber floor and 86mm for garage concrete floor. The both floors level variations exceed 50mm tolerance for floor variation indicated in the MBIE Guidelines. The dwelling floor slopes are generally sloping from east to west of the dwelling with a few locations noticeably exceeding the local slope variation 1:200 (0.5%) MBIE tolerance. The garage concrete floor slopes are generally sloping from east to west of the garage with exceeding the local slope variation 1:200 (0.5%) MBIE tolerance. Hence, the dwelling timber floor and garage concrete floor fall within the “foundation re-level indicated” category.

- 1) for dwelling's floor : 70 mm
- 2) for garage : 86 mm

- Timber floor re-levelling by jacking and packing internal piles as practicably level as possible. Adequate fixing of pile/packing to bearer connections and packing between foundation and superstructure elements following jacking and packing repairs should be installed as per MBIE guidelines. Our recommended target tolerances are within 25mm overall floor level variation with local floor slopes not exceeding 1:200. Replacement of

piles to be recommended if requiring more than 100mm packing to re-level or pile loose on footings or pile more than 15mm out-of-plumb.
