RE: 46 Charles St, Christchurch 8011

Building Act exemption: BCN/2018/608
46 Charles Street Waltham
Foundation Repairs

RE: STRUCTURAL ASSESSMENT – 46 CHARLES STREET, WALTHAM, CHRISTCHURCH 8011.

**RE: STRUCTURAL REPAIR ASSESSMENT – 46 CHARLES STREET,
WALTHAM, CHRISTCHURCH 8011.**

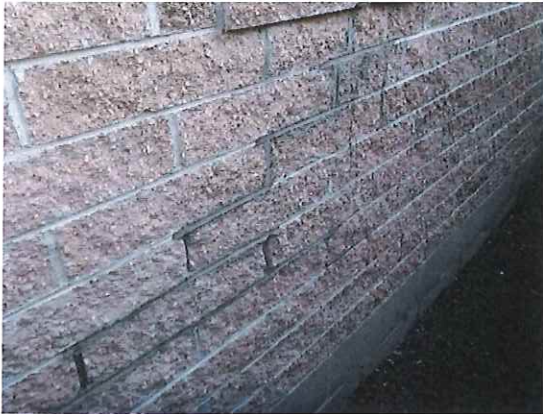
Moderate mortar step cracks to the Summer hill stone veneer at southeast corner of the dwelling were observed. Except this, minor mortar step cracks to the Summer hill stone veneer were identified at a few locations around the dwelling. A single moderate separation in between concrete blocks of perimeter foundation wall was observed at southeast side of the building.

Photo 4. Moderate mortar step cracks to the Summer hill stone veneer at south east corner of the dwelling

- As Summerhill stones veneer was moderately damaged, it is recommended to take them down and re-clad with appropriate fixing to timber walls where required.

The Summer hill stone veneer previously assessed to have moderate damage, has been taken down and re-cladded. The Summer hill stone veneer observed with minor mortar step cracks, has been repaired by raking out the mortar and repointing.

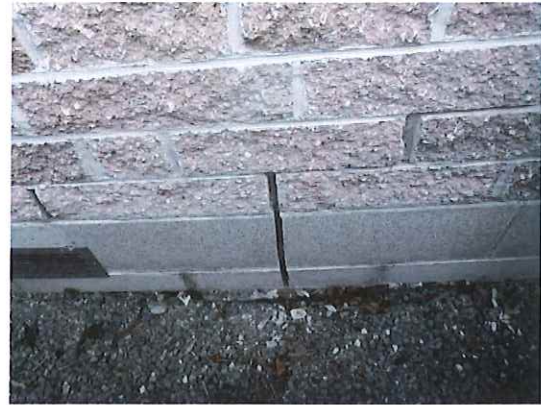
Photo 5. Moderate separation in between the concrete blocks of perimeter foundation wall.

- Rake out mortar along the moderate crack or missing mortar of perimeter foundation block wall, and repointing with appropriate fixing to timber walls where required. Locally remove broken bricks and replace with new bricks.

The block wall perimeter foundation wall observed with moderate separation at southeast side of the dwelling, has been repaired and plastered.

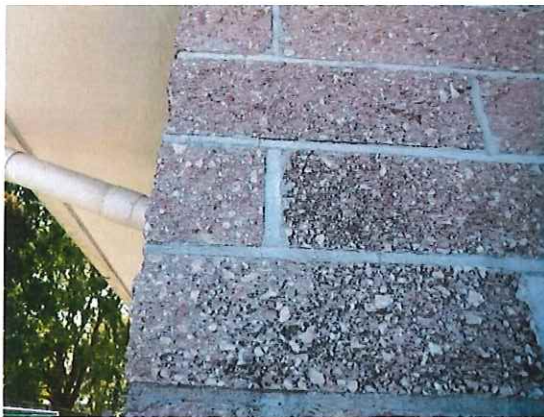
Photo 6. Minor mortar step cracks around the dwelling.

- Rake out mortar along the minor crack lines of dwelling Summer hill stones veneer, and repointing with appropriate fixing to timber walls where required. Locally remove broken bricks and replace with new bricks.

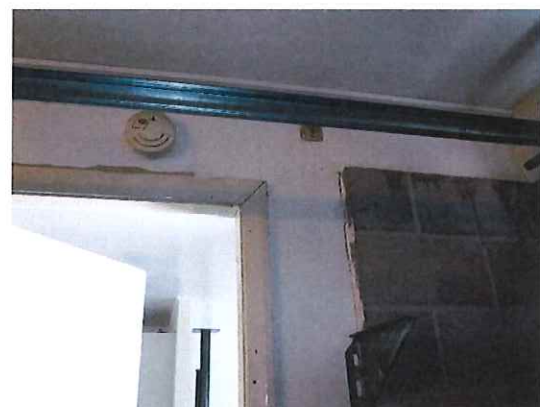
No apparent damages to the dwelling wall lining and ceiling were identified during our inspection. However, minor vertical sheet separations at corner of openings were observed at attached garage wall linings.

Photo 9. Minor vertical sheet separation at corner of opening to garage wall lining.

- (Post re-level) Where diagonal cracks from corners of openings are less than 50mm long and cracks or separations are typically along sheet joints, re-stop to wall (Fibafuse) and ceiling plasterboard.

- (Post re-level) Where diagonal cracks from corners of openings are exceeding 50mm length and panel fractured, replacement of wall and ceiling plasterboard with equivalent bracing elements (GIB Braceline) is recommended. Installation of new fasteners to be in a bracing pattern around the plasterboard sheet perimeter in accordance with manufacturer's guidelines.

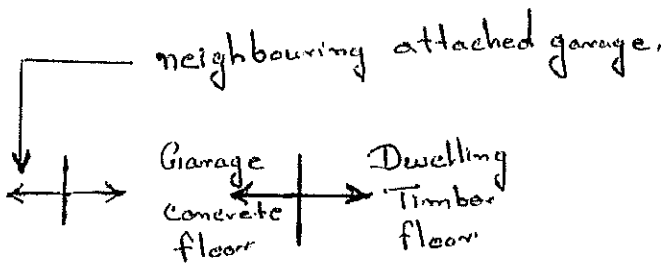
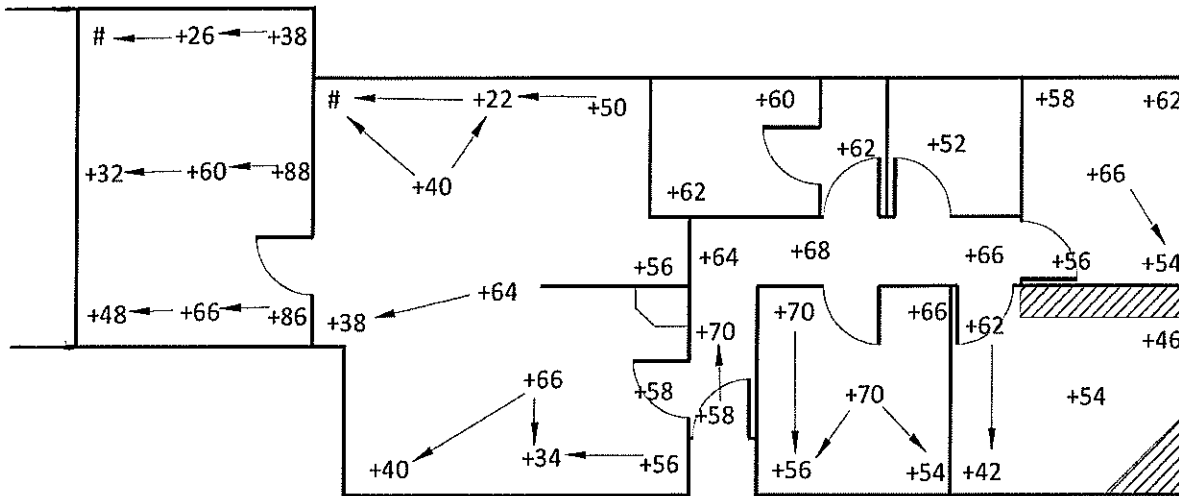
DWELLING: FLOOR LEVEL PLAN

A floor level survey using Zip-Level Pro-2000 instrument of a typical accuracy of $\pm 3\text{mm}$ was carried out during the inspection and is presented in the Floor Level Plan attached in this report. It should be noted that the purpose of the floor level survey is to provide assistance in determining possible structural damage of the building and therefore should be treated as indicative only. Where a high-level dependence and an accurate and credible presentation of the survey information are required, a registered professional surveyor should be engaged to carry out the survey.

The overall floor level variations were measured to be approximately 70mm for dwelling timber floor and 86mm for garage concrete floor. The both floors level variations exceed 50mm tolerance for floor variation indicated in the MBIE Guidelines. The dwelling floor slopes are generally sloping from east to west of the dwelling with a few locations noticeably exceeding the local slope variation 1:200 (0.5%) MBIE tolerance. The garage concrete floor slopes are generally sloping from east to west of the garage with exceeding the local slope variation 1:200 (0.5%) MBIE tolerance. Hence, the dwelling timber floor and garage concrete floor fall within the “foundation re-level indicated” category.

- Timber floor re-levelling by jacking and packing internal piles as practicably level as possible. Adequate fixing of pile/packing to bearer connections and packing between foundation and superstructure elements following jacking and packing repairs should be installed as per MBIE guidelines. Our recommended target tolerances are within 25mm overall floor level variation with local floor slopes not exceeding 1:200. Replacement of

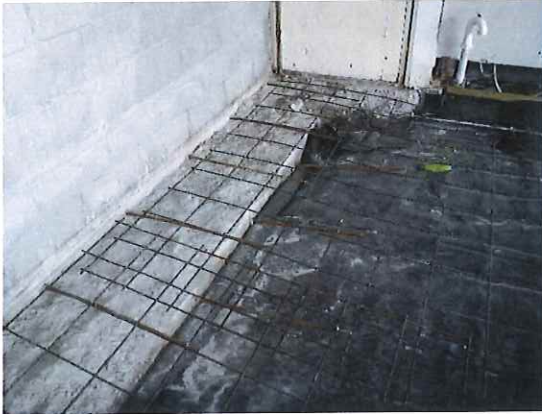
We have undertaken pre-pour inspection as a construction monitoring process. (Please refer to the attached inspection note). The garage concrete floor was observed to have been partially replaced with SE62 mesh, D10 starter bars fixed into existing concrete foundation, and DPM.

Photo 1. Garage concrete floor prior to pour concrete (View1)

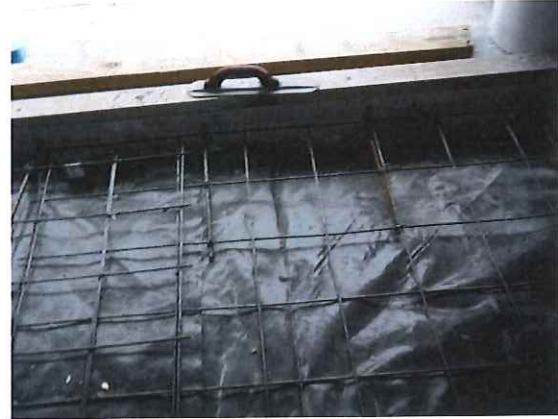
Photo 2. Garage concrete floor prior to pour concrete (View2)

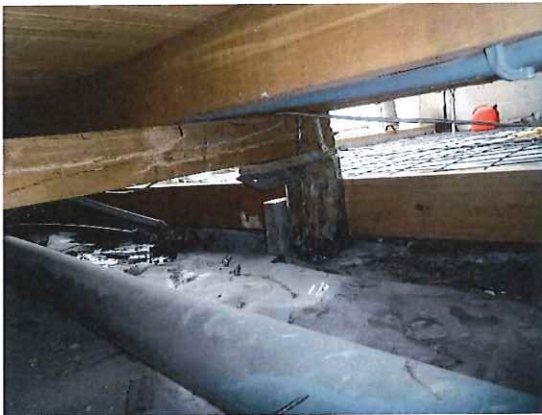
Photo 3. Single timber packer at interface of bearer and pile with steel strap connection

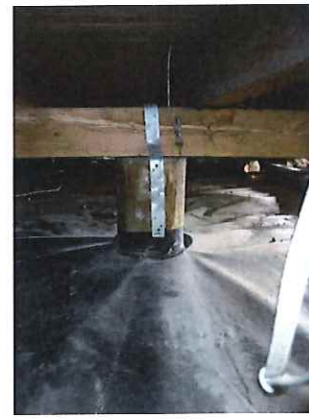
Photo 4. Steel strap connection to pile and bearer

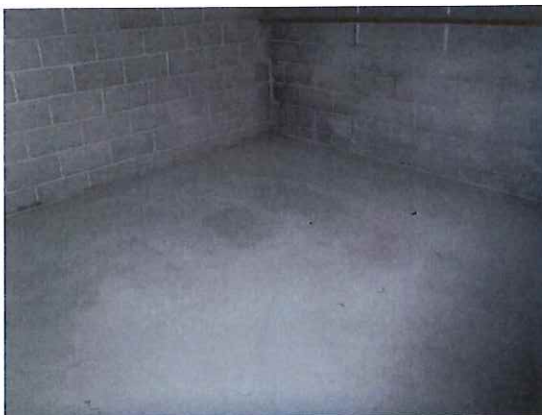
We have undertaken our level survey after repair process. The overall floor level variation was found to be approximately 26mm for garage concrete floor, with typically no local steep slopes exceeding 1V:200H identified during our assessment. Please refer to level survey plan attached.

Photo 5. Garage concrete floor after cast

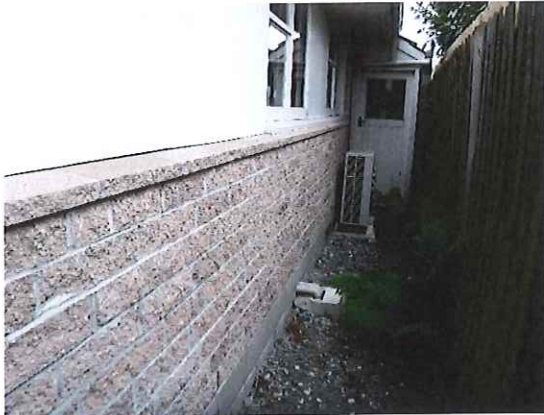
Photo 7. Re-cladded Summer hill stone and foundation block wall repair

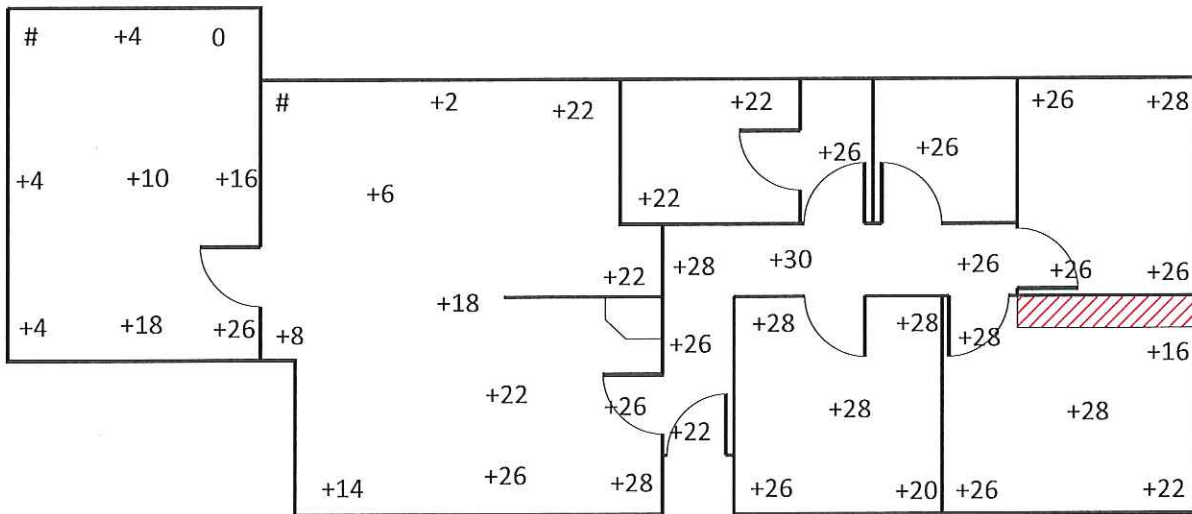
DWELLING: FLOOR LEVEL PLAN

We have undertaken our level survey after jack and pack repairs. The overall floor level variation after jacking and packing repairs undertaken was found to be approximately 30mm for dwelling timber floor, with typically no local steep slopes exceeding 1V:200H identified during our assessment. Please refer to level survey plan attached.
