Property Inspection Report

148 Mazengarb Road Paraparaumu

Prepared for: Carol Abernethy

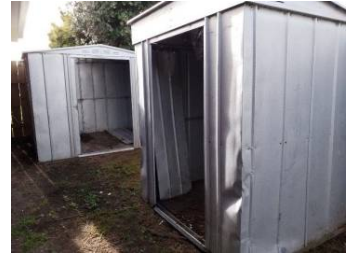
Two old steel sheds in poor condition overall.

This site is well established and in a reasonably well presented condition.
The site may require a tidy up in areas, or simply show signs of general ageing and weather deterioration, but there are no major problems here of concern.
Two old steel sheds in poor condition overall.

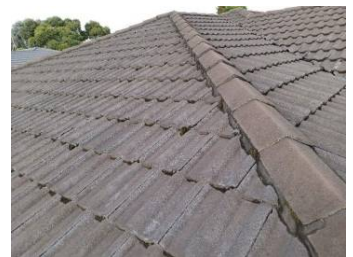
Roof cladding main:1

Lichen treatment required.

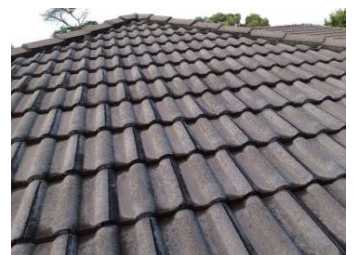
Roof cladding main:3

Lichen treatment required.

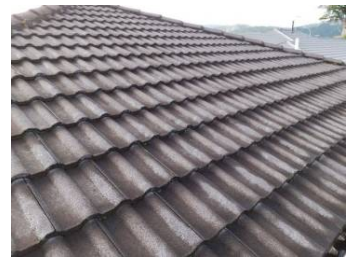
Roof cladding main:5

Lichen treatment required.

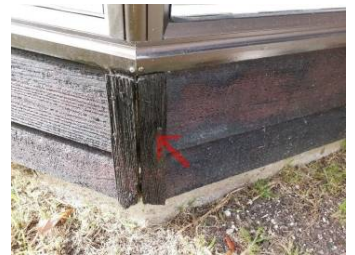
External Wall Cladding:1

Ground heights here to high ,this will rot the timber weatherboards .

Remedial attention suggested.
Damage evident, possible replacement of damaged area may be the best or easiest option here.

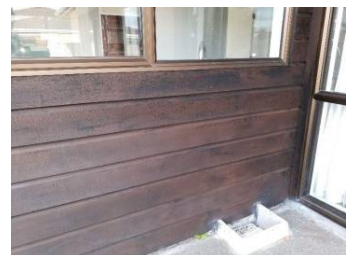
External Wall Cladding:2

Remedial attention suggested.
Cosmetic upgrade required.

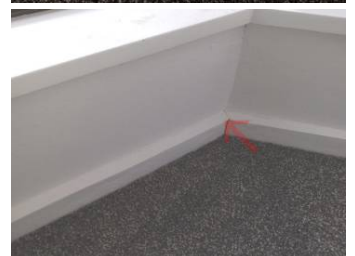
Generally good .
[Remedial attention suggested here .](#)
Cosmetic upgrade required.

[Remedial attention suggested.](#)
[Cosmetic upgrade required.](#)

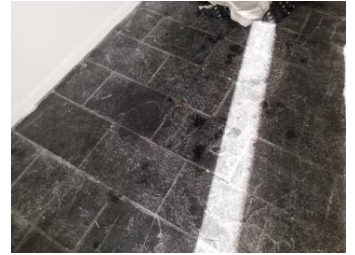
Tile fitted.
[Re-polishing required here.](#)

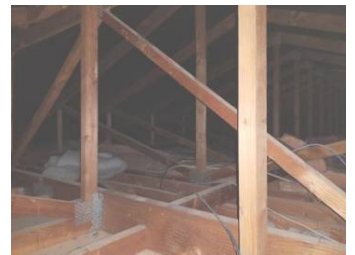
Image 1:

Trusses good .
No insulation to garage area ,this is quite normal .

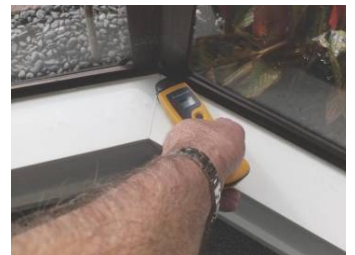
Image 2:

Living room.
High readings to the window sill and associated damage to skirting indicate condensation issues to large window rather than a leak .
