# Property Info Pack

**226 Westminster  
Street, St Albans.**

# Pre Sale Building Report

## 226 Westminster Street, Mairehau

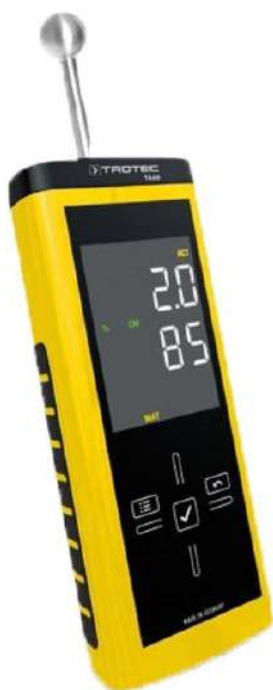
Are there any current elevated moisture readings?

No elevated moisture readings have been recorded where tested

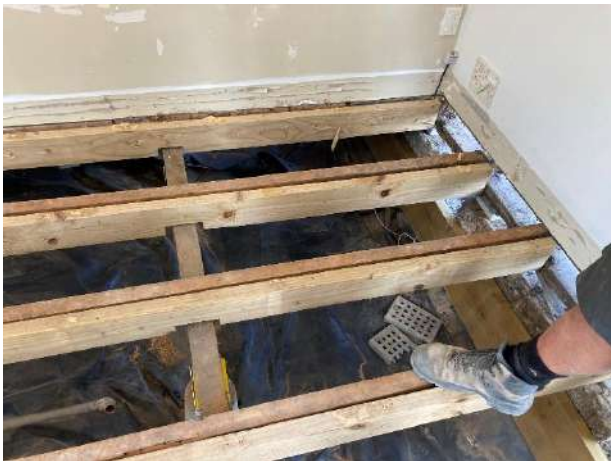
*Figure 1 - Doubled joists is the area where floors heights are reduced – New plate can be seen along the foundation.*

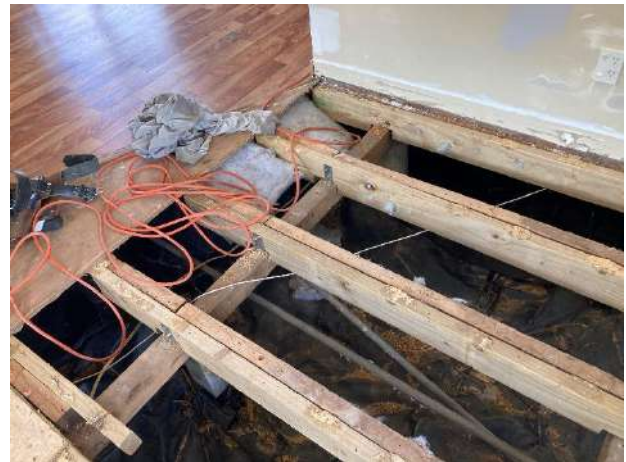
*Figure 2 - fixings between joists and bearer.*

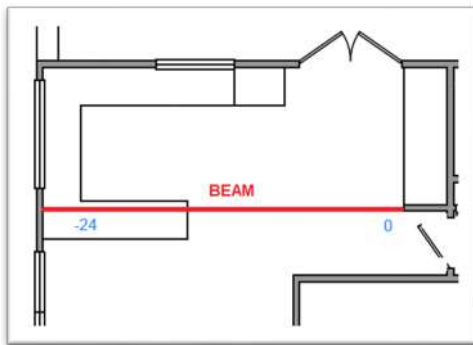
- 3.7 At some time in the past, a wall between the kitchen and dining/living rooms has been removed in order to create a more open plan living space. A beam has been installed to replace the support provided by the original wall. This beam drops approximately 24mm down towards the east, although the ceiling is relatively level along the length of the room.

*Figure 2 - Location of the beam across the kitchen and dining/living room*

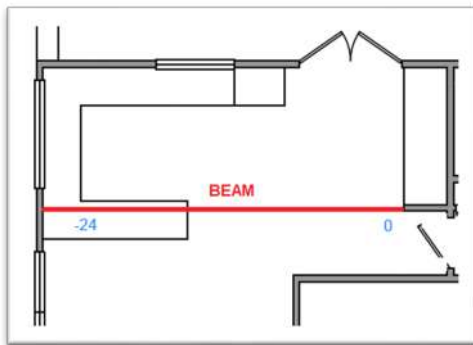
- 3.7 At some time in the past, a wall between the kitchen and dining/living rooms has been removed in order to create a more open plan living space. A beam has been installed to replace the support provided by the original wall. This beam drops approximately 24mm down towards the east, although the ceiling is relatively level along the length of the room.

*Figure 2 - Location of the beam across the kitchen and dining/living room*

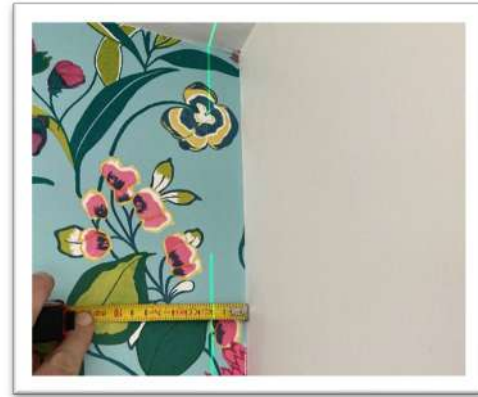
Figure 5 - Wall leans approximately 30mm over its full height

- 3.9 I identified several other features that appear to show a general trend in the floor slopes and leaning walls towards the north.
- 3.10 It appears that the floor slopes in the dining/living rooms have been repaired independently of the foundations. This is typically achieved by packing the joists to create a more level floor rather than lifting the floor and subfloor framing, and then packing between the bearers and the piles (or foundation wall).

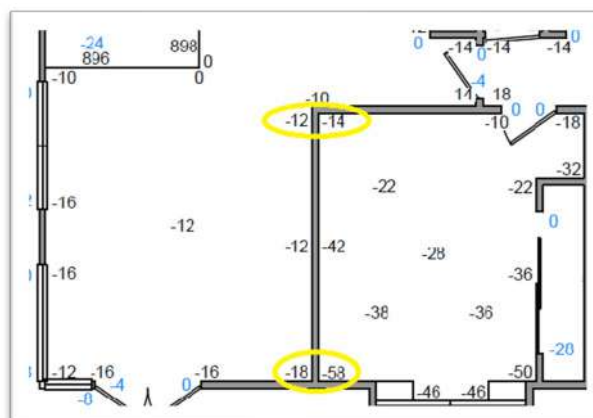
- 3.11 The extent of the re-levelling through the living room is in the order of approximately 40mm. The wall that separates the dining/living room from the adjacent bedroom differs only 2mm at the southern end (-12mm in the dining room and -14mm on the other side of the wall in the bedroom). However, the northern end of this wall differs by approximately 40mm (-18mm in the living room and -58mm in the bedroom). See highlighted areas in the image below:

Figure 6 - Discrepancies in the floor heights on adjacent sides of the bedroom wall

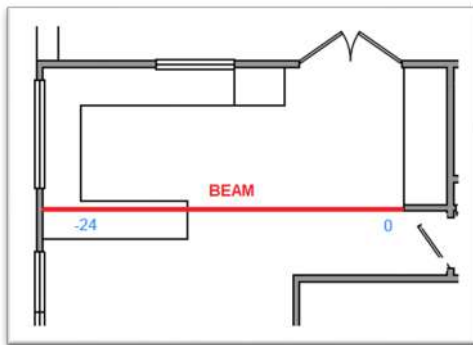
- 3.7 At some time in the past, a wall between the kitchen and dining/living rooms has been removed in order to create a more open plan living space. A beam has been installed to replace the support provided by the original wall. This beam drops approximately 24mm down towards the east, although the ceiling is relatively level along the length of the room.

*Figure 2 - Location of the beam across the kitchen and dining/living room*
