PROPERTY INFO PACK

34 CHARTWELL STREET, BURWOOD

Property Inspection Report

This is to be a visual, non-invasive, inspection of the property for the purposes of a pre-purchase report on the condition of the house and buildings, in accordance with the New Zealand Standard for Residential Property Inspections NZS 4306:2005.

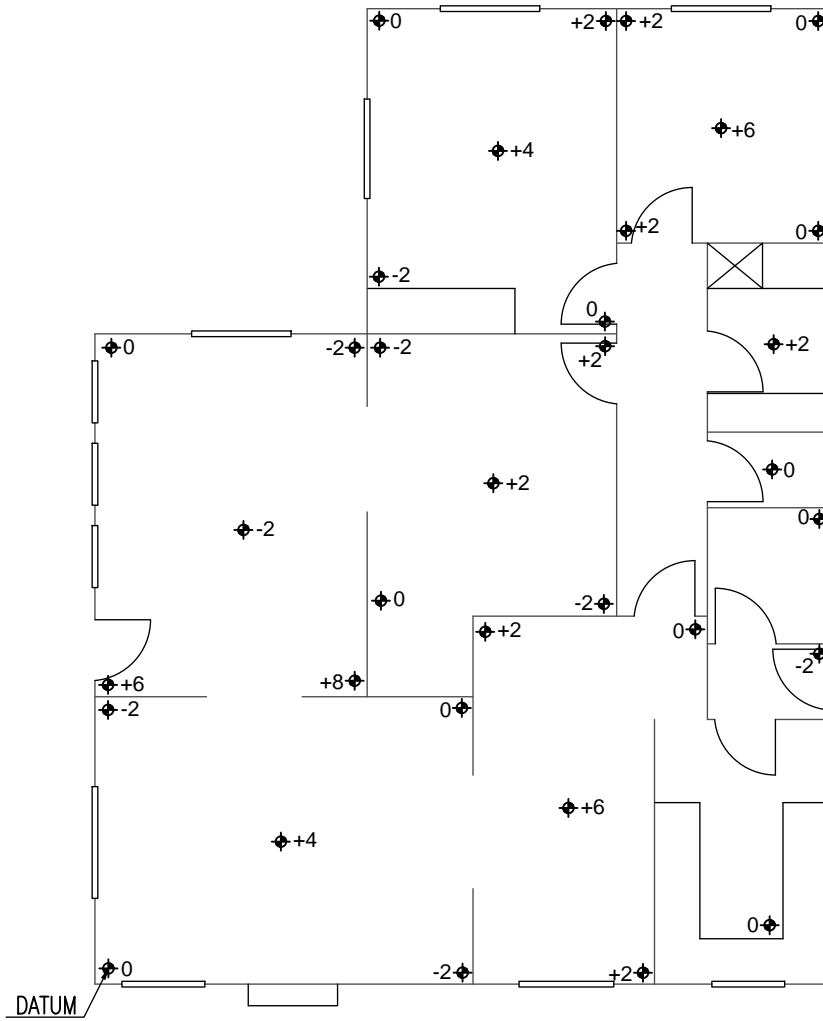
AS-BUILT PLAN
SCALE 1:100

Room/Location	Commentary
Floor Level	<ul style="list-style-type: none">- The final floor variation is 10 mm.- No re-levelling required.- Refer attached as-built level plan.- Refer PS3 supplied by the contractor.
External Cladding	<ul style="list-style-type: none">- No damage to the Summerhill Stone cladding is observed during the inspection.
Internal Walls and Ceiling	<ul style="list-style-type: none">- Damage to the internal walls and ceiling has been repaired.
Foundation	<ul style="list-style-type: none">- Minor crack to the perimeter foundation has been repaired. PS3 supplied by the contractor.

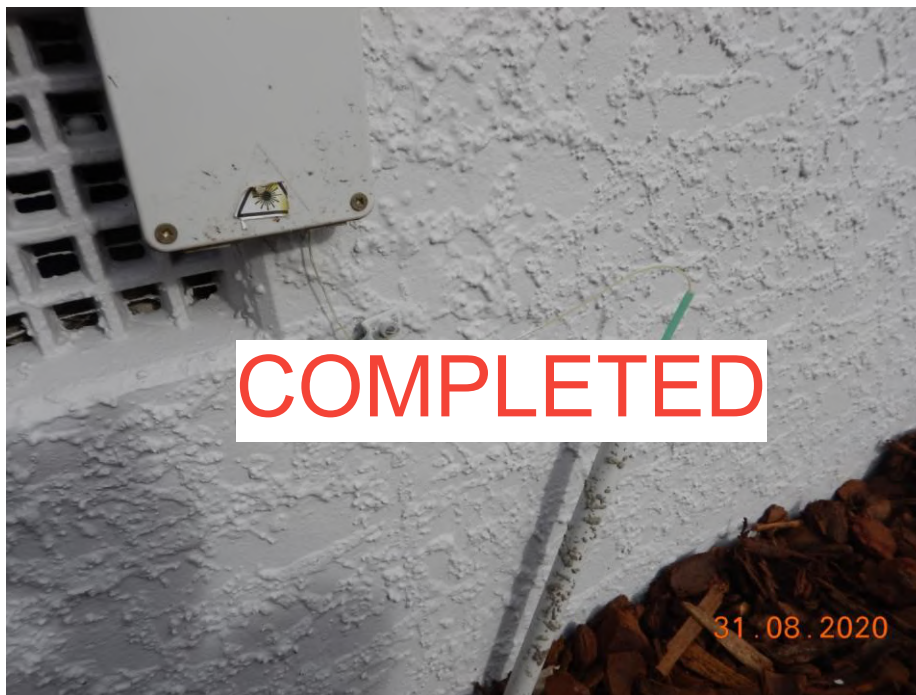
1. The fibre optic wire coming in at the front of the house appears to be still connected but only just. This may need repair.

Fibre optic wire may need repair.

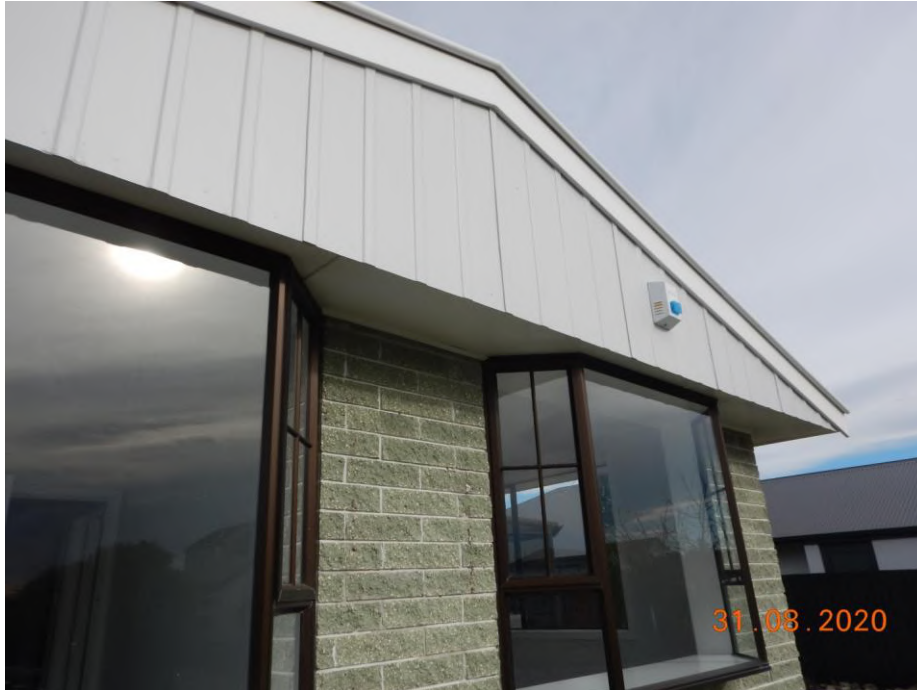
2. The fibre cement panels at the street frontage gable end and the soffit sheets may contain asbestos. This is not a problem unless the material is disturbed. It is the home-owners' duty of care to advise any person working on these areas that asbestos may be present and to take the appropriate health and safety precautions. Note that it is not possible to be sure of the presence of asbestos without testing the materials.

The profiled material of the gable and the flat soffit sheets may contain asbestos.

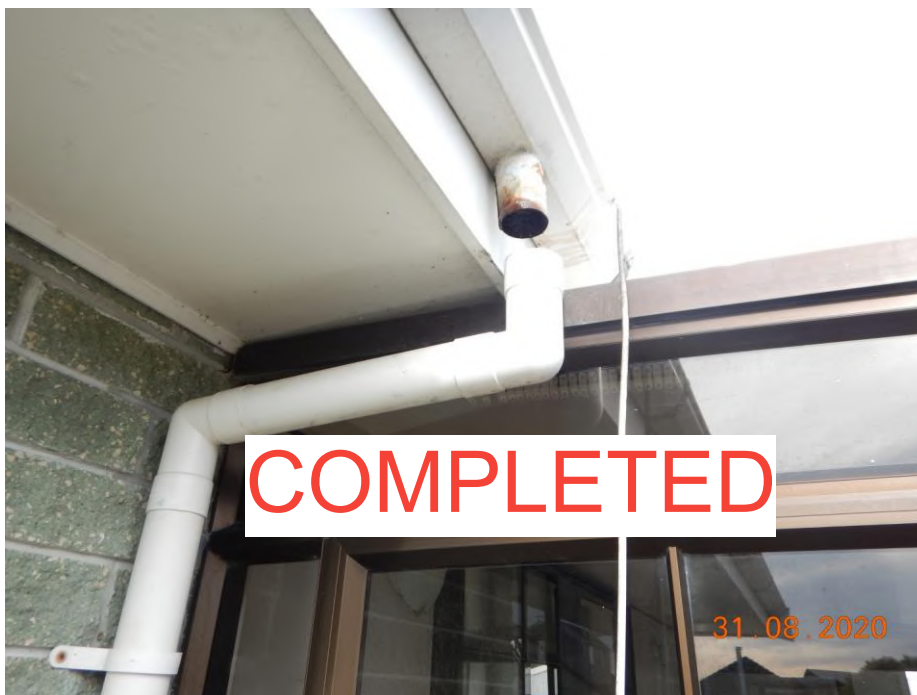
3. The downpipe adjacent to the conservatory is disconnected from the spouting dropper. The conservatory downpipe is also sagging and probably not draining correctly, it is also not feeding into the riser properly.

Downpipe is disconnected from the dropper.

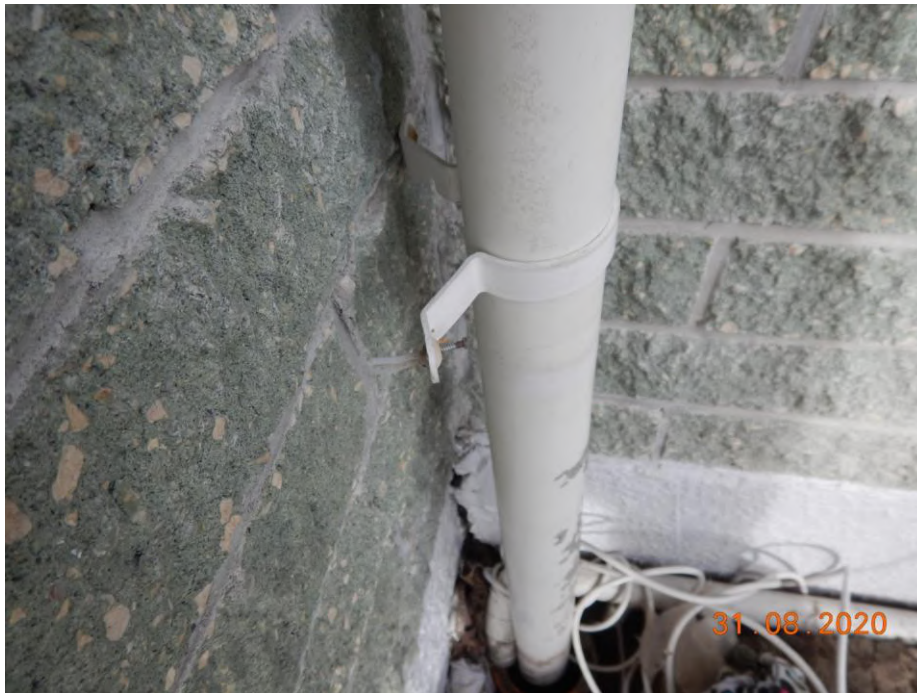
The bracket on the same downpipe has broken.

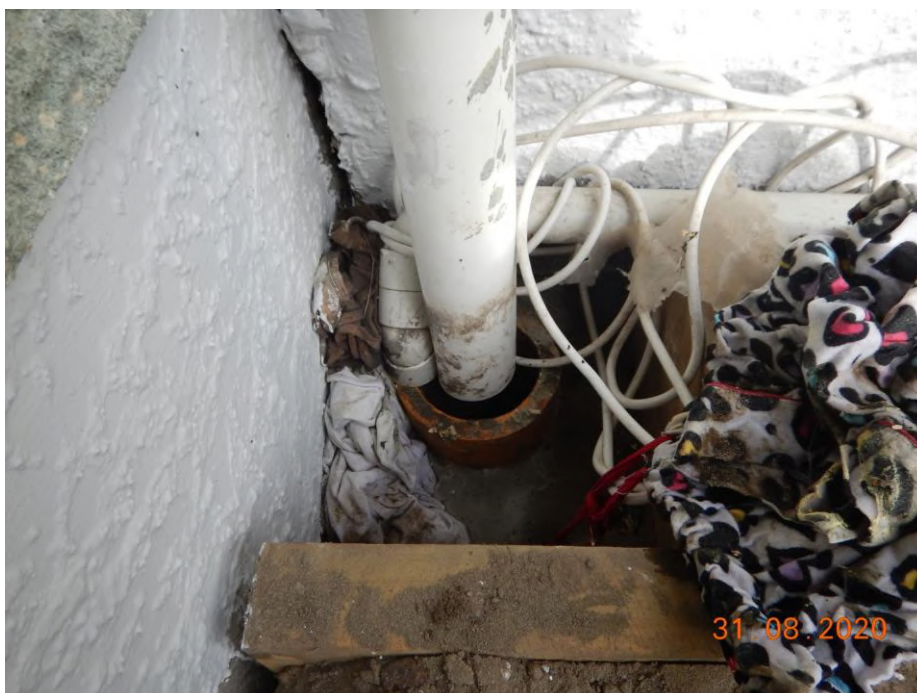
The smaller downpipe from the conservatory doesn't feed into the rise properly and will spill on the foundation, causing dampness and potentially undermining the foundation strength.

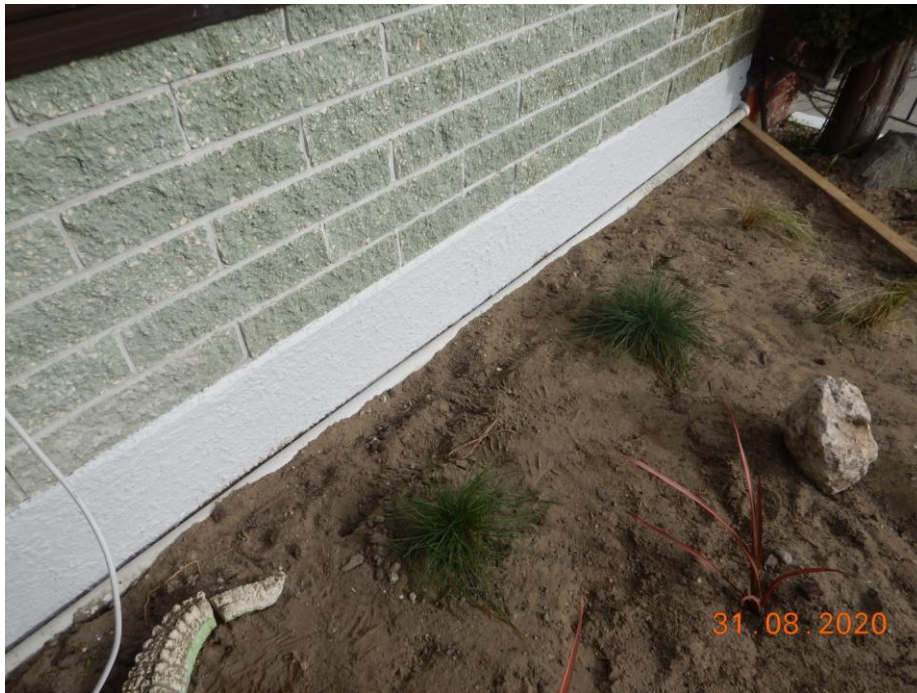
The conservatory downpipe needs raising up where it sags in the middle of this run to ensure proper drainage.

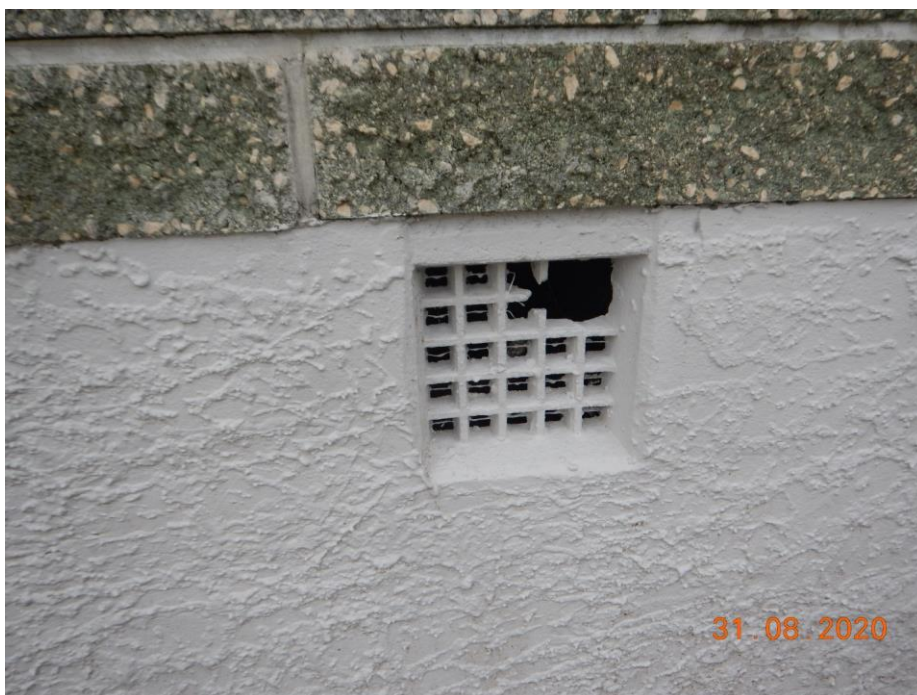
4. There are 2x broken foundation vents that should be repaired to prevent rodent access.

Both the broken foundation vents are on the SW end of the house.

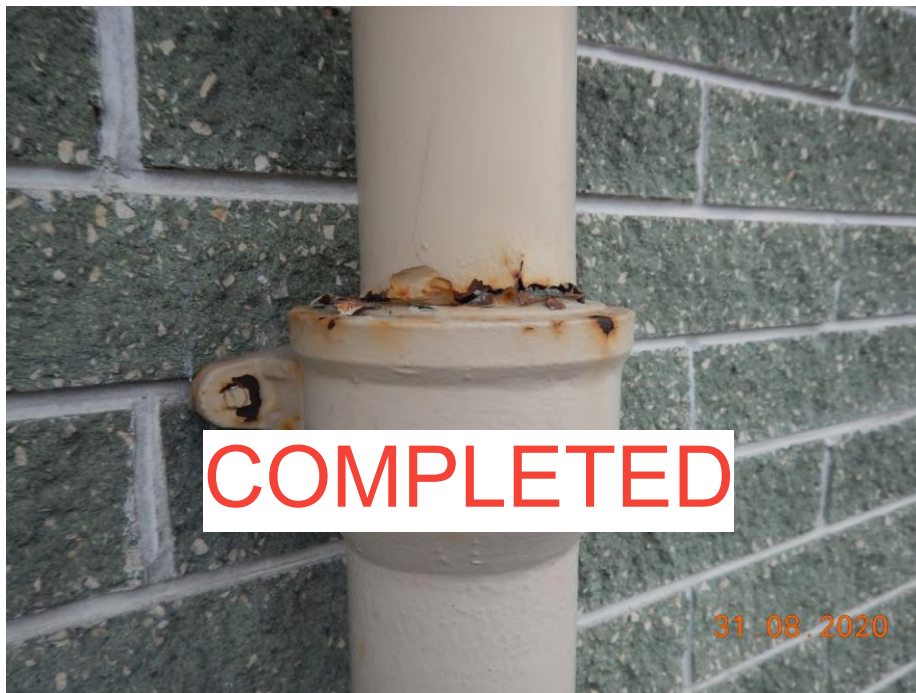
5. The terminal vent of the sewer has completely rusted through and the top part (above the collar) will need replacing to prevent odours in the vicinity.

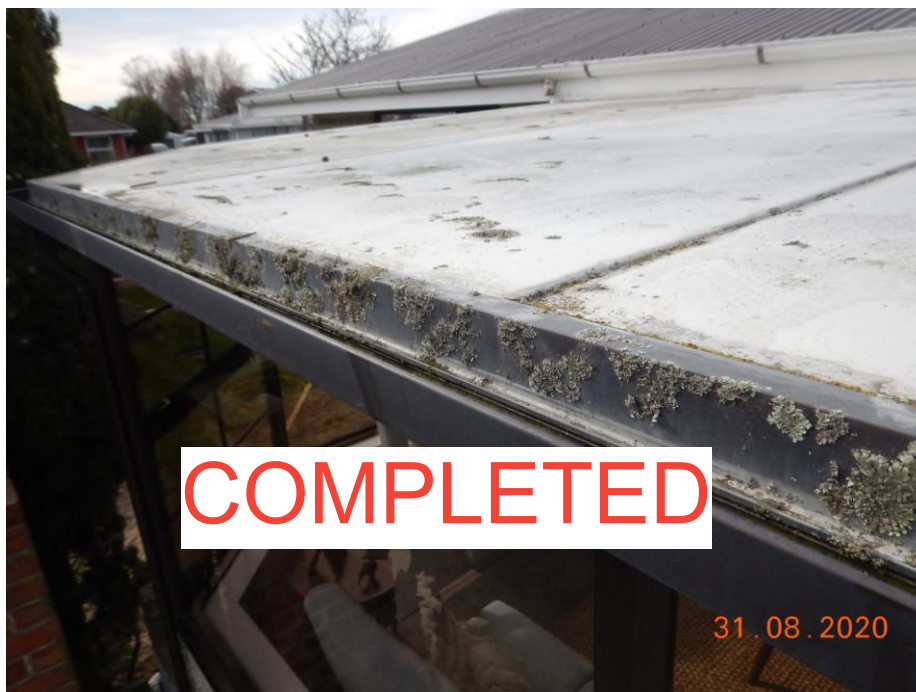
6. The conservatory roof needs to be treated against lichen growth to prevent the lichen eating into the metal.

Lichen growth is unsightly but also damaging to the metal.

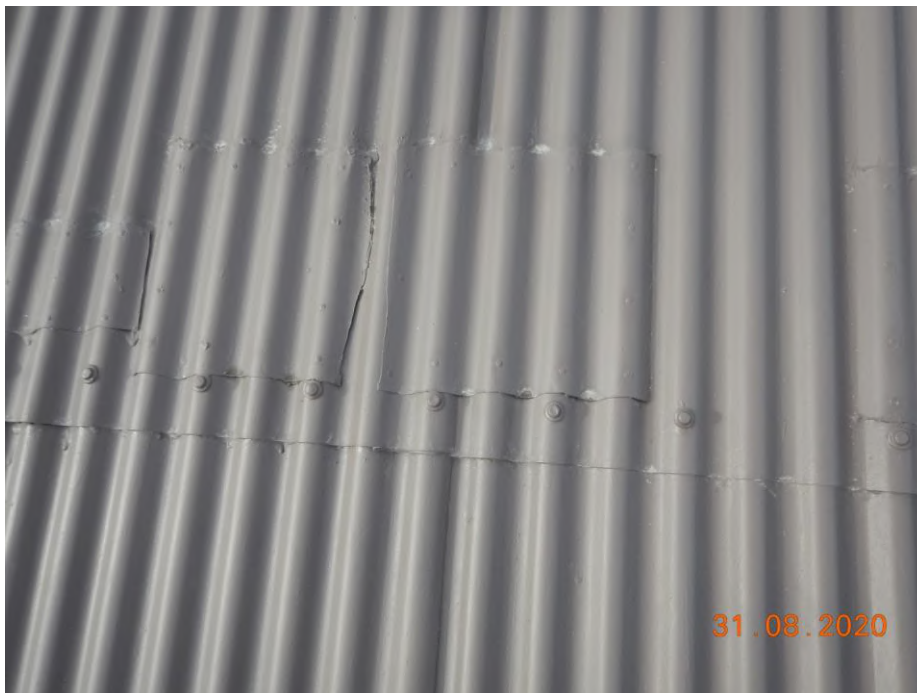
7. I counted 14x patches in the short-run corrugated iron which have probably been fixed over rusty areas. There is no rust evident at the moment and the roof may last some years yet if maintained and painted well.

This row of 14x patches are all on the lower part of the top run of iron and where the upper and lower sheets lap.

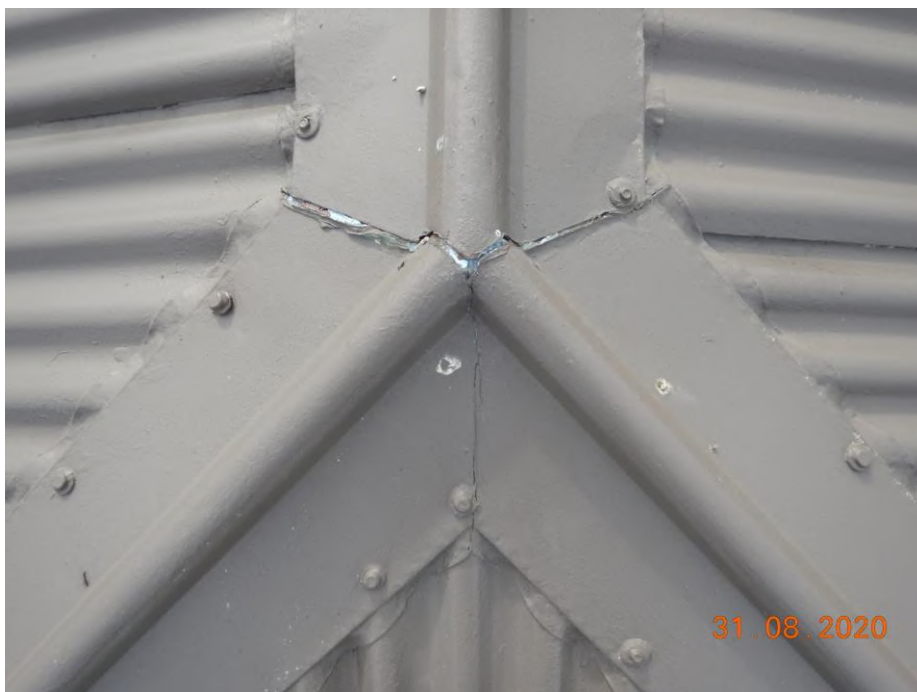
Also keep an eye on the ridge joints. This one was probably painted on a warm day and the iron has shrunk away in colder conditions. This may need sealant and repainting.

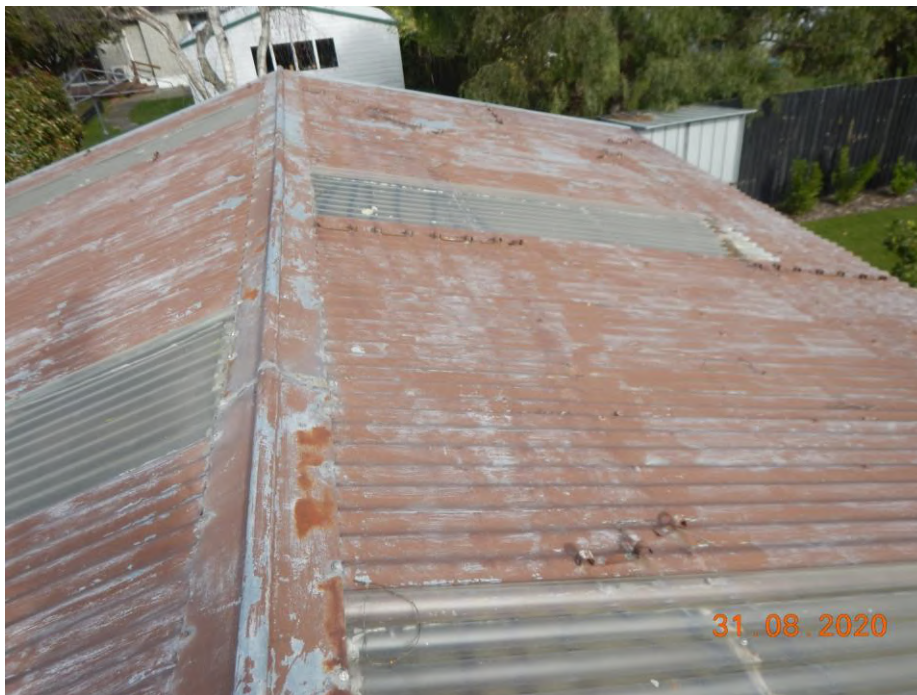
8. The garage roof is in average condition. If the surface rust was treated and the roof was paint it may last many more years. Note that the polycarbonate panel for light, get brittle from UV over time and can become dangerous to walk on.

Due for a paint.

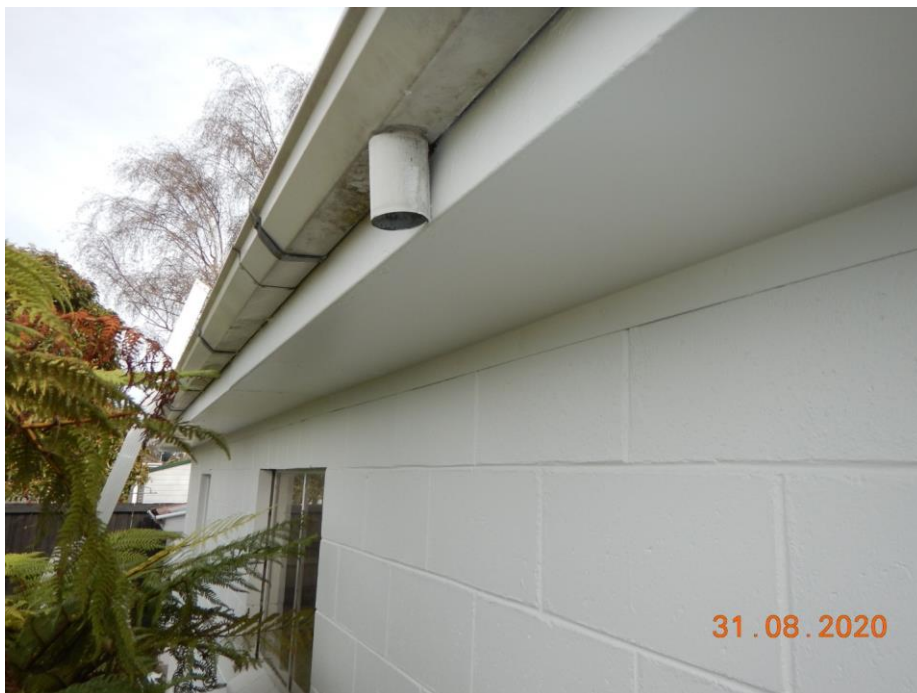
Dropper, but no downpipe and no stormwater riser, meaning no stormwater pipes to the garage.

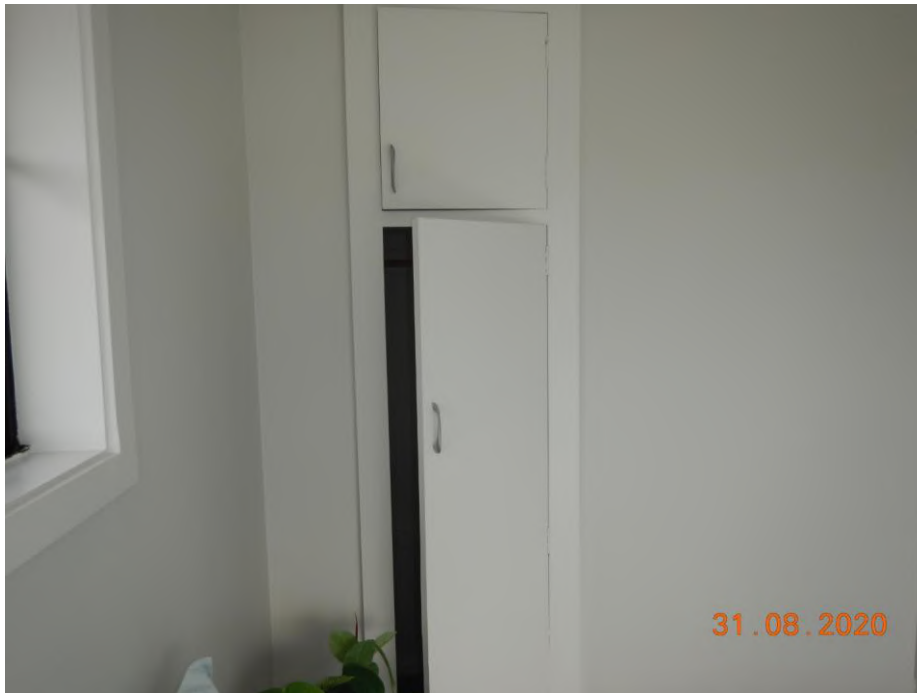
9. Bedroom cupboard doors all need attention. The top one here is sticky, the bottom one doesn't stay closed.

Bedroom cupboard doors need attention.

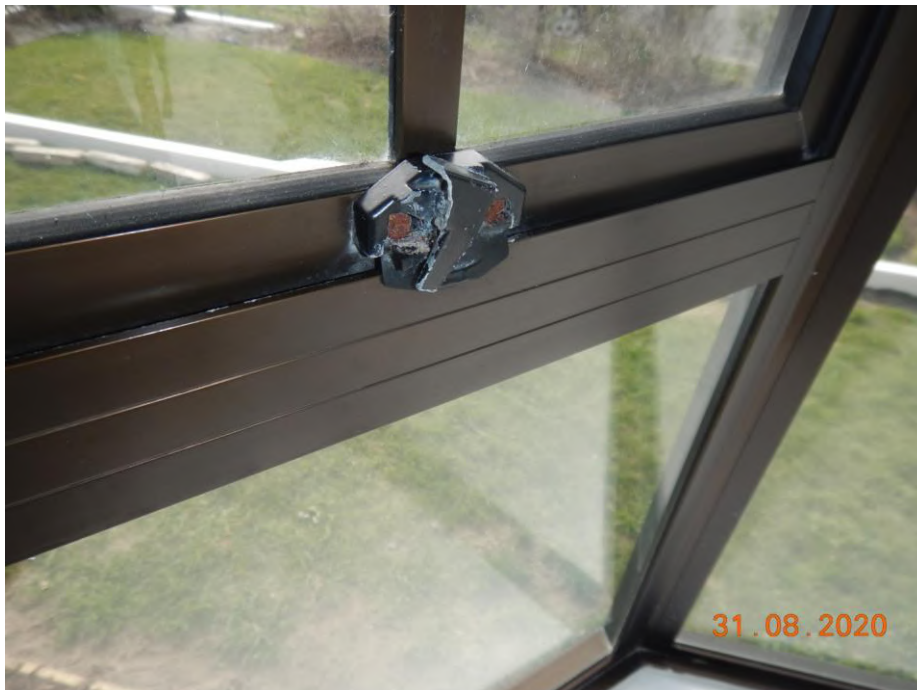
10. Broken fitting on the east bedroom window and broken handle on the sliding door between the middle bedroom and the conservatory.

Broken window fittings can usually be easily replaced.

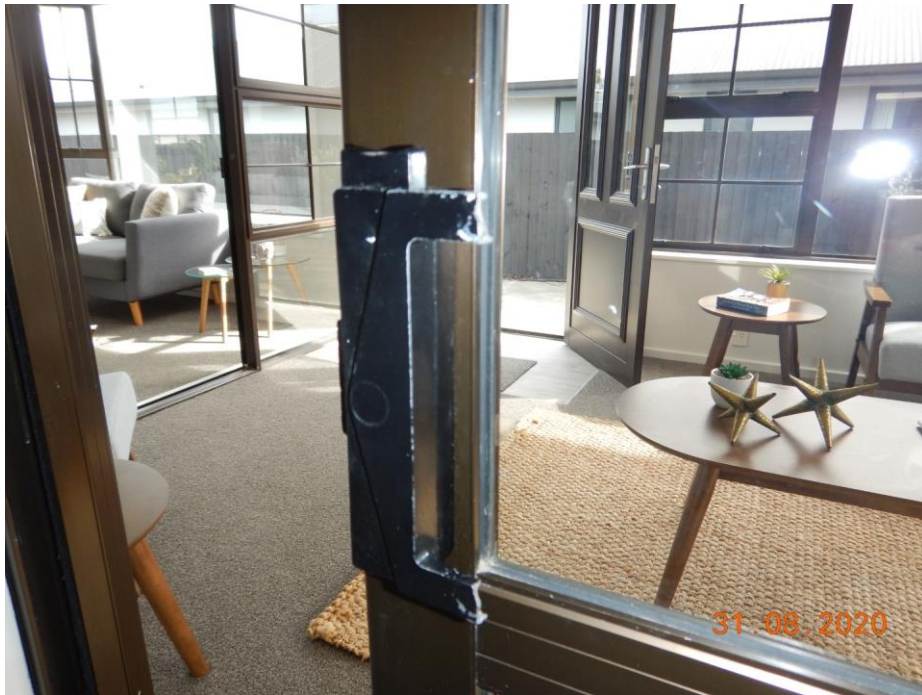
Broken door handle should also be able to be replaced.

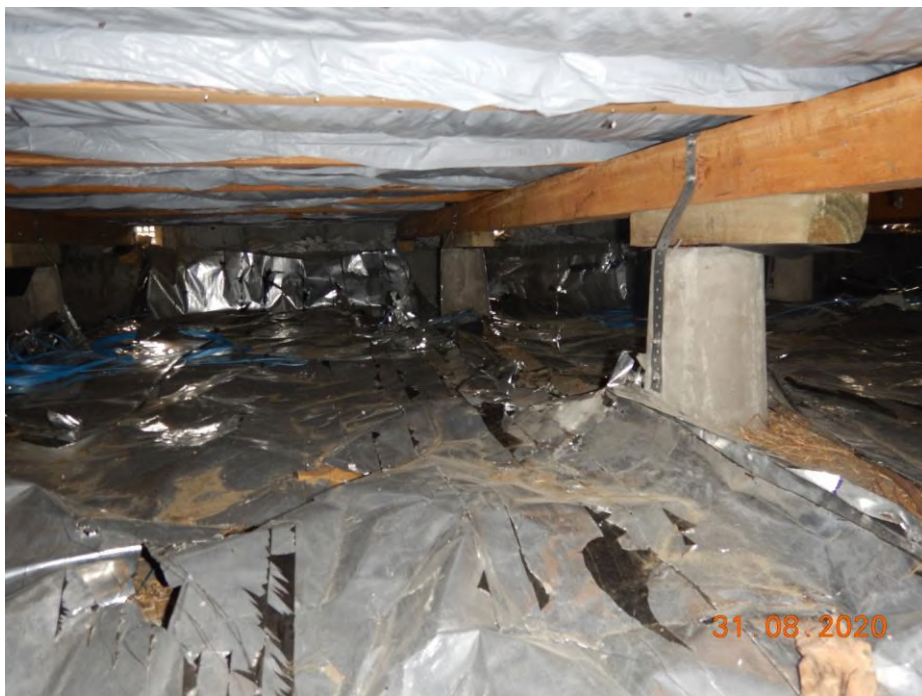
11. Sisalation under-floor is now not able to be repaired or replaced by law. DPM is a better option.

Sisalation cannot be repaired or replaced.

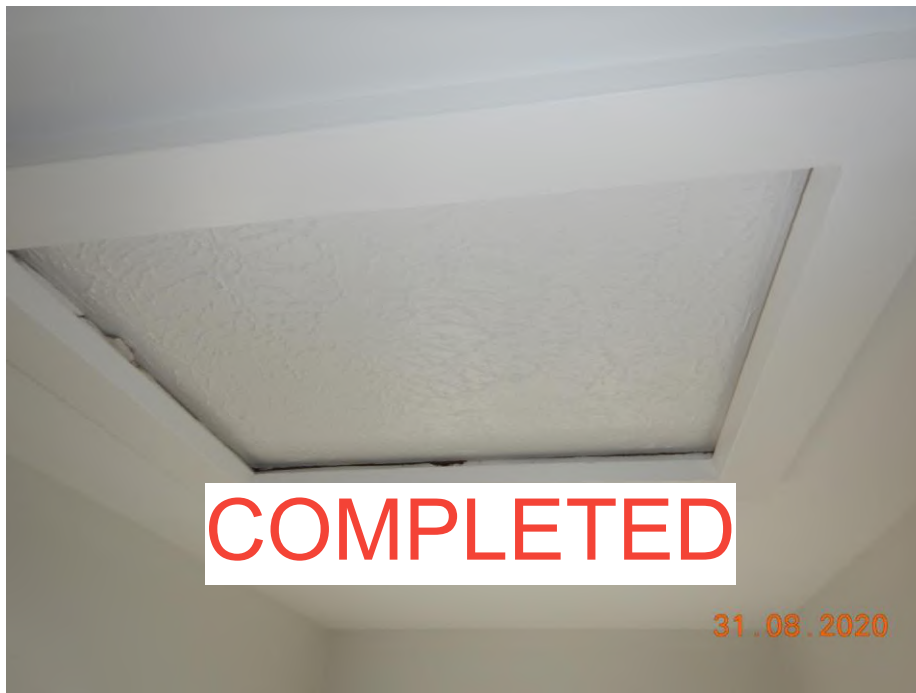
12. The stipple on the manhole cover in the hall probably contains asbestos and should be thrown away. It also doesn't fit properly. This can be replaced with a piece of plasterboard or better yet, a piece of MDF. Note to ask the current owners for the paint colours throughout the house so that minor touch-ups like this can be done.

This stipple on the manhole cover probably contains asbestos.
