**Information request – CLM/2011/100661 - 6 Freebairn Street, Redwood, Christchurch 8051.**

**Date Created:** 25/08/2011 16:21  
**Created :** Miller, Doug  
**Subject:** Assessment  
**Note:** 1967 one level dwelling, 3 bedrooms, brick veneer exterior cladding, decromastic tile roof, on concrete piles and ring foundation. Lounge extension and garage - concrete slab foundation. Moderate cracking to brick veneer and ring foundation, exterior chimney to be removed to ceiling and reinstated. Minor cracking in garage concrete slab. Cosmetic cracking to walls and ceilings throughout interior rooms.  
 No liquefaction. 100% free space sub floor, 600mm Habitable and weatherproof

<b>Address</b>	6 FREEBAIRN STREET, REDWOOD, CHRISTCHURCH, 8051	<b>EQC Claim Number</b>	CLM/2011/100661
<b>Hazards</b>	Nil hazards	<b>EQC Assessor (L,F)</b>	Miller, Doug
<b>Inspection Date</b>	25-Aug-2011	<b>Placard</b>	No Sticker
		<b>EQC Estimator (L,F)</b>	Blaauw, John

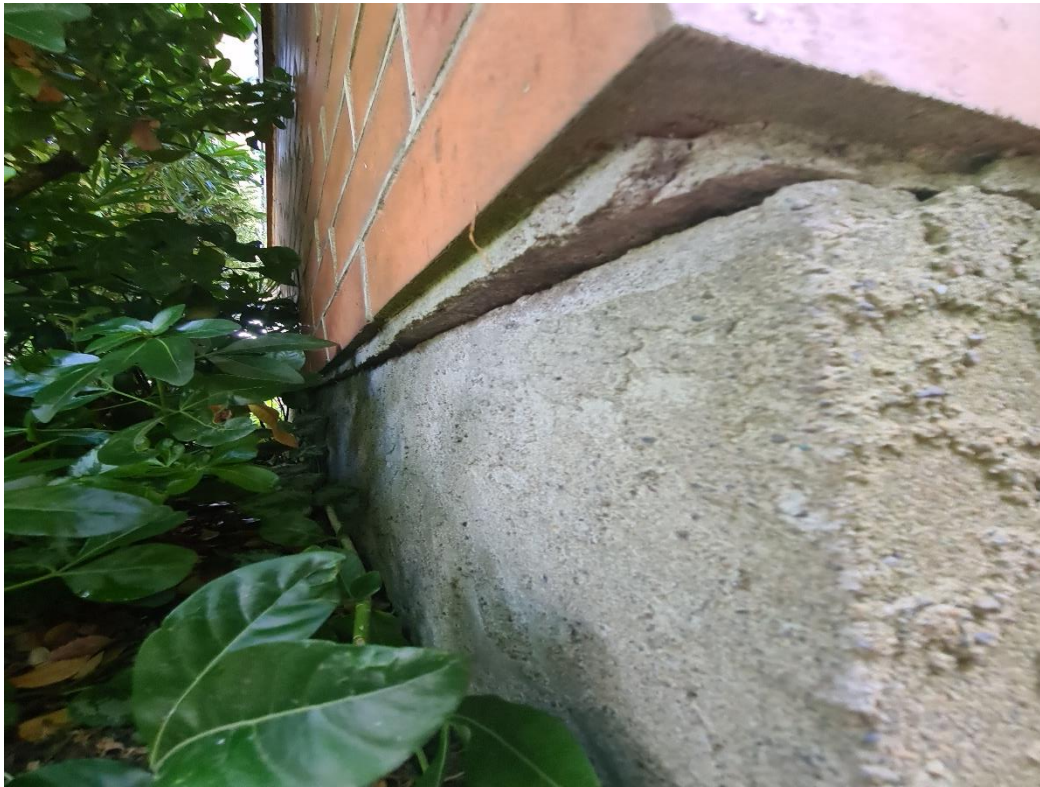
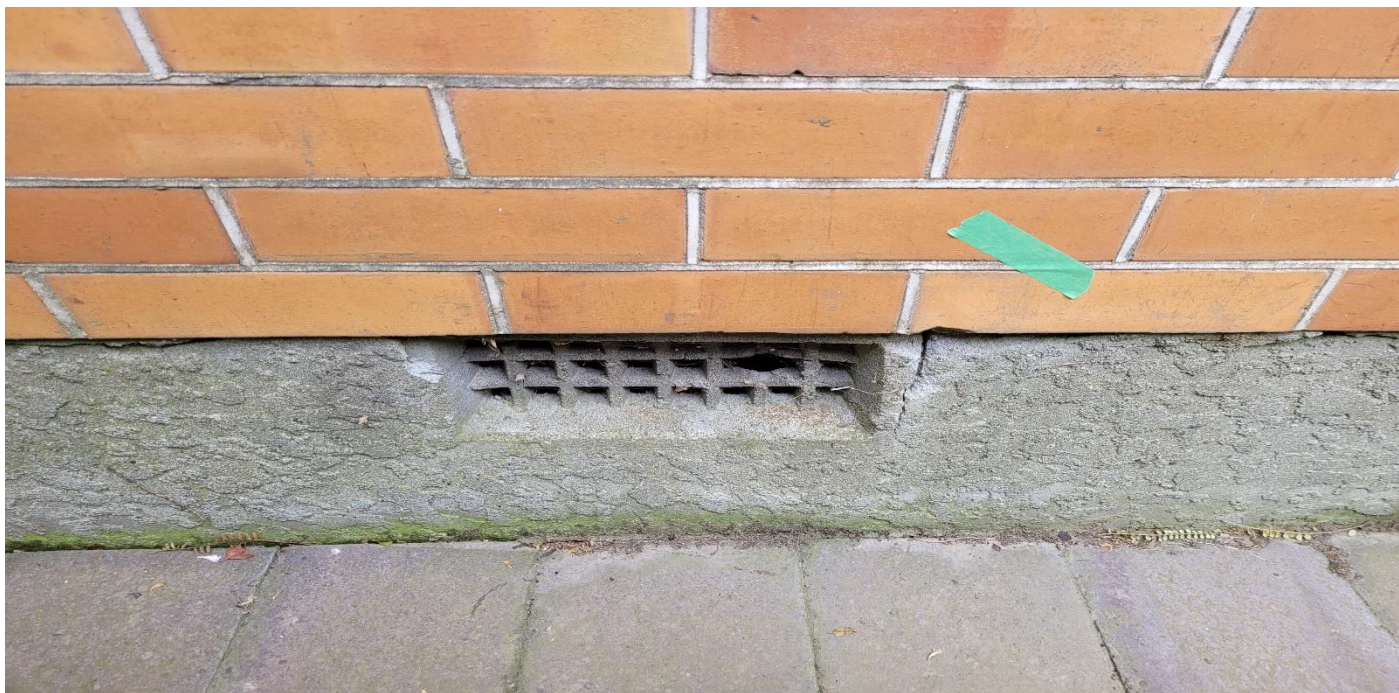
### **Dwelling Foundation:**

The floor levels have not been checked by WWC. The ring foundation shows possible superstructure movement and multiple cracking at vents around all elevations.

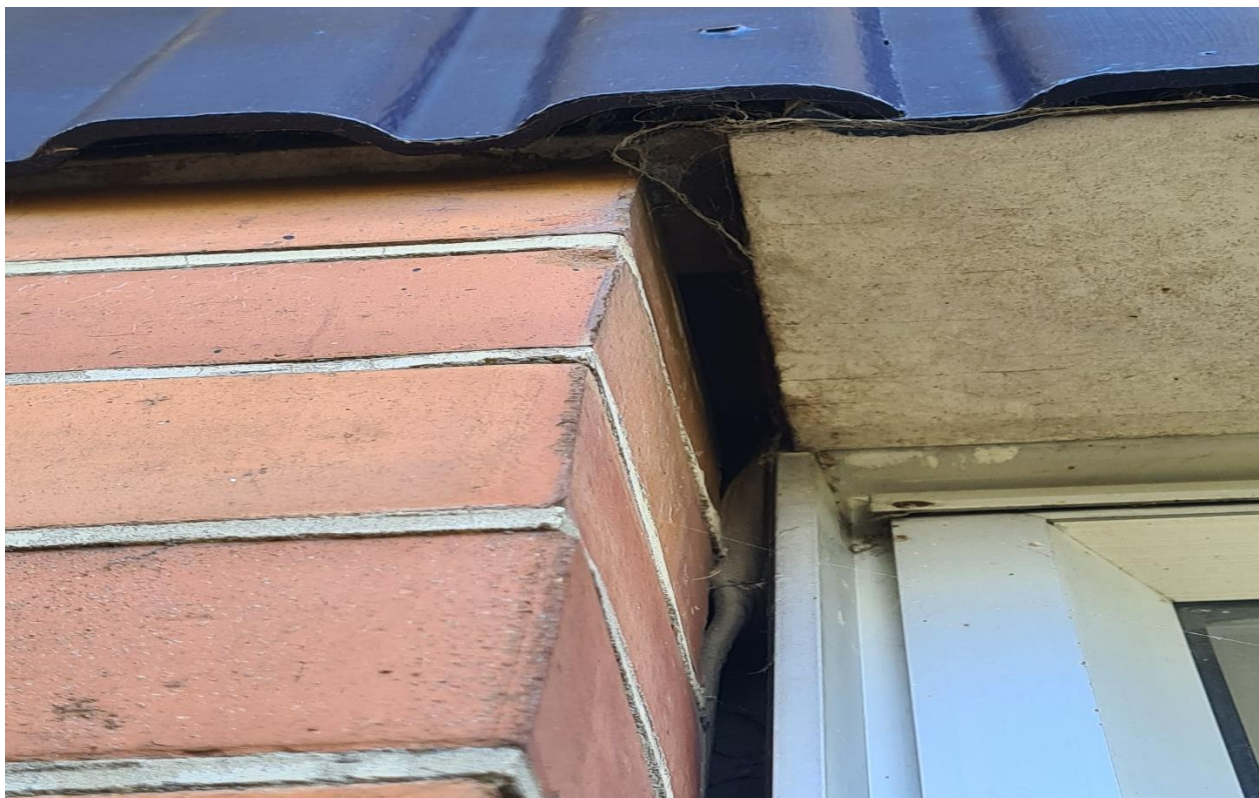
**Cladding:**

Visual inspection of the cladding shows some potential missed, or not completed, damage from the EQ sequence. We recommend cladding investigation to confirm requirement and repair methodology.

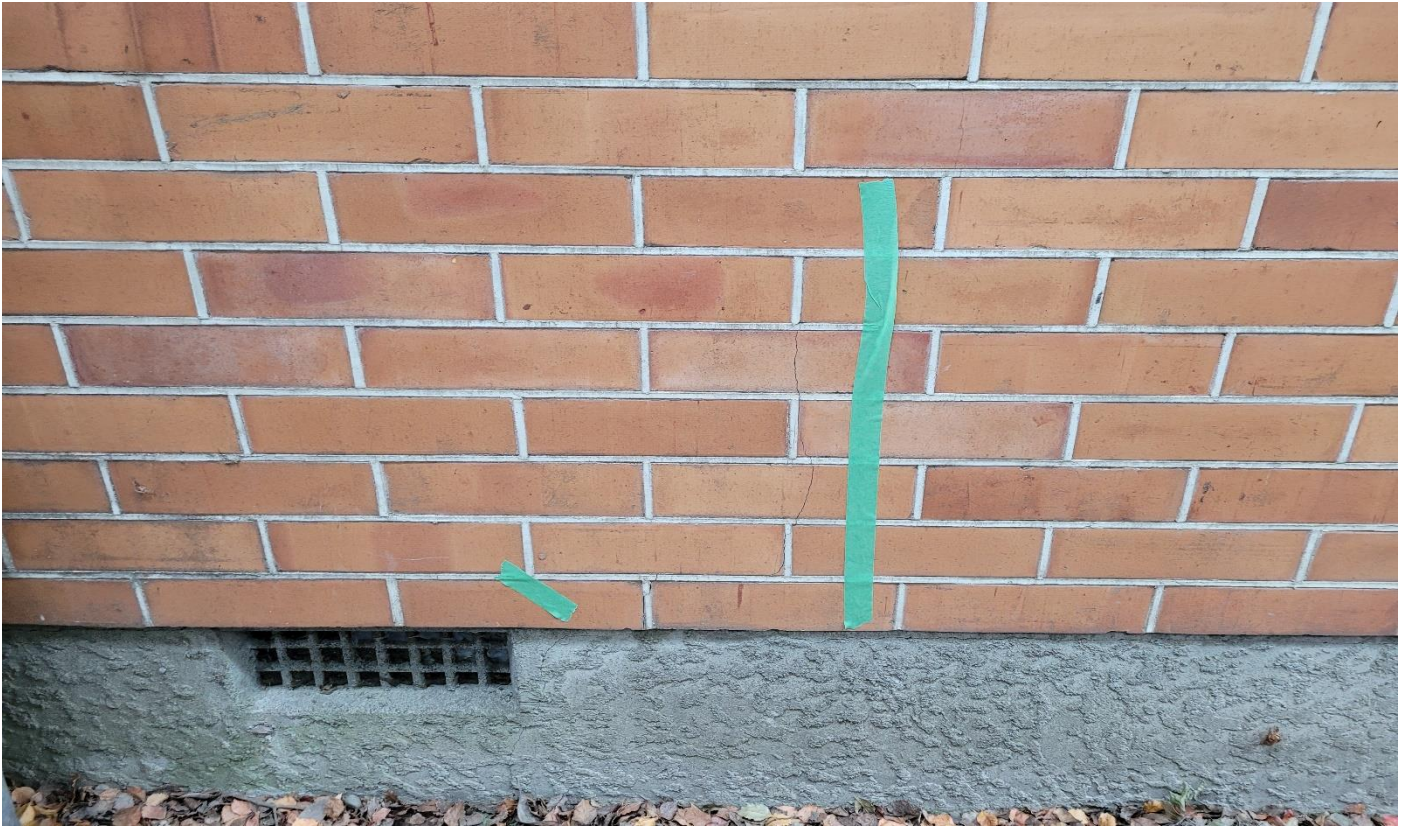
The cracked brickwork does not appear to have been replaced and cladding movement is noticeable.

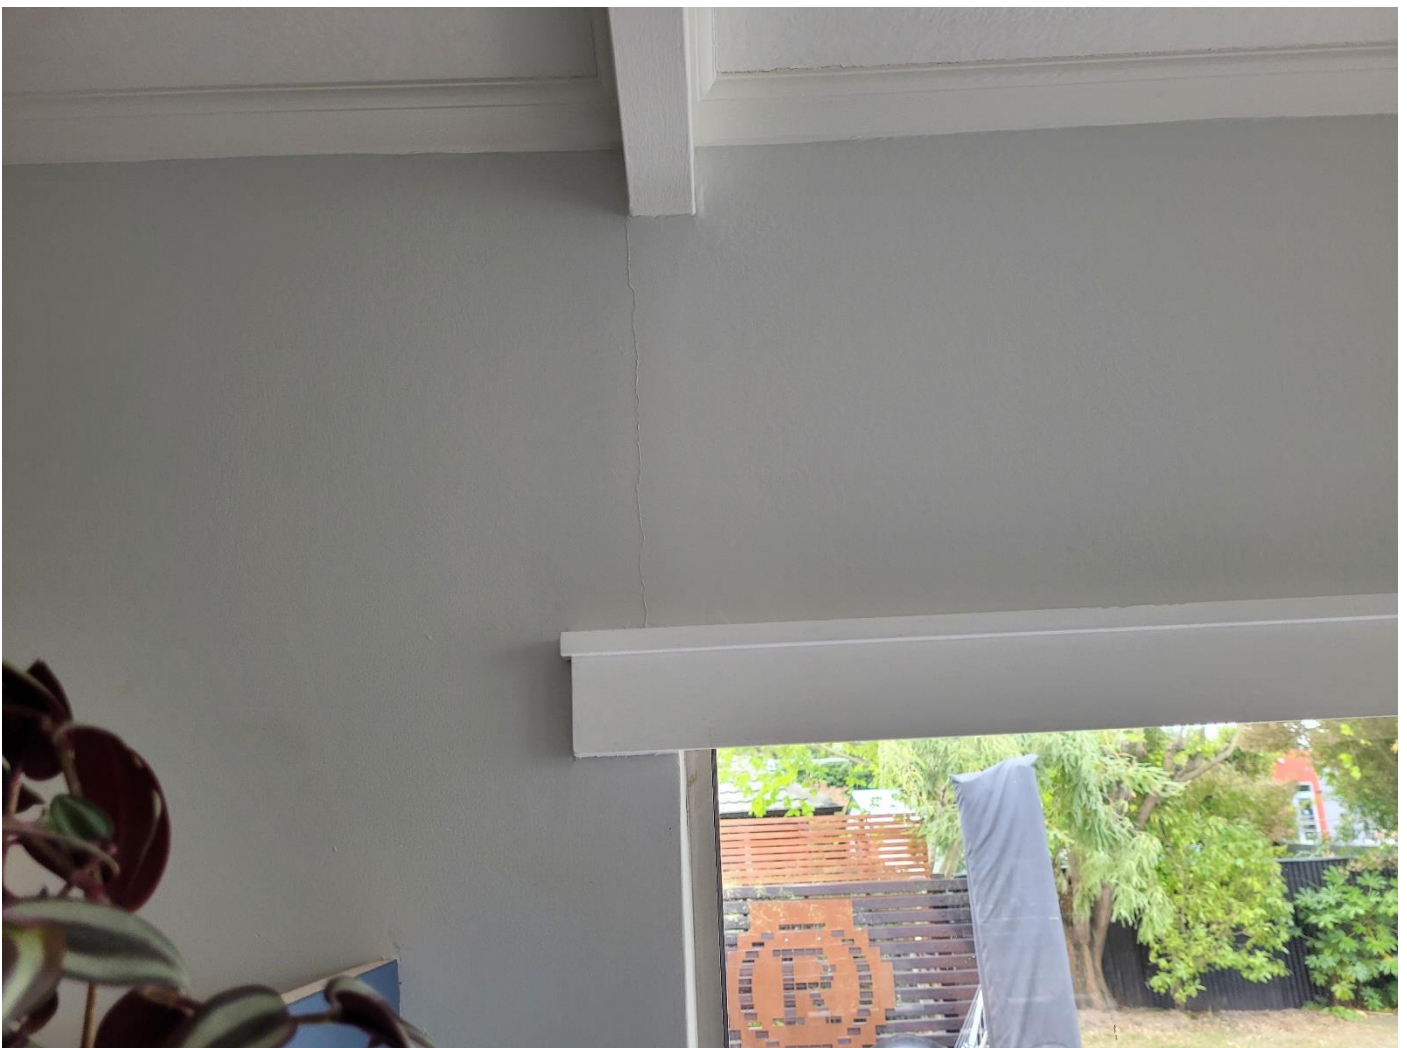
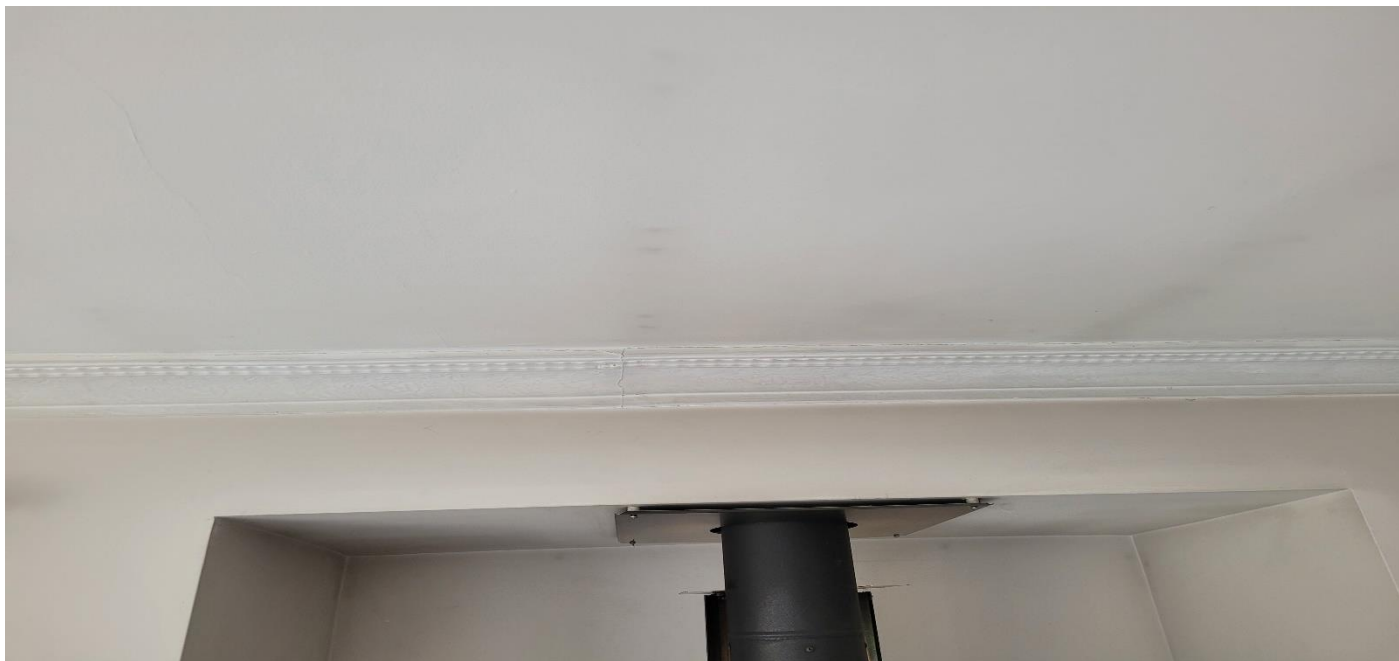
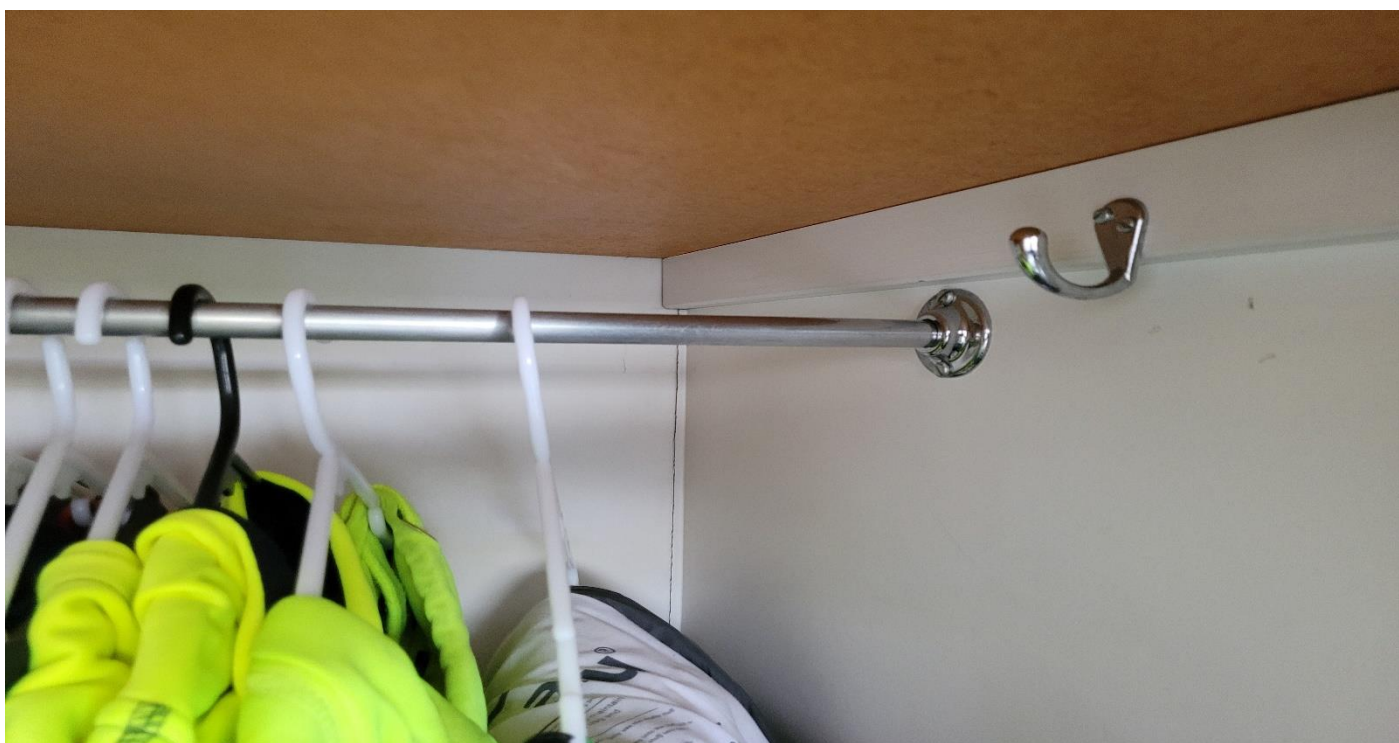
**Interior repairs:**

Cosmetic repairs to linings have failed in multiple places and wardrobes appear to be missed damage.

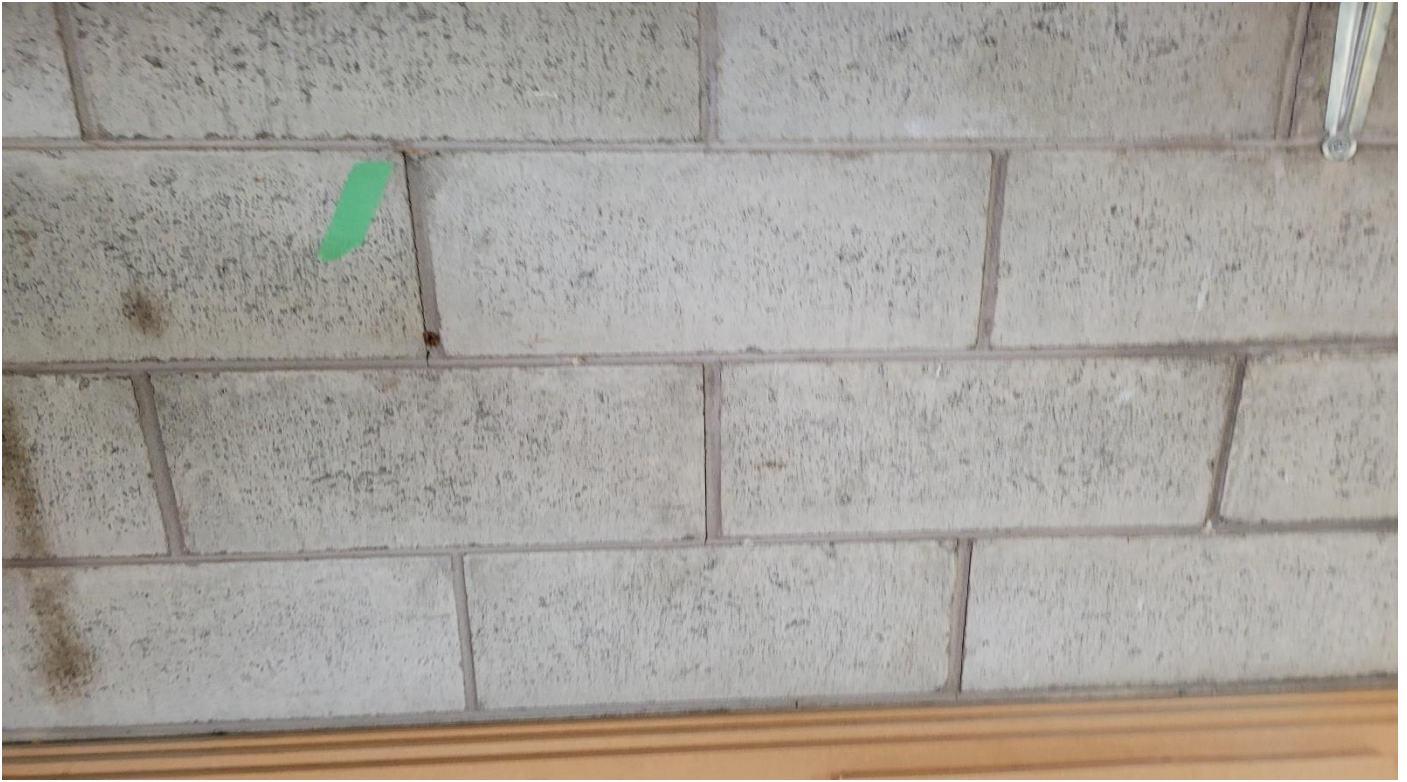
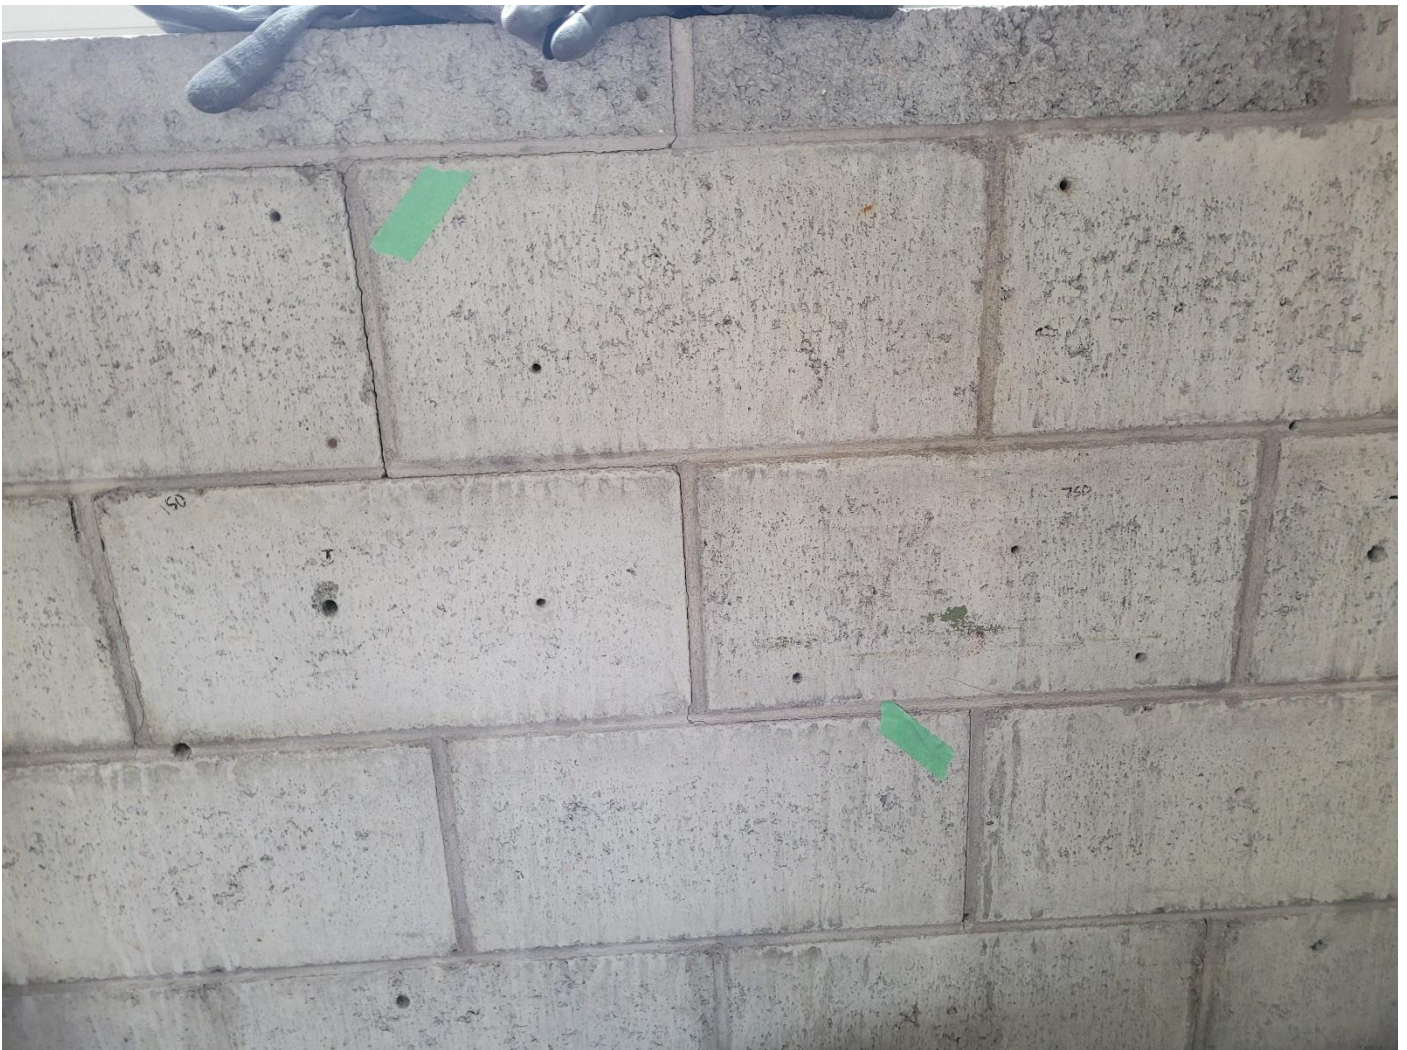
**Garage:**

Garage repairs have been deleted but the step cracking remains.
