EQC Full Assessment Report

Claim Number:	CLM/2011/058677	Assessment Date:	08/10/2011 14:51
Claimant:	Vicky Hembry	Assessor:	Downs, Harawira
Property Address:	46A PACIFIC ROAD NORTH NEW BRIGHTON CHRISTCHURCH 8083	Estimator:	caldwell, dean
		Property Occupied By:	Owner Occupied

Assessment of Property at 46A PACIFIC ROAD, NORTH NEW BRIGHTON, CHRISTCHURCH 8083 on 8/10/2011

Your claim number: CD0317948
Insured name: Pacific Property Rentals Limited
Address of damaged property: 46A Pacific Rd, North New Brighton, Christchurch, 8083

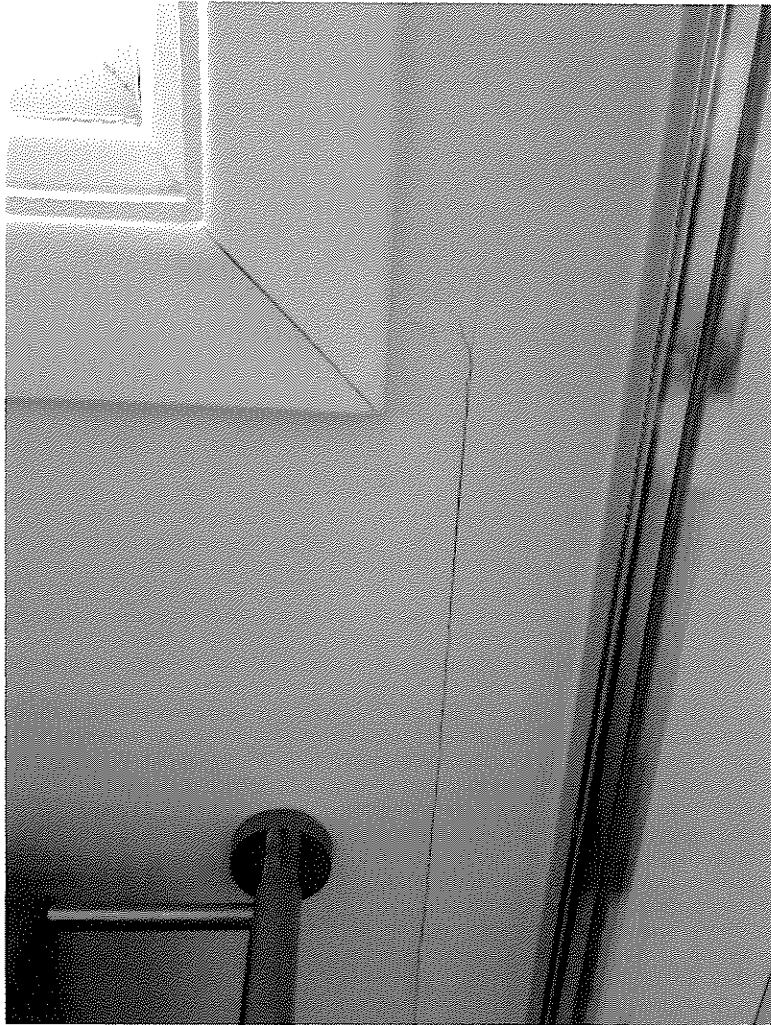
Figure 2 : Bathroom, crack to wall, window trim

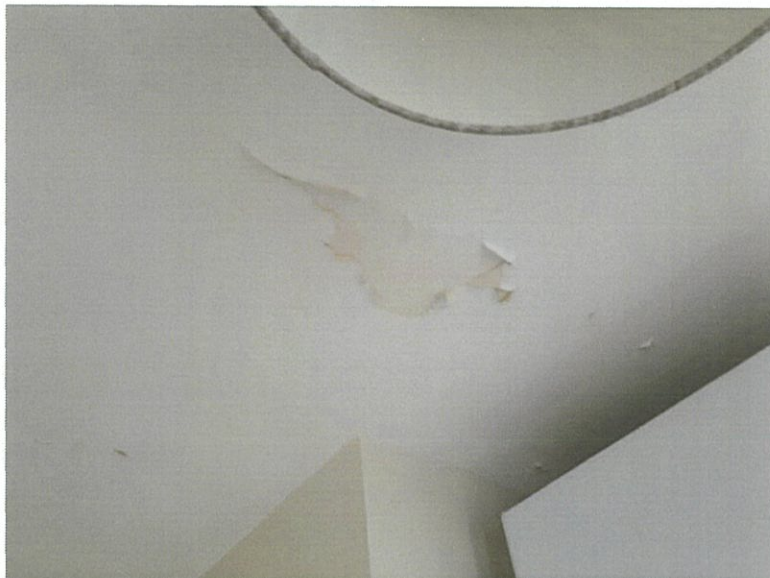
Figure 3 : Bathroom. Peeling ceiling paint. Not eq related.

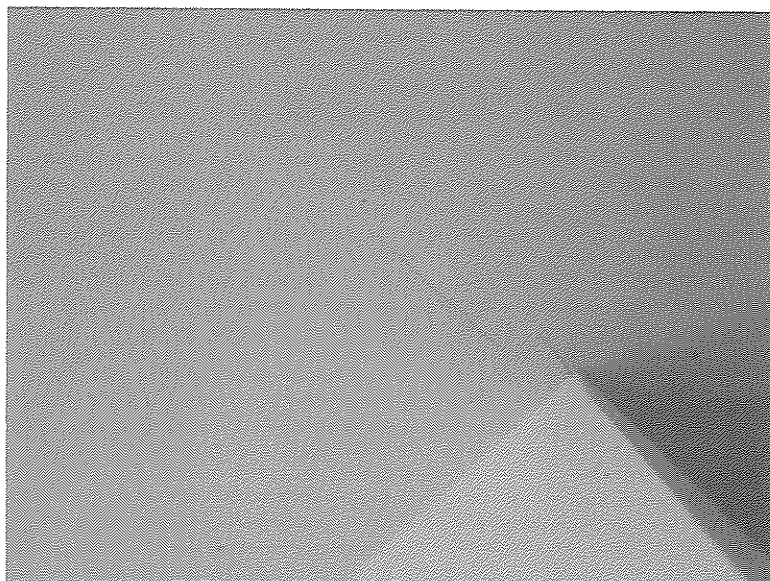
Figure 7 : Cracks to kitchen ceiling

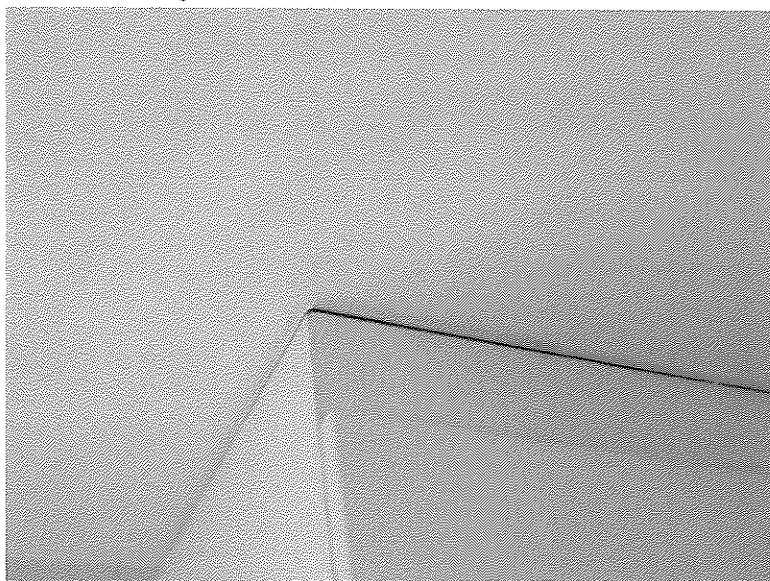
Figure 8 : Cracks to kitchen ceiling

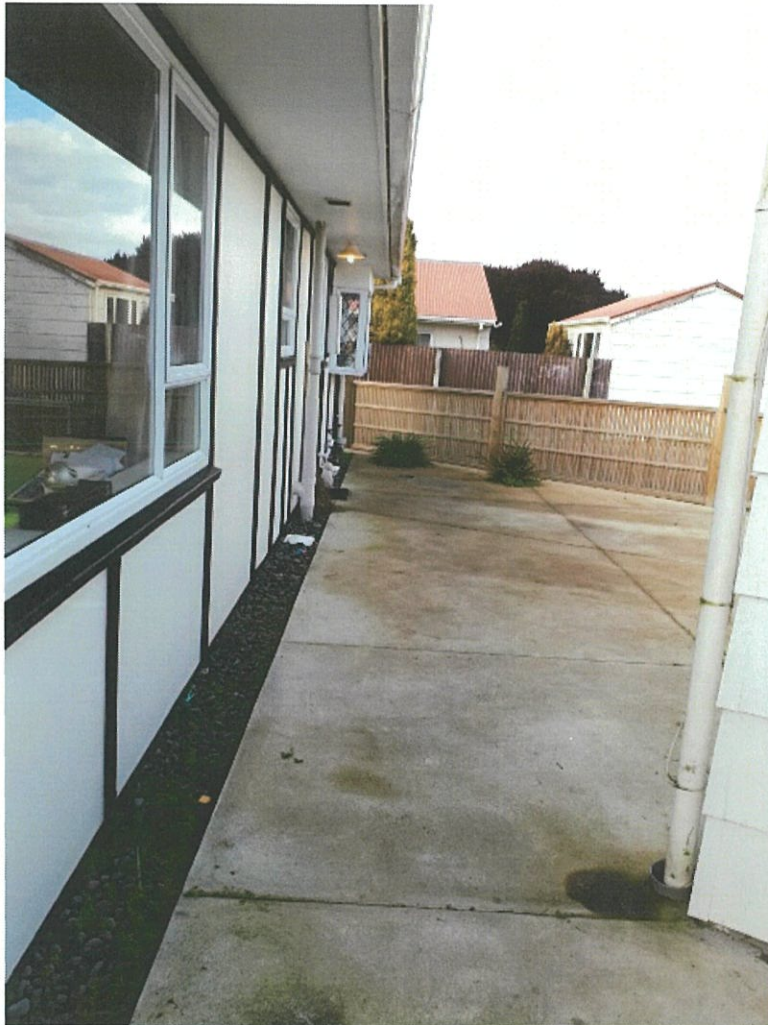
The property retains concrete paths of approximately 60m² which have suffered minor cracking due to excessive shaking from the event.

Figure 10 : West elevation. Concrete paths new since Canterbury events. Cracks to paths on all elevations, total replacement cost of damaged areas under excess of \$5,000.00

This will require removal and partial replacement of approximately 18m².

However, this will not form part of the claim as the replacement cost will not exceed the applicable \$5000.00 excess.
