# PRE-PURCHASE BUILDING REPORT

Property Address	46A Pacific Road, North New Brighton, Christchurch 8083		
Client	Lynley Hands		
Date of Inspection	22nd May 2023	Time	9:00 am
Inspector	Jamie Chapman National Certificate in Carpentry		
LBP Number	137228		
Inspection Type	Pre-Purchase Report		
People Present	Inspector, Owner		
House Occupied	Yes

# CERTIFICATE OF INSPECTION IN ACCORDANCE WITH NZS 4306:2005

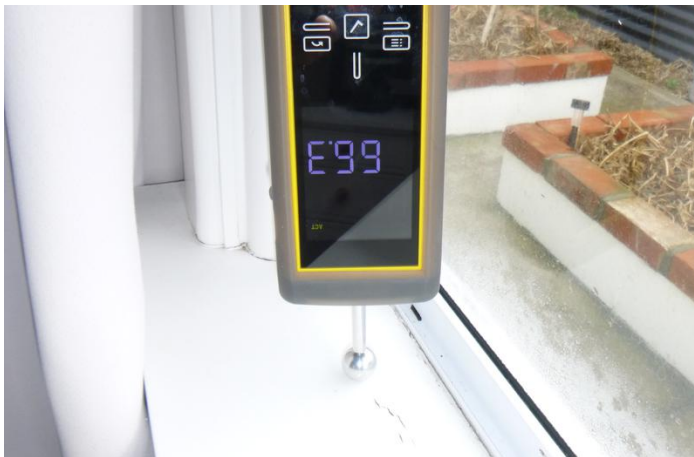
Photo 3

Elevated moisture levels were detected around the external joinery, with visible swelling to the MDF reveals refer to the external joinery section for further information.

Elevated moisture level detected on window reveal in bedroom 2.

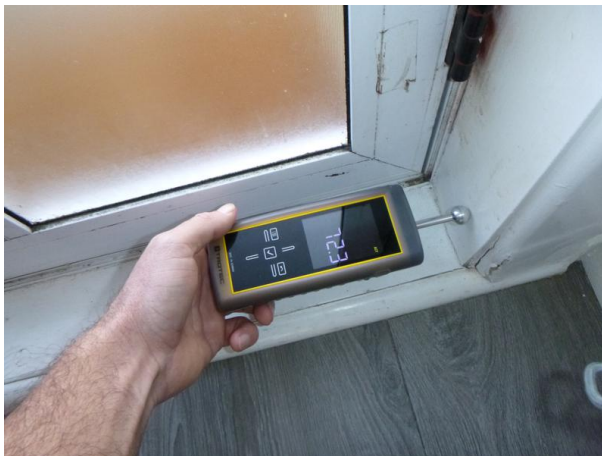
Photo 4

Elevated moisture level detected on door reveal in the entrance way.

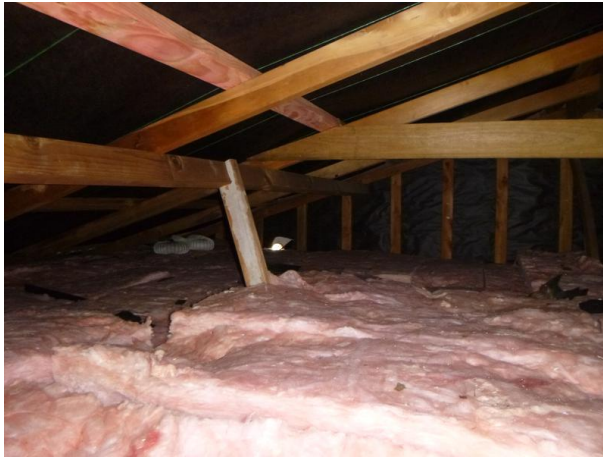
Photo 5

Missing vent cover to the gable as seen from ceiling hatch.  
Recommend adding vent cover.

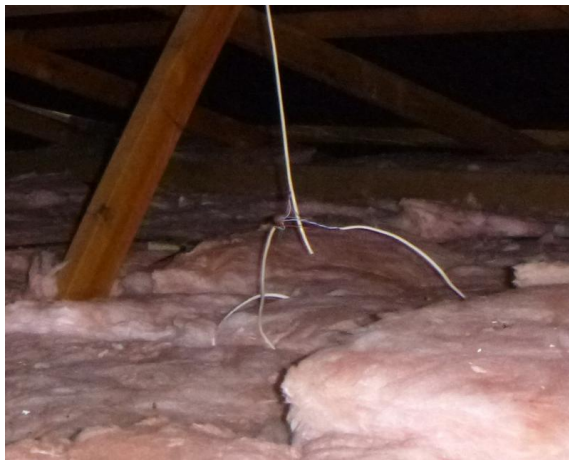
Photo 6

Photo of exposed data wires.

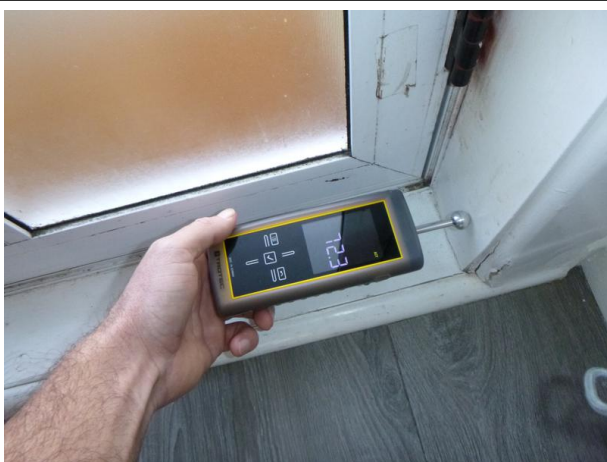
Photo 11

Elevated moisture readings around front door.

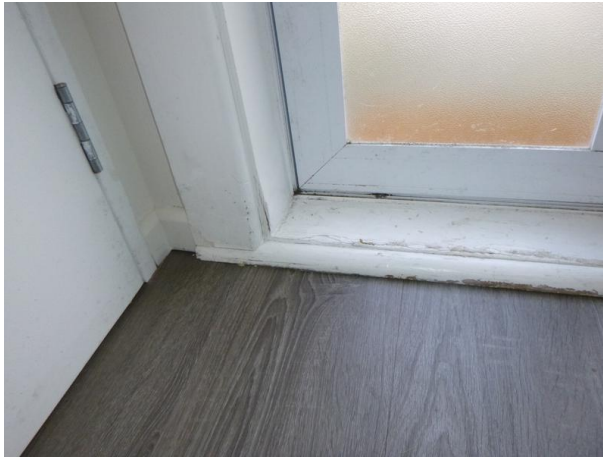
Photo 13

Moisture damage to MDF timber reveals.

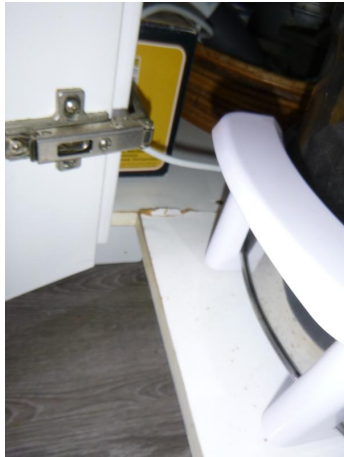
Photo 16

Minor damage to inside kitchen cabinet, slightly elevated moisture readings to kickboard but no leaks detected at the time of inspection. Recommend checking regularly for swelling or signs of leaks.

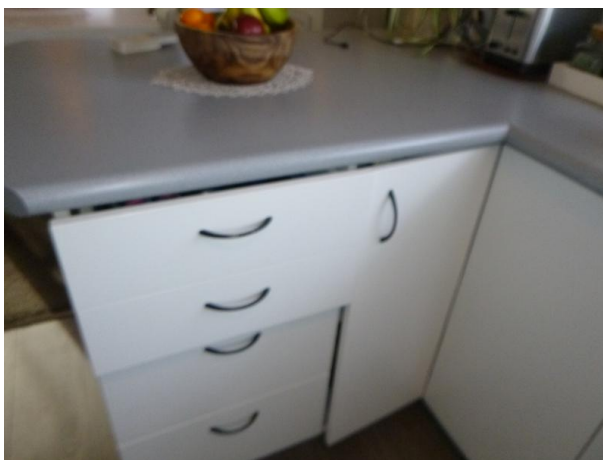
Photo 17

Minor adjustments required to allow operation of kitchen joinery.

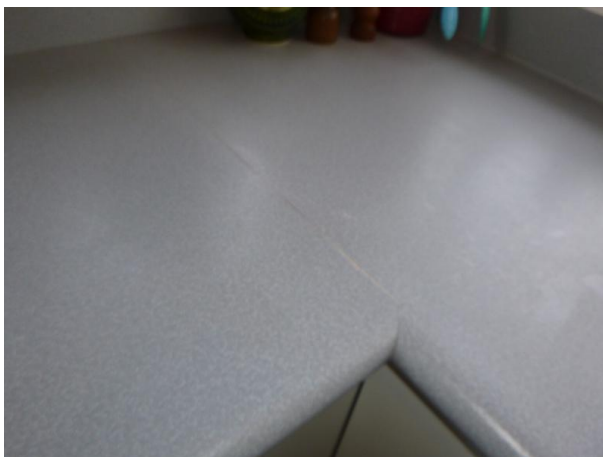
Photo 18

Minor benchtop defect in join. Recommend sealing to keep moisture out.

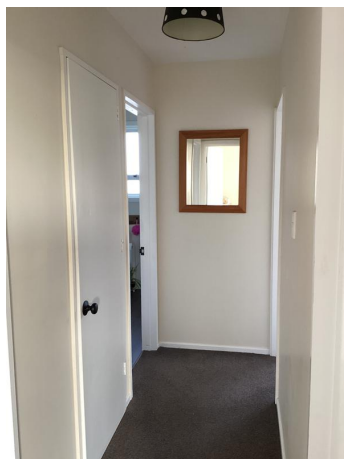
Photo 19

Photo of hallway. Recommend putting a latch set on the cupboard to allow door to stay closed.

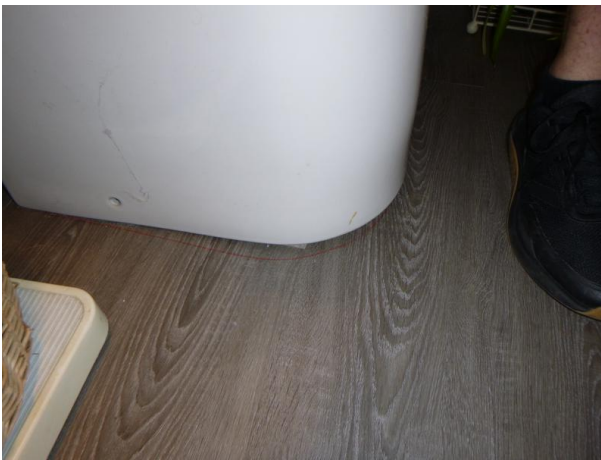
Photo 21

Photo of toilet not properly secured to the floor. Recommend securing to avoid any damage or injury.

Seal all floor-to-wall junctions. Secure the toilet to floor. Replace the missing seal at the bottom of the shower door.

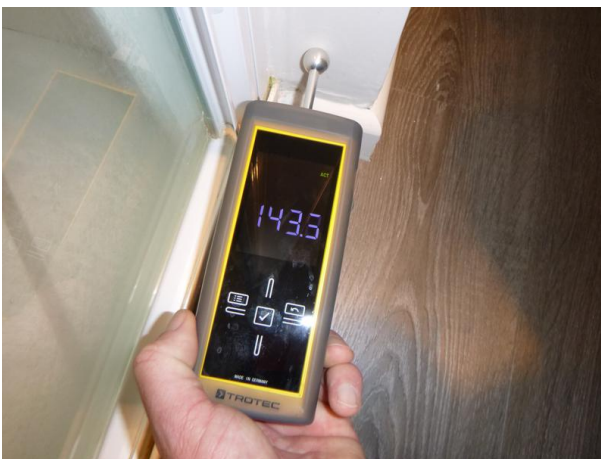
Photo 22

Elevated moisture reading next to shower.

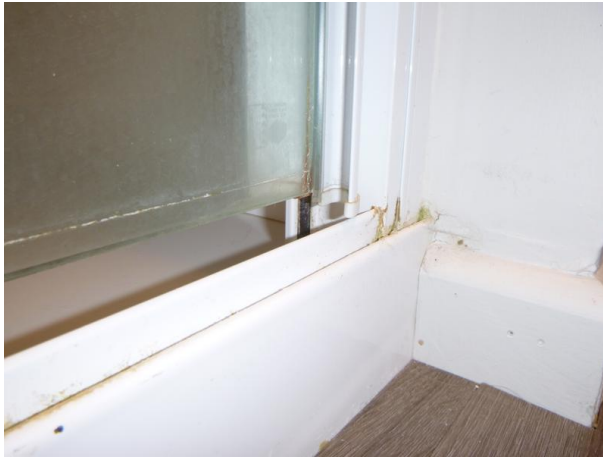
Photo 23

Defects - Shower door missing bottom seal.

Elevated moisture reading next to shower likely caused by the bottom seal missing on shower glass door. Recommend putting one on and monitoring for any swelling.

Install a door seal at the bottom of the shower glass door to prevent any further moisture issues.

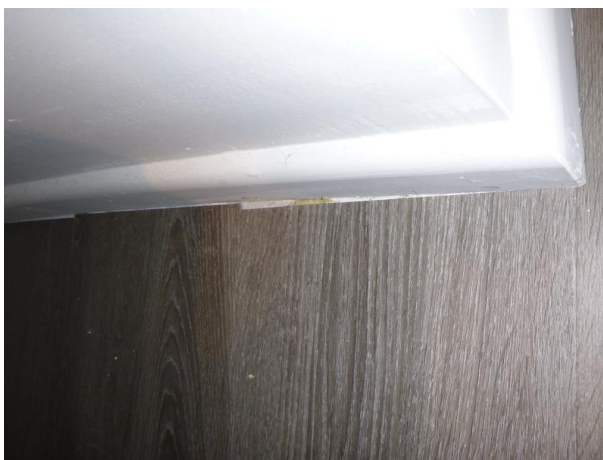
Photo 24

Ensure all wet areas are sealed against flooring and skirting.

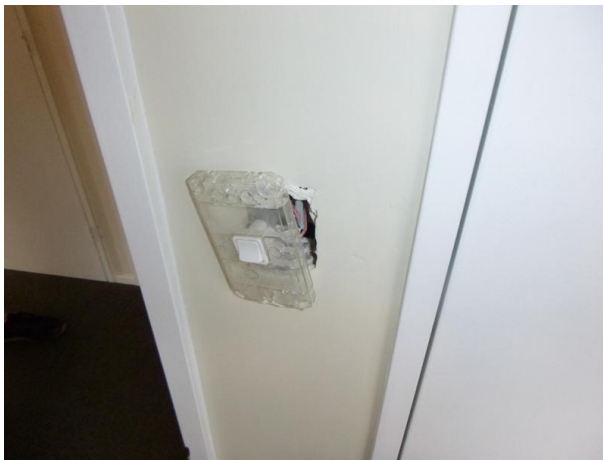
Photo 26

The light switch in bedroom 1 not fixed to the wall. Recommend attaching to the wall.

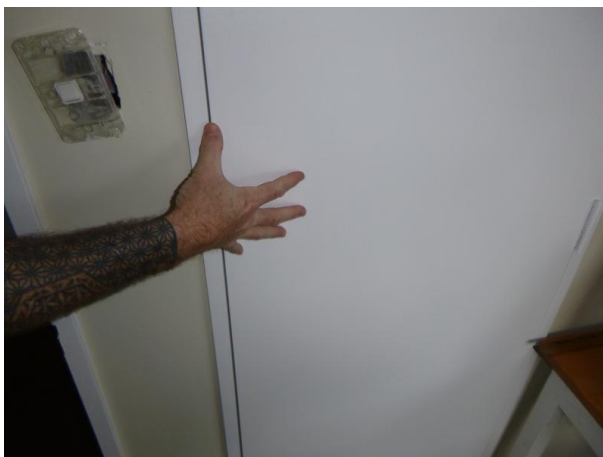
Photo 27

No door handle. Recommend installation for ease of use.

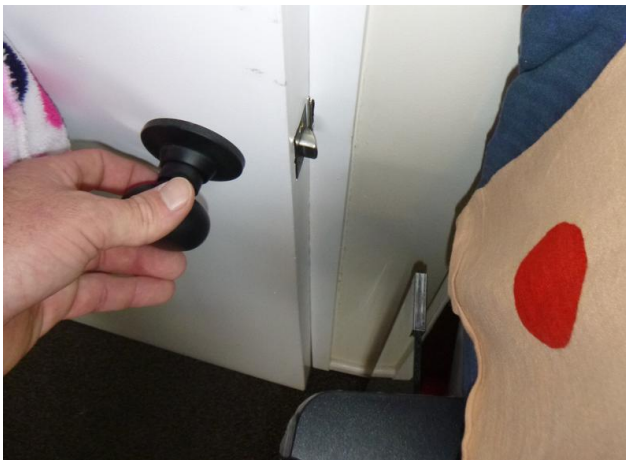
Photo 30

Minor adjustment to bedroom 3 to allow easy use. Minor adjustment to door to restore functionality.

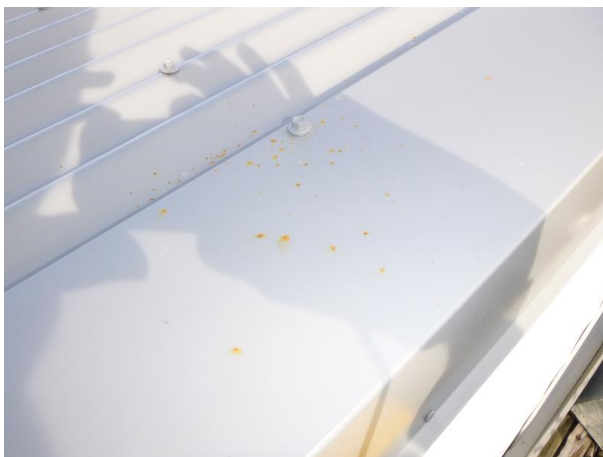
Photo 33

Minor rust. Monitor and clean as part of regular maintenance.

Recommend to clean and remove surface rust from the barge flashing on the garage as per the photo below.

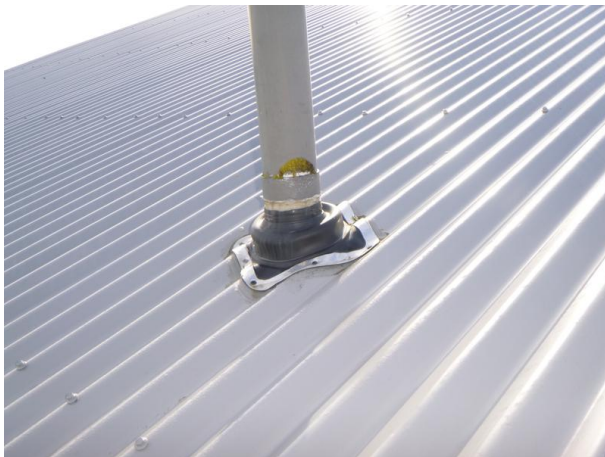
Photo 49

Boot flashing requires a back flashing.

Although the roof penetrations may have been compliant at the time of construction it is recommended that future maintenance would include the installation of a watershed back flashing is installed under any EPDM boot flashing with a pipe diameter over 85mm, as per, E2/AS1 permits the use of boot flashings where: the maximum roof pitch is 45°, the minimum pitch is 10°,

or if the base of the flange covers one or more complete troughs or if the pipe diameter is no more than 85 mm.

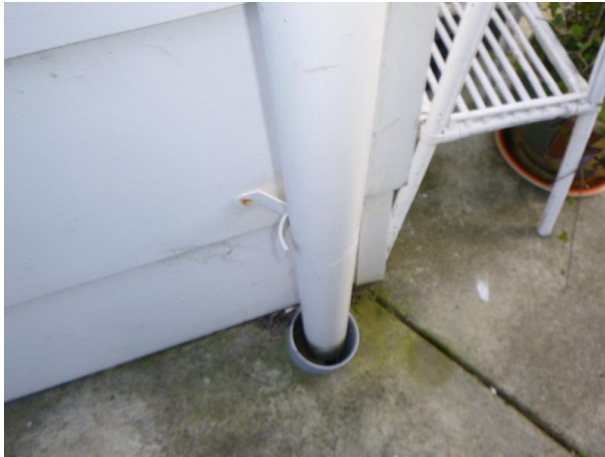
Photo 55

Broken downpipe bracket on the garage, recommend replacing.

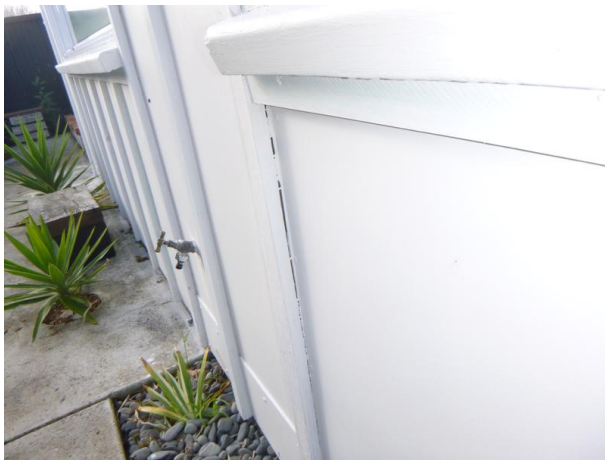
Photo 39

Recommend silicone to seal gap.

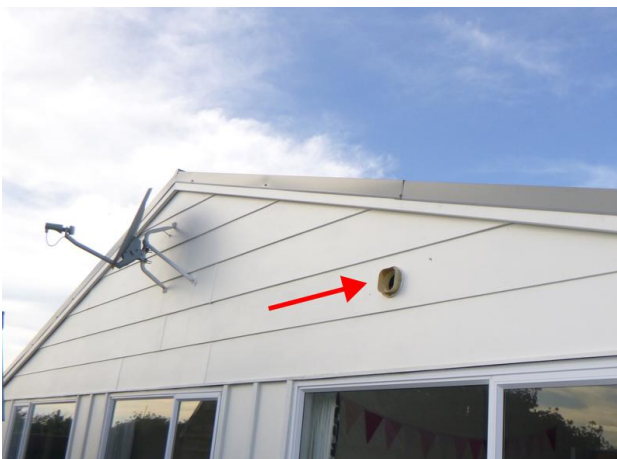
Photo 40

Roof space vent missing cover. Recommend adding a vent cover.

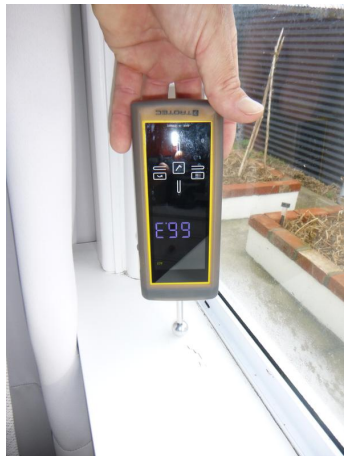
Photo 43

MDF (medium density fibre-board) reveals were withdrawn from the market following the realisation that they are sensitive to moisture. A higher level of maintenance should be expected than timber reveals.

Managing moisture is essential. Higher than normal moisture readings were indicated that may be due to condensation, or the joinery leaking. Further investigation will be required to locate the source of moisture and repair as necessary.

Elevated moisture reading on MDF. This is common throughout the property.

Have a specialist in exterior joinery investigate and report on maintenance and repairs required.

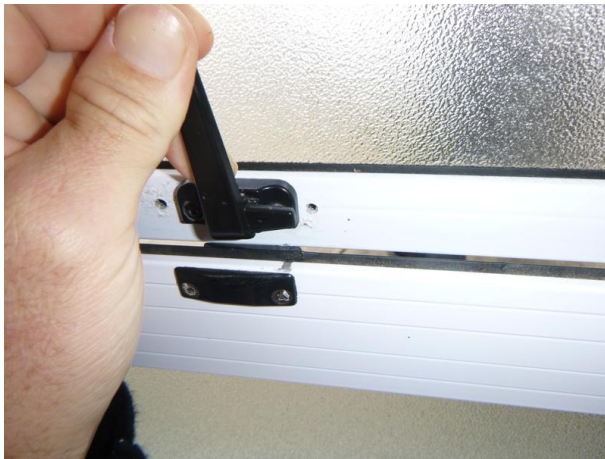
Photo 44

Window hardware requires general maintenance.

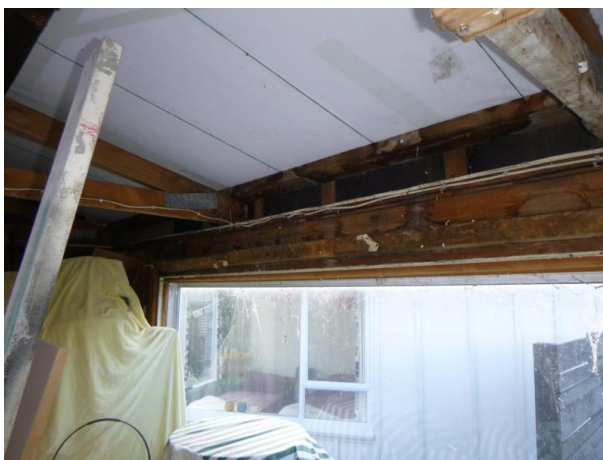
Photo 48

Minor moisture stain. New roof has since been put on.

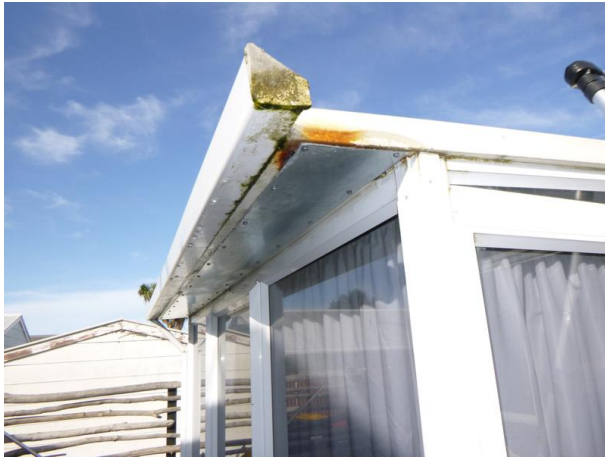
Photo 57

Rust to conservatory gutters.

Clear gutters of debris and treat rust to gutters.

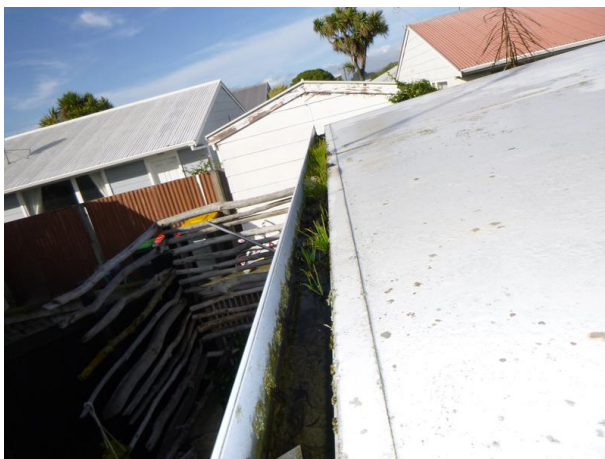
Photo 59

Clear conservatory gutters of debris.

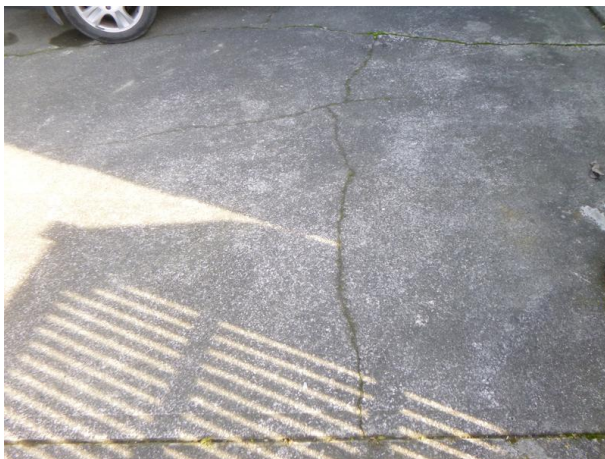
Photo 61

Driveway with visible cracking.

General upkeep and maintenance of driveway by cleaning and keeping free of debris.

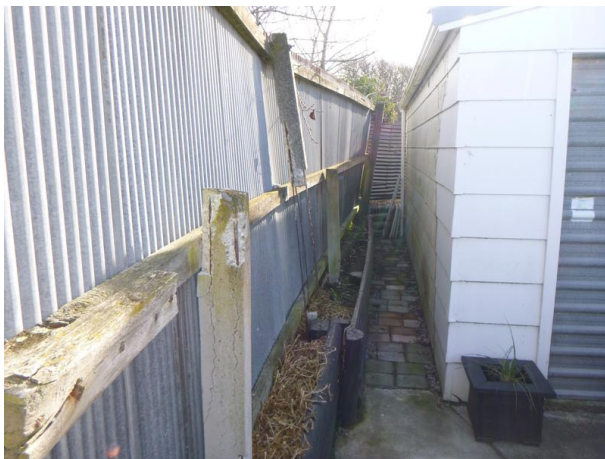
Photo 62

Concrete post requiring replacement.

Maintenance is required throughout the property with the boundary fences.

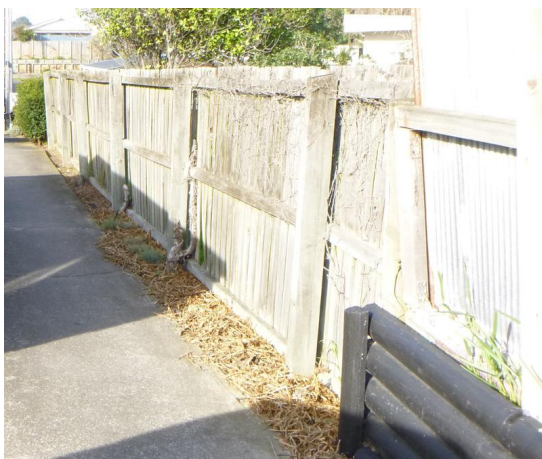
Photo 63

Driveway fencing, general upkeep required.

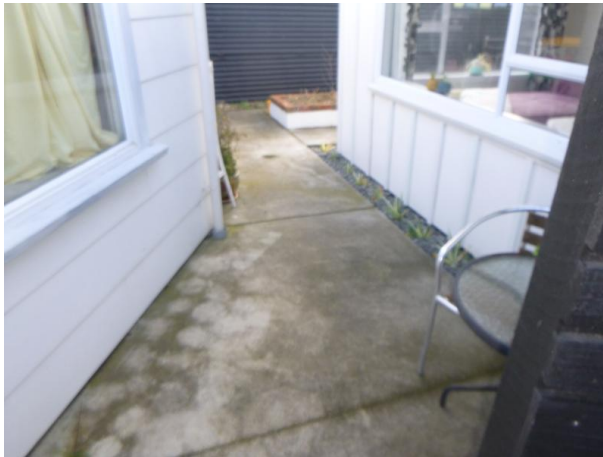
Photo 69

Concrete path. Minor cracks throughout.

Clean down to remove moss and reduce slip hazard as part of regular maintenance.

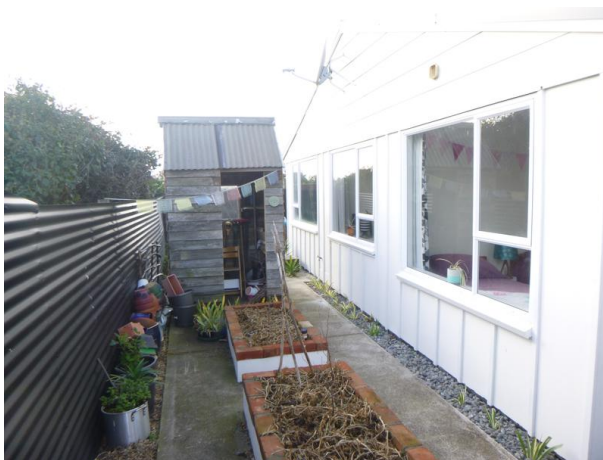
Photo 70

Concrete path. Minor cracks throughout.

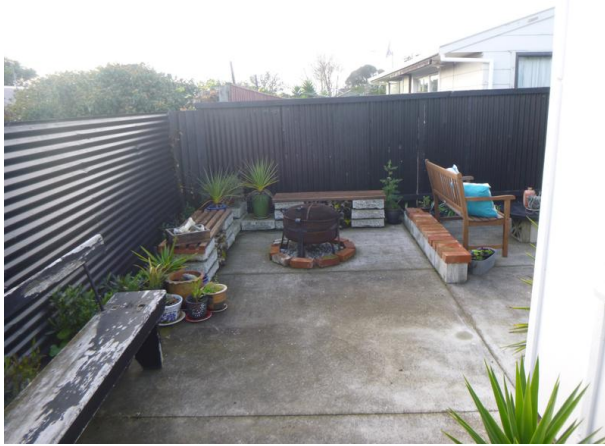
Photo 71

Concrete path. Minor cracks throughout.

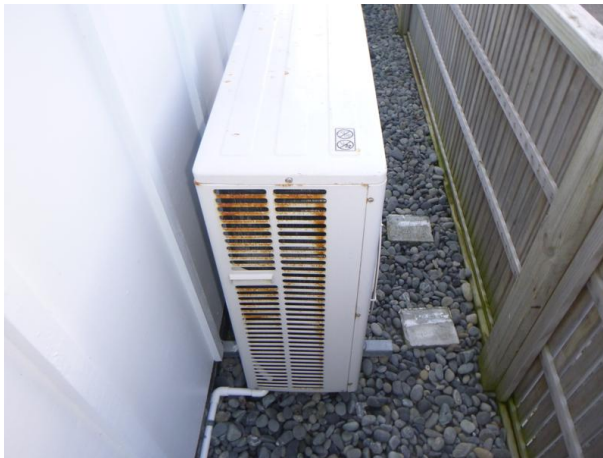
Photo 75

Heat pump outdoor unit. Rust visible due to been in the exposure zone.

Service as per manufacturer's recommendations. Clean heatpump filters every 4 - 12 weeks depending on the placement of the unit.
