Information request - CLM/2011/105656 - 19 Philpotts Road, Mairehau, Christchurch 8052.

Dwelling Inspection Checklist: Show measurements indicate damage

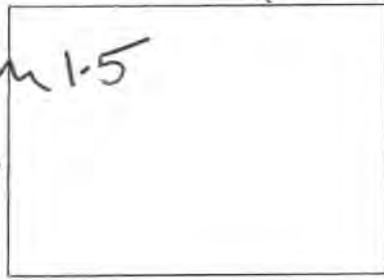
Bed 1

| Room | Earthquake Damage | Walls | Ceiling | Floor | Repair Strategy |
|---|---|---|---|---|---|
| Bedroom 1 | Y | ✓ | | | Putty out & stop cracks in walls, supply & paint (1.5m) |

| Room | Repair Strategy | Units | Length | Breadth | Depth | Quantity | Rate | Cost |
|---|---|---|---|---|---|---|---|---|
| Bedroom 1 | Repair Cracks to Walls | P/H | | | | 1 | 45 | 45 |

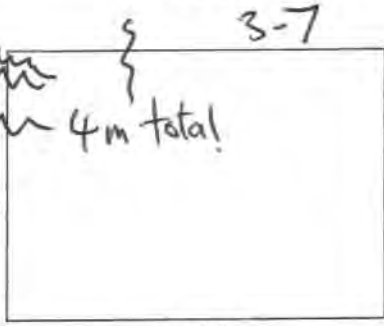
Bed 3

| Room | Earthquake Damage | Walls | Ceiling | Floor | Repair Strategy |
|---|---|---|---|---|---|
| Bedroom 3 | Y | ✓ | | | Putty out & stop cracks in walls, supply & paint (1m) |

| Room | Repair Strategy | Units | Length | Breadth | Depth | Quantity | Rate | Cost |
|---|---|---|---|---|---|---|---|---|
| Bedroom 3 | Repair Cracks to Walls | P/H | | | | 3 | 45 | 135 |
