Information request – CLM/2011/053068 - 27 Reginald Street, Burwood, Christchurch 8083.

Statement of Claim Checklist

Statement of Claim Checklist / Repair Strategy

# Inspection Summary

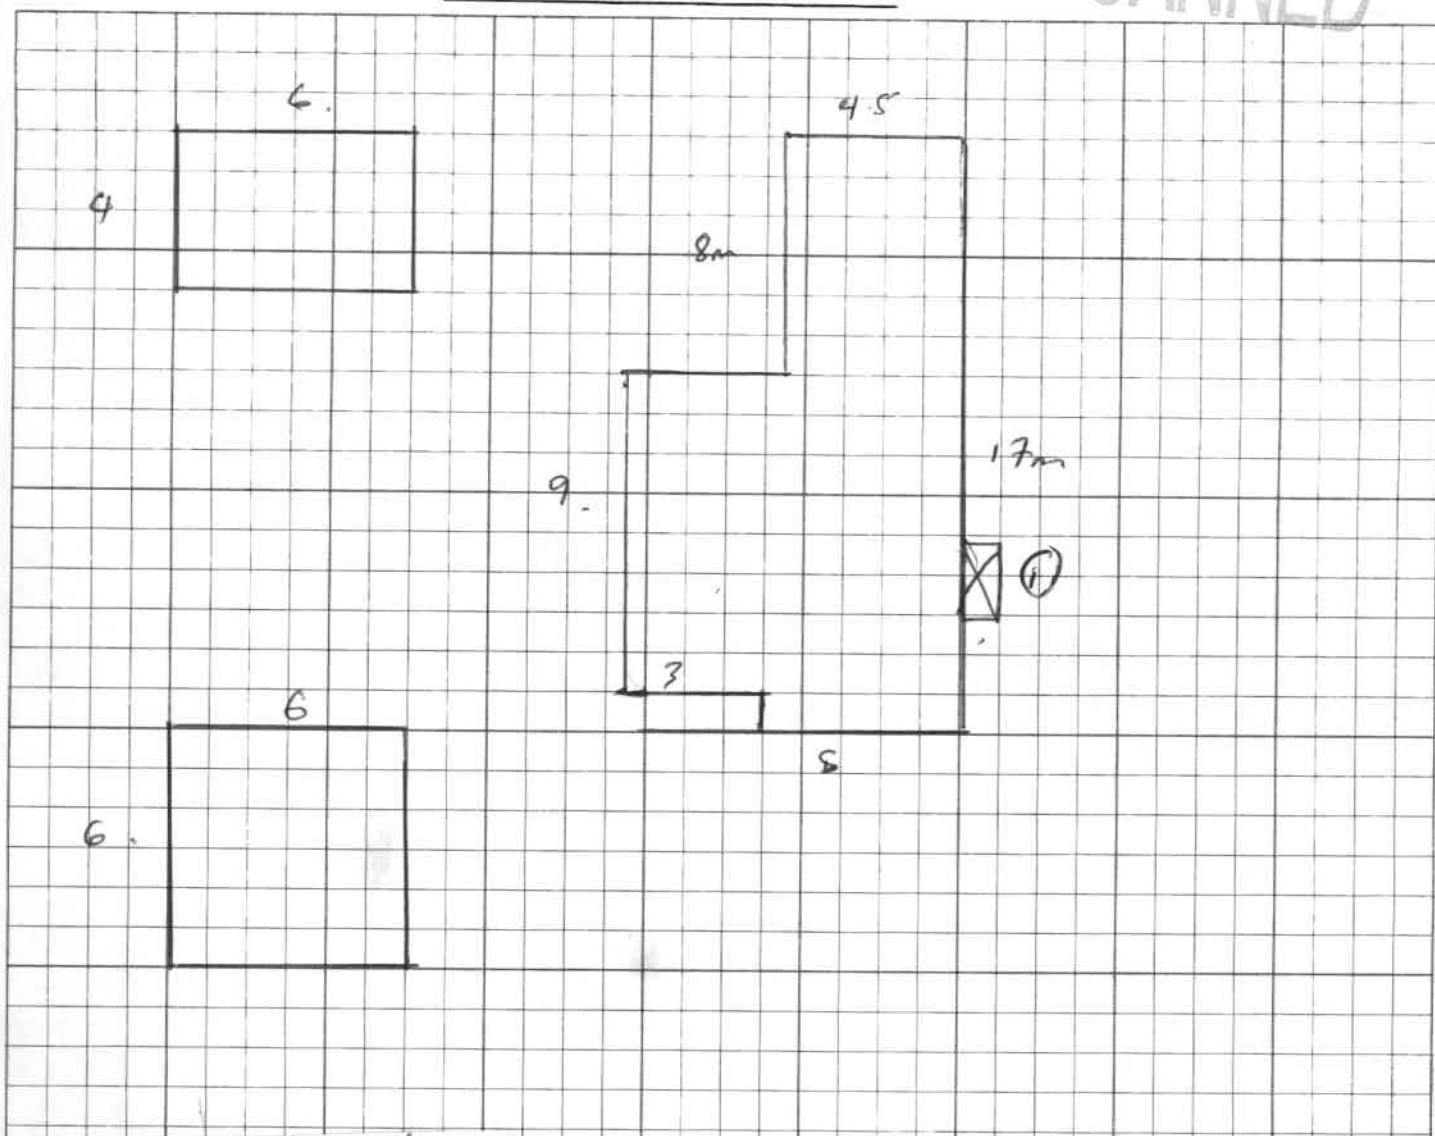
① Chimney Cracked

② Minor cracking to grout corner steps. Silicon Sealant.

DESCRIPTION:	Units	Length	Breadth	Depth	Qty	Rate	Cost
<u>Loange</u>							
Minor Crack to concrete slab, grind crack epoxy fill w/ gap and paint. Cracking to grout in corners off steps. Remove loose grout and silicon sealant to corners.							
<u>Chimney Block & Rendered</u>							
Cracking to block & loose blocks remove to below crack. Clament to get removed & send invoice to EQC. Re-build block chimney approx 2m & Render finish - fit new cowl.

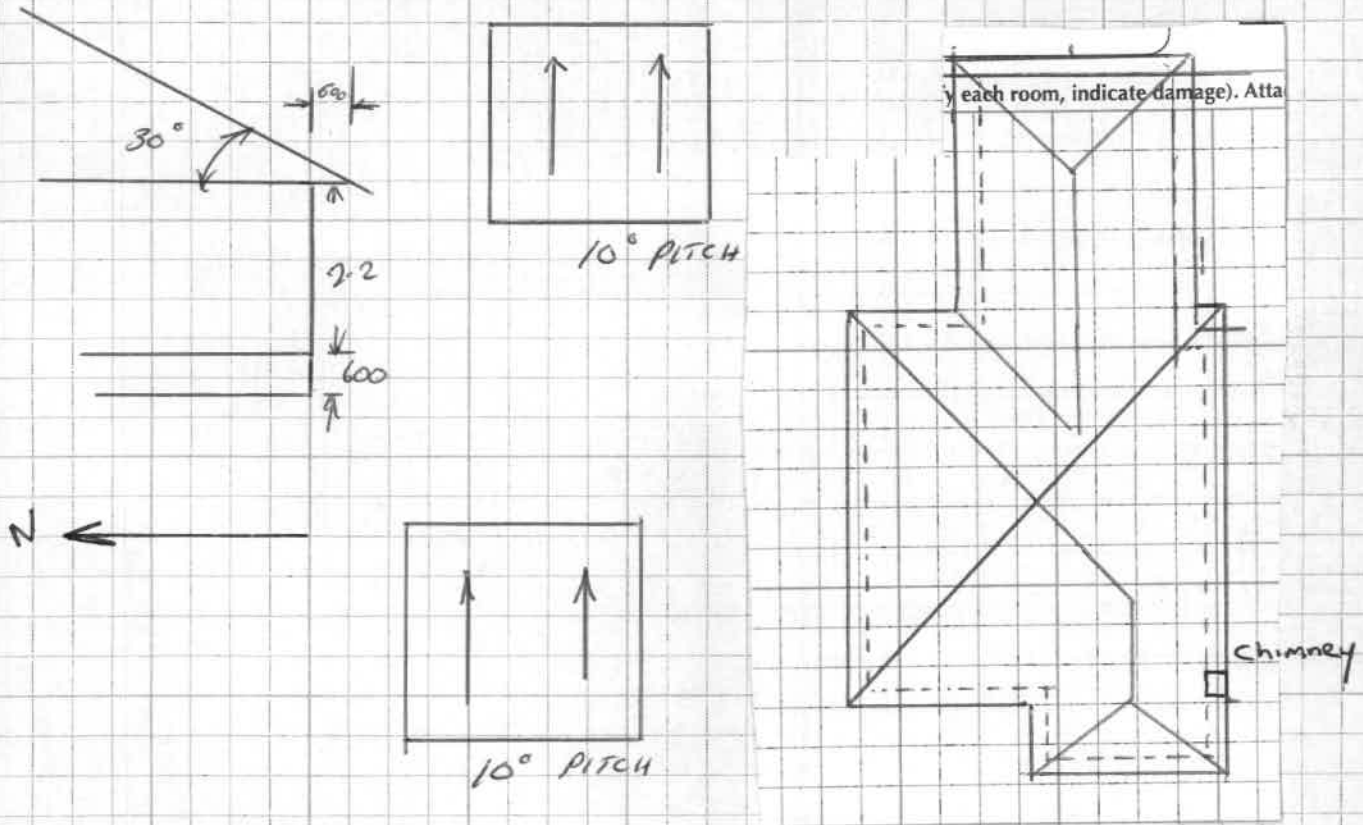
1950's split level three bedroom
 brick veneer dwelling on piles with concrete tile roof.
 Extension to rear of dwelling on concrete slab, lateral spread
 between extension + original dwelling, requiring uplifting + repiling.

Item	Event Damage	Repair Strategy
	Y / N	
Foundations	Y	dwelling. strip all brick veneer from external walls of original dwelling. Remove roof tiles at connection of original dwelling to extension. Disconnect services. lift dwelling remove piles + repile + new ring foundation. Set down + reattach to extension reconnect services - relay tiles + rebrick external walls. - Redecorate as required.
concrete Piling slab	Y	
Services	Y	GARAGE: slumped in 3 corners. Within acceptable tolerance to be relevelled via screw jacking and underpinning.
Other Dwelling Items	N/A	
4.0 x 5.2 Outbuildings Sleepout.	N	
Land & Retaining Walls (Discuss with Supervisor)	Y	lateral movement.

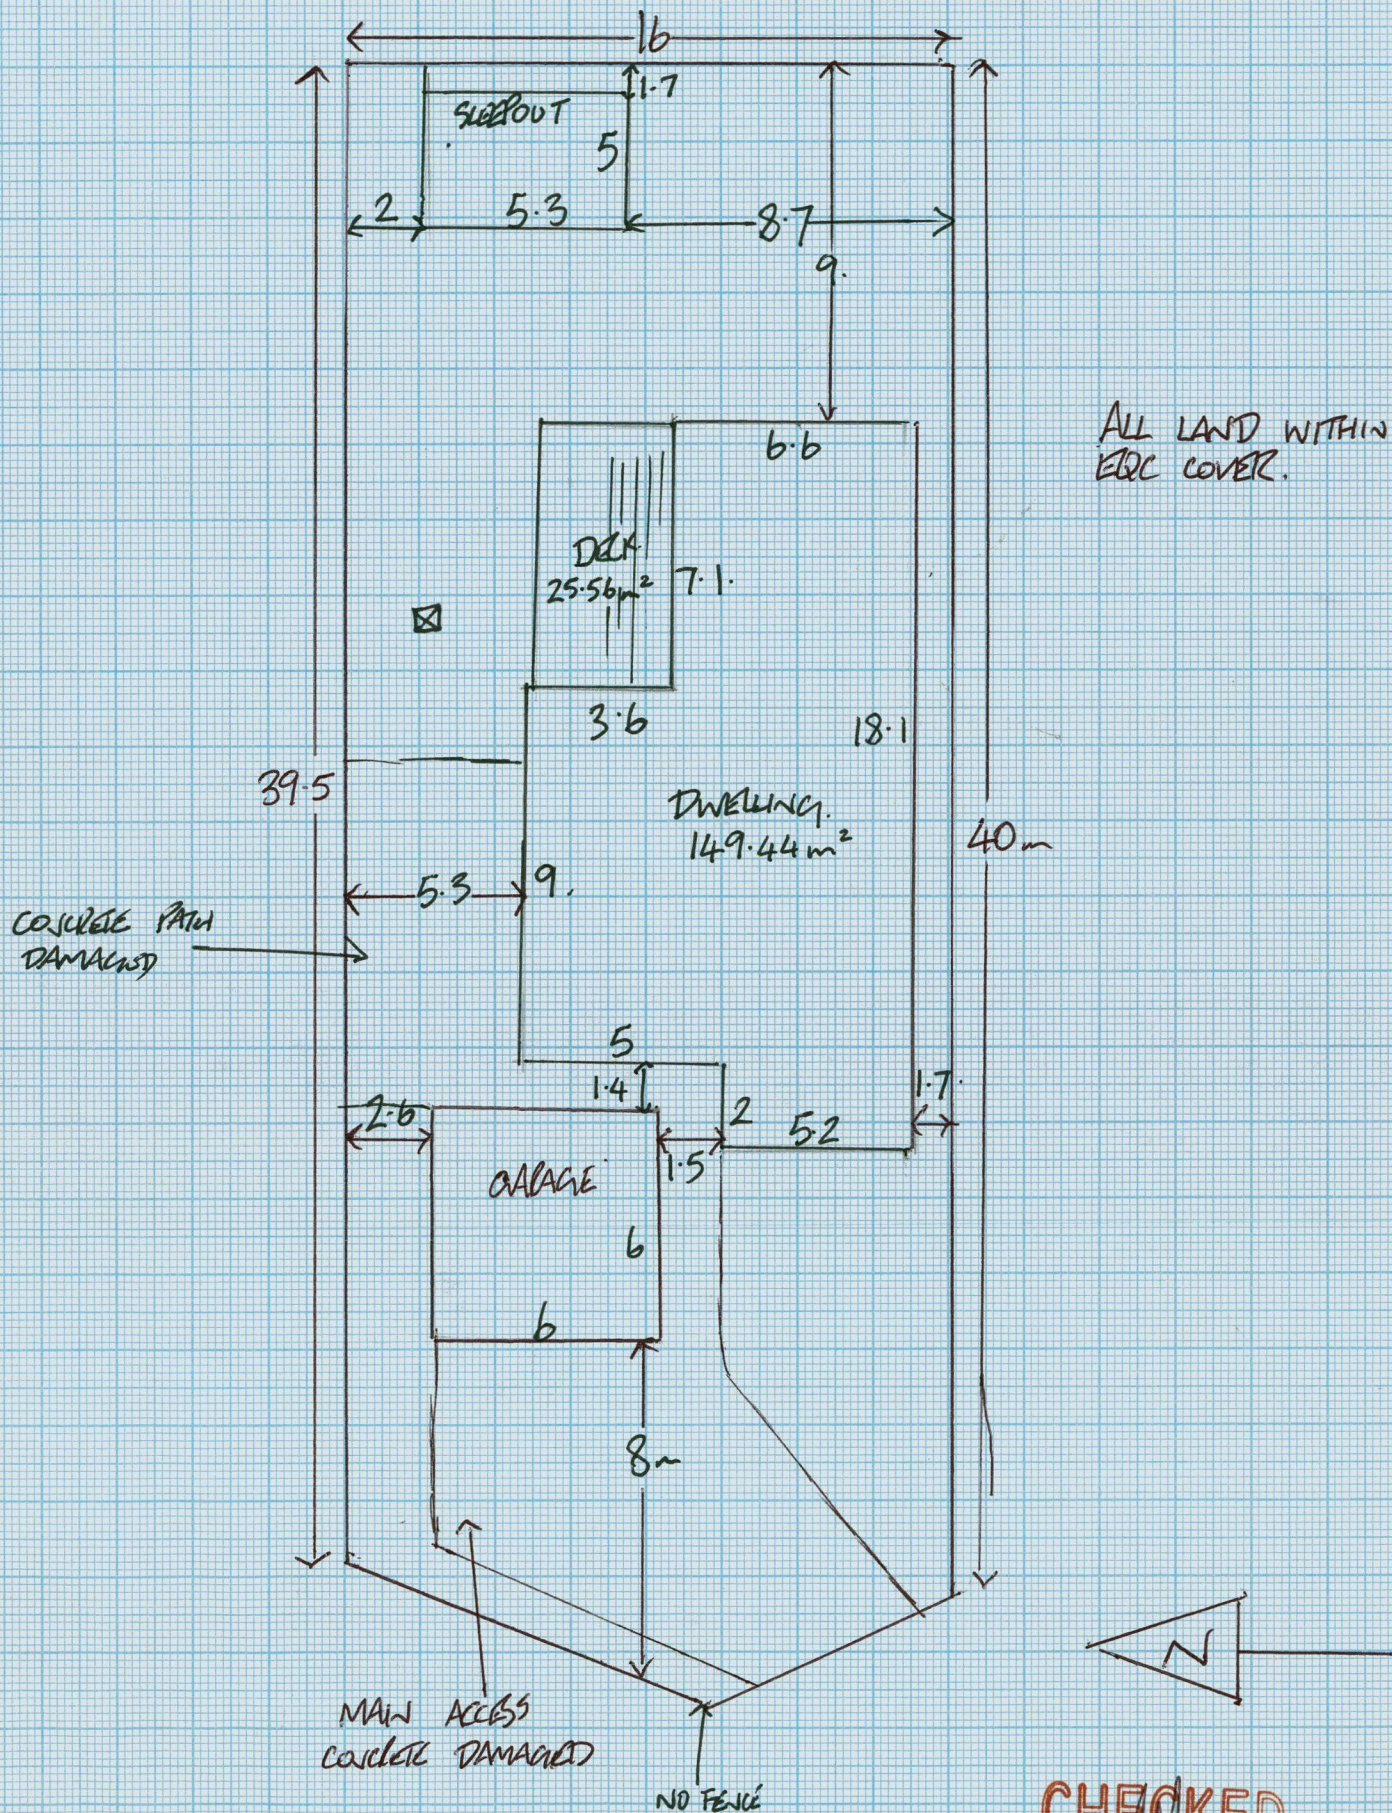
THE ENGINEER HAS NOTED APPROX 49 M²  
OF EVACUATED LAND  
AT THE TIME OF OUR INSPECTION THE ONLY  
VISIBLE EQ LAND DAMAGE WAS 0 M²
