Information request – CLM/2012/012045 - 15 Len Hale Place, Parklands, Christchurch 8083.

Statement of Claim Checklist / Repair Strategy

CLM/2010/030980

J A Syme
15 LEN HALE PLACE
PARKLANDS
CHRISTCHURCH
H
W
M

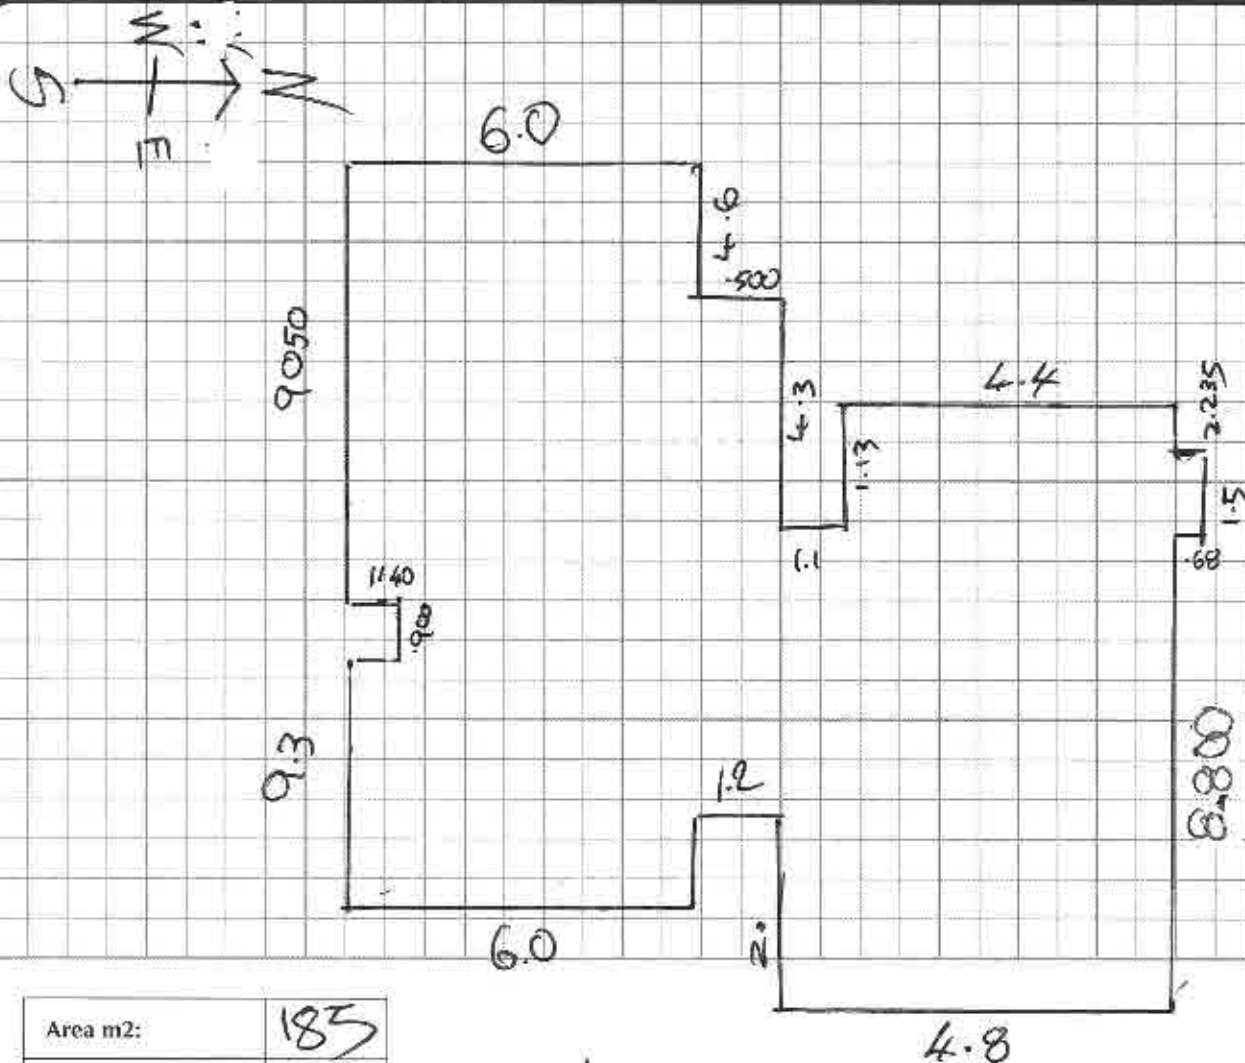
Dwelling Inspection Checklist: Show measurements indicate damage

Minor damage to interior involving cracks to walls and ceilings in a number of rooms. No external damage.
