RESIDENTIAL PROPERTY INSPECTION

Inspection Address: 43 Opawa Road

Inspection Date: Wednesday, 27 March 2024

BuildQual NZ Ltd

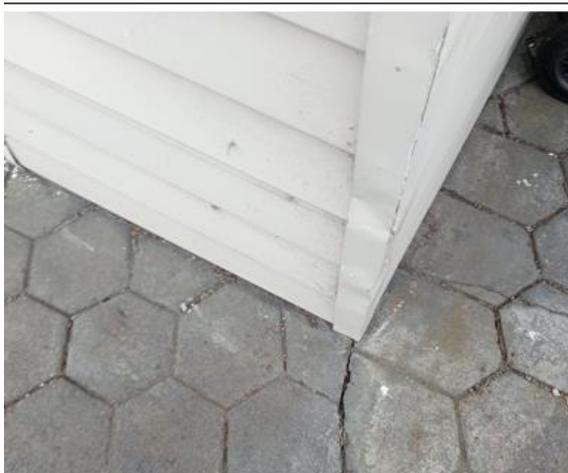
| ITEM ASSESSED | DEFECT | COMMENTS/NOTES |
|---|---|---|
| Steps, Handrails, Paths, Driveway | Minor | There are a few minor cracks in the concrete driveway |

Impact damage to the garage. Minor cracking of the concrete driveway

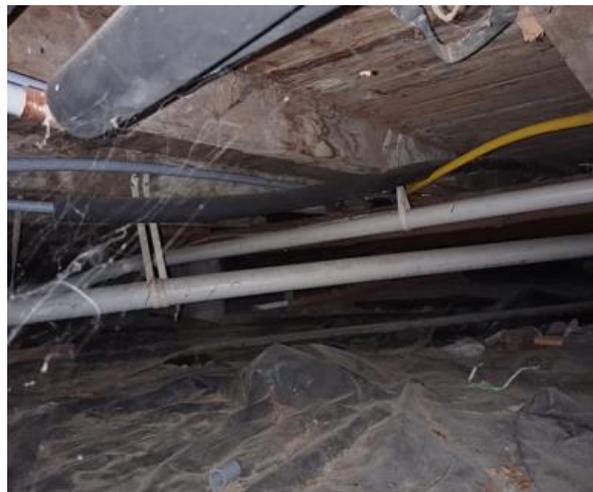
| ITEM ASSESSED | DEFECT | COMMENTS/NOTES |
|---|---|---|
| Ground Vapour Barrier | None | Has ground vapour barrier in the area observed from subfloor vent |

Subfloor space from open subfloor vent

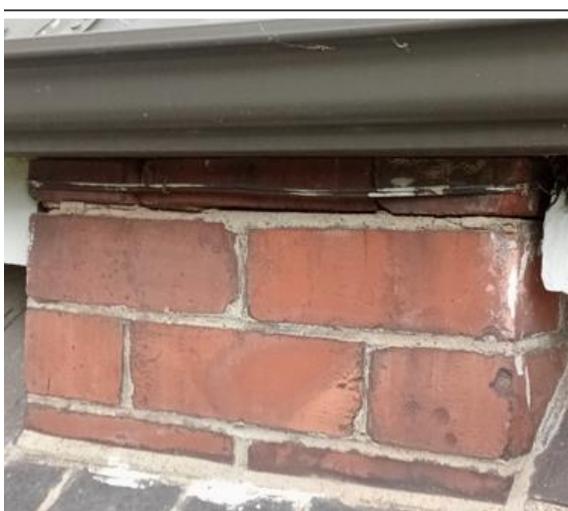
| ITEM ASSESSED | DEFECT | COMMENTS/NOTES |
|---|---|---|
| Chimney | Minor | Cracking to the mortar of the top course of bricks |

Cracks in the top course of the brick chimney

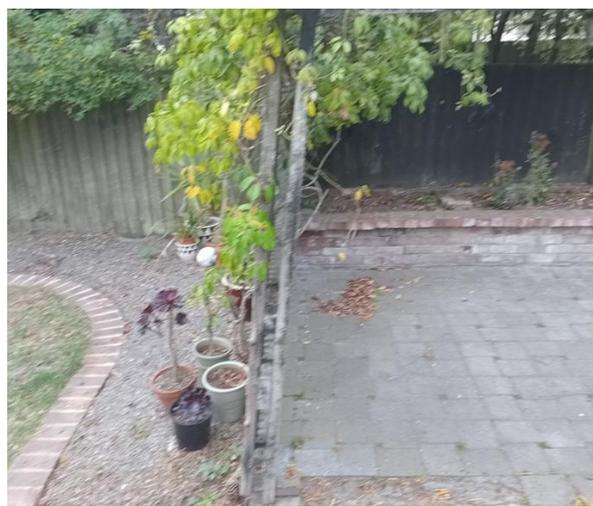
| ITEM ASSESSED | DEFECT | COMMENTS/NOTES |
|---|---|---|
| Fencing <ul style="list-style-type: none">○ Material Type○ Height○ Condition | Minor | Lean on the stand-alone garden structure. Cracking noted to the brick garden boxes. |

Lean on stand-alone garden structure

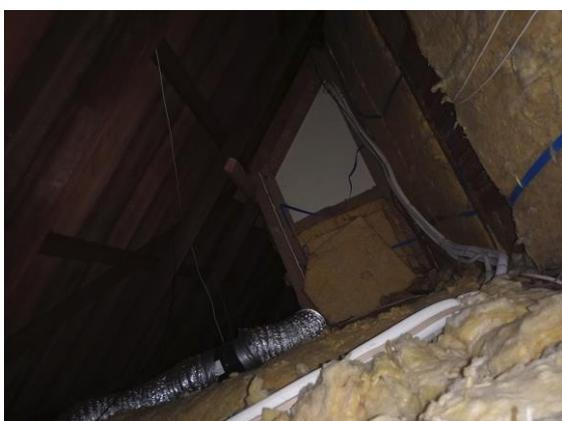
| ITEM ASSESSED | DEFECT | COMMENTS/NOTES |
|---|---|---|
| Thermal Insulation – Type, clearances, approximate thickness, and coverage. | Minor | Batts are approx. 140mm thick |

Insulation

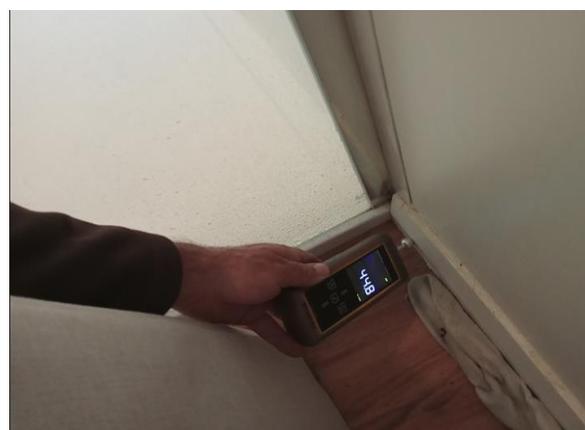
The moisture readings were between **21.2** and **49.7** – these are in the dry range.

Moisture testing – dry range

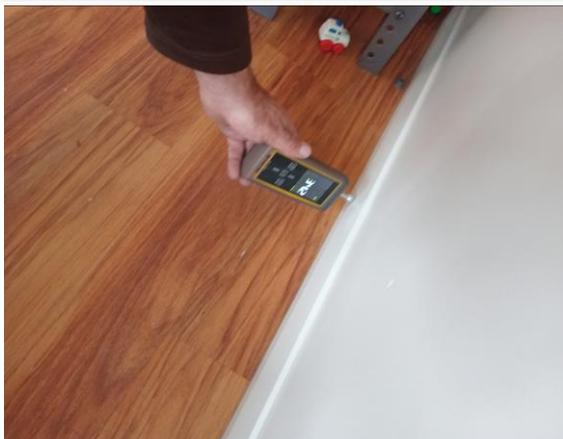
Moisture testing – dry range

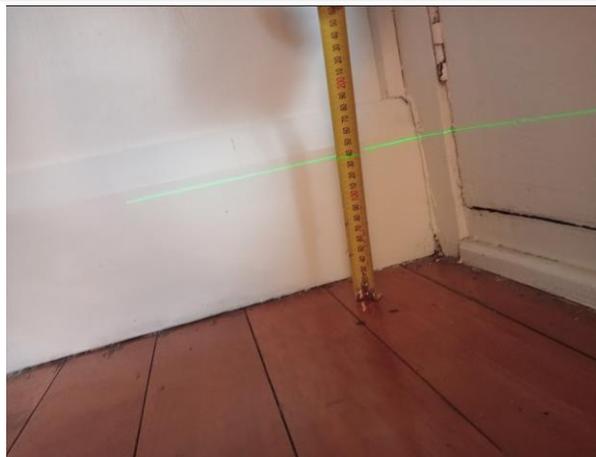
| ITEM ASSESSED | DEFECT | COMMENTS/NOTES |
|---|---|---|
| Timber Floors | Minor | Some noticeable undulations in timber floors. Floor levels varied by approx. 45mm. This is within the floor plan tolerance permitted by the MBIE guidelines for homes that may have been subjected to earthquake damage. |

Laser floor level assessment
