Building and Timber Pest Inspection Report

Inspection Date: Thu, 3 Oct 2024

Property Address: 11 Patomar St, Kedron QLD 4031, Australia

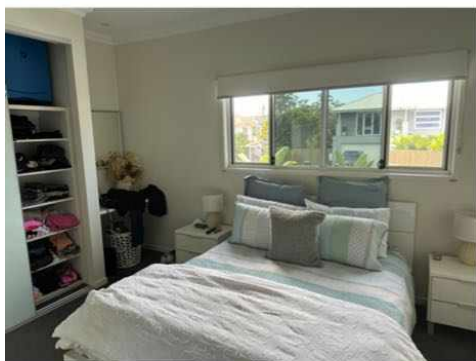
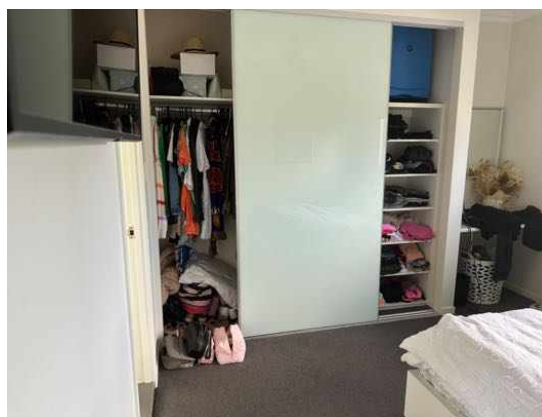
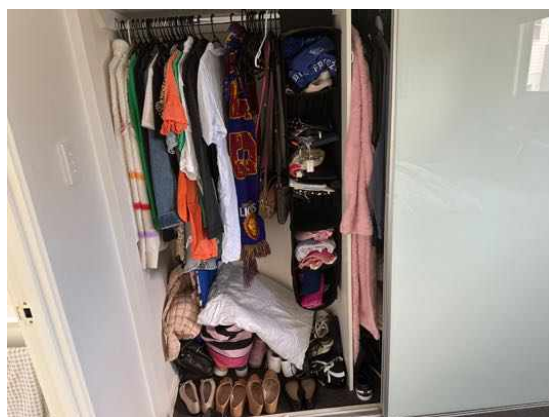
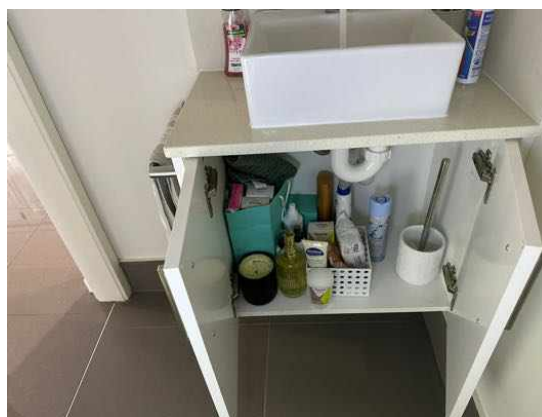
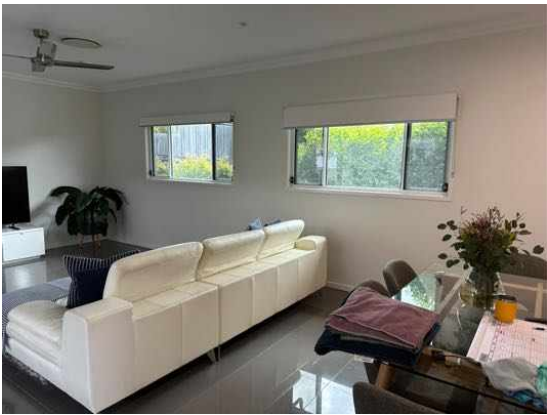
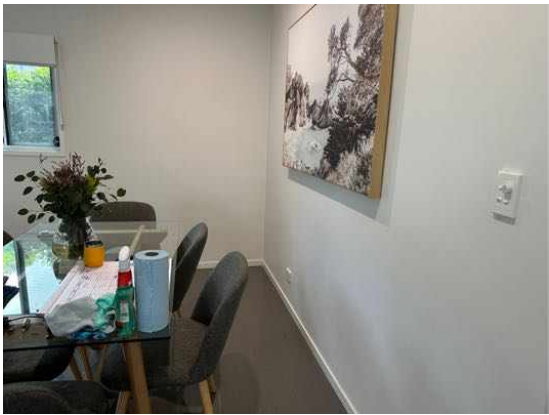
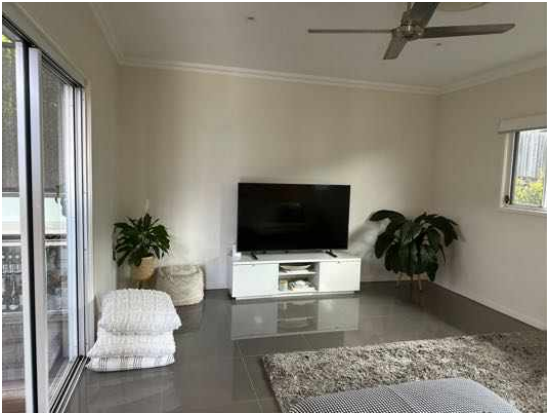
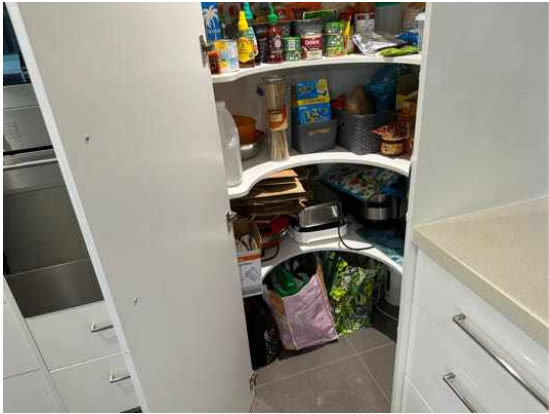
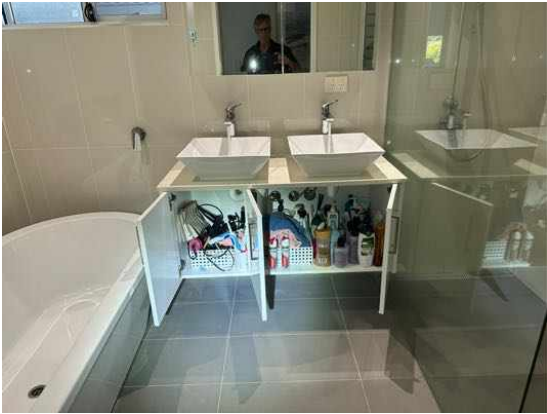
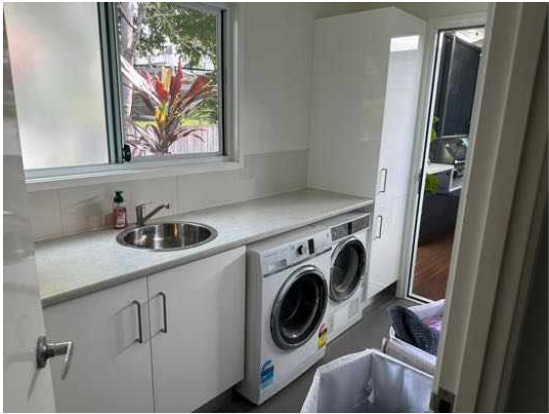
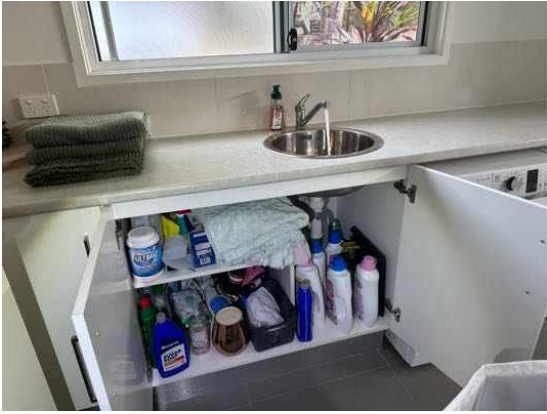
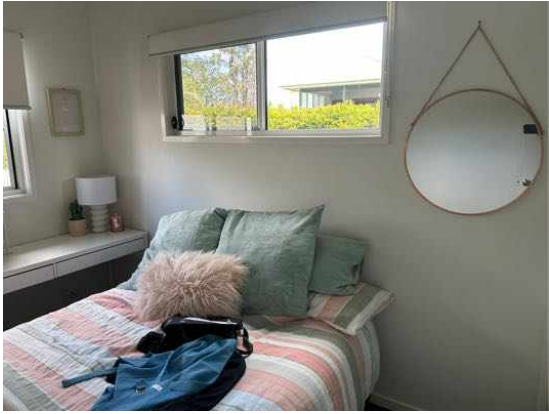
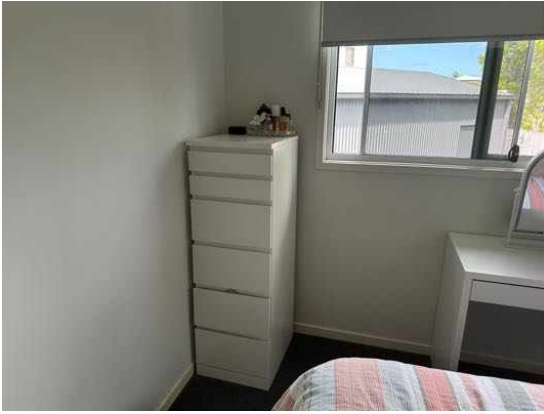
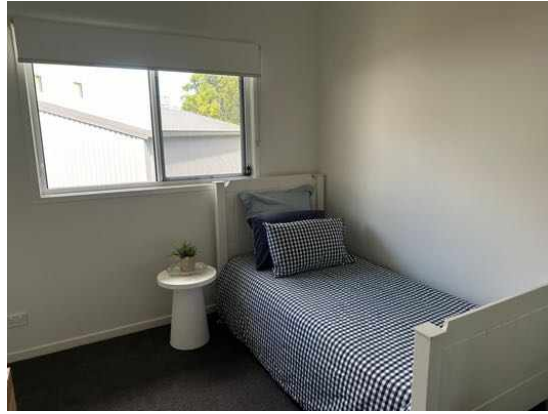
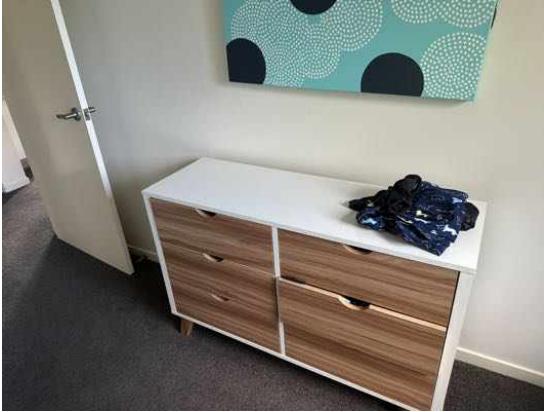
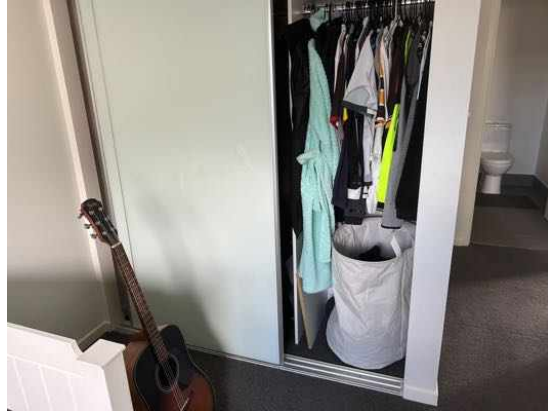
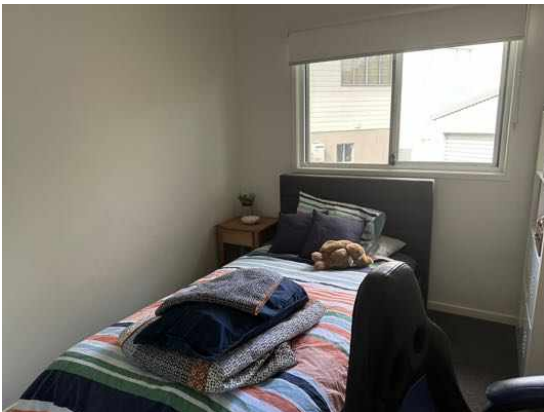
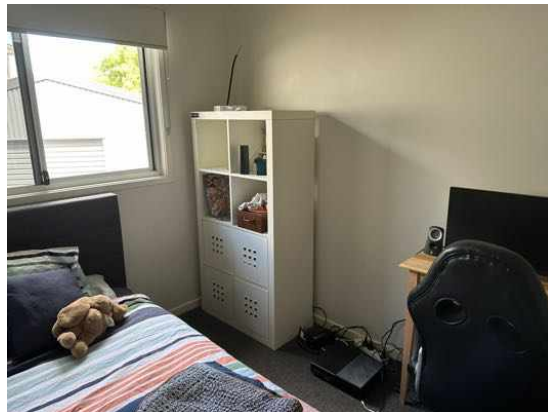
Building: Main Building
Location: All Internal Areas
Finding: Additional Photos - Obstructions and Limitations
Information: These photographs are an indication of the obstructions and limitations which impeded full inspection of the property at the time of inspection. These obstructions can hide an array of defects and should be removed to allow full inspection to be carried out. A re-inspection is recommended once the areas are made accessible.

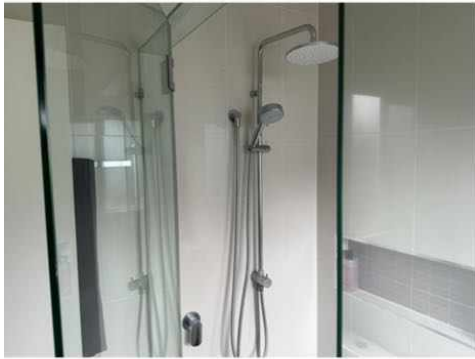
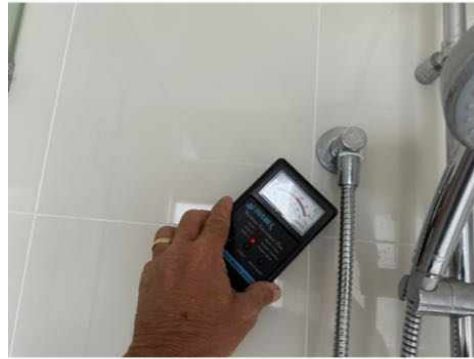
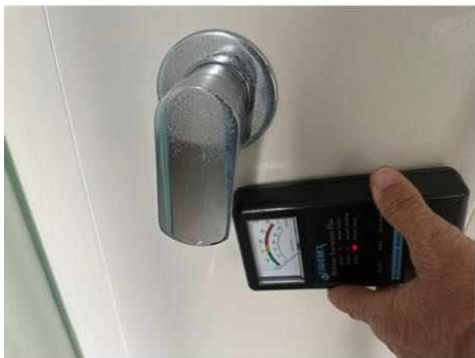
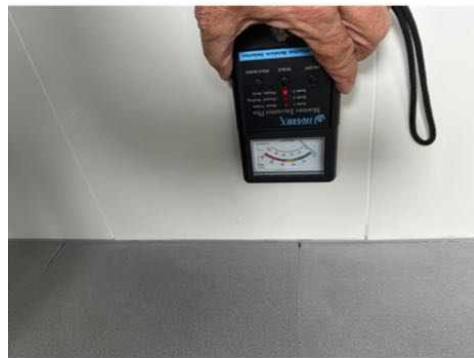
Building:	Main Building
Location:	Ensuite
Finding:	Additional Photos
Information:	Additional photos are provided for your general reference. No moisture detected.

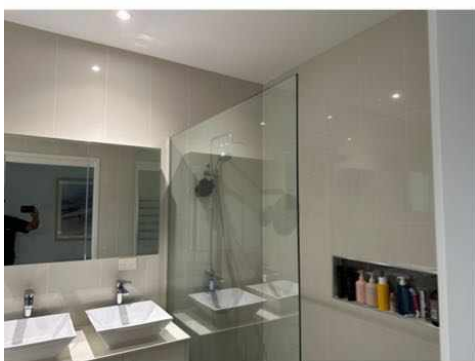
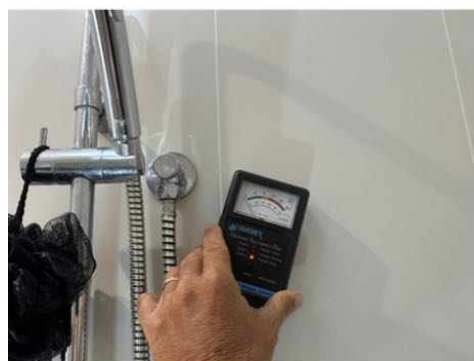
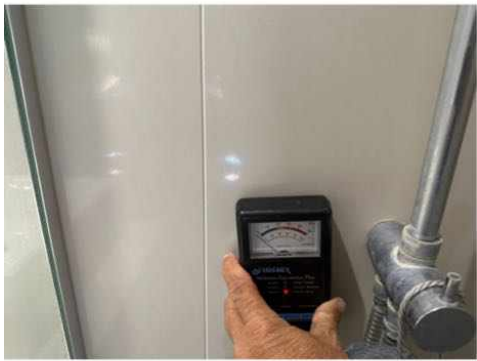
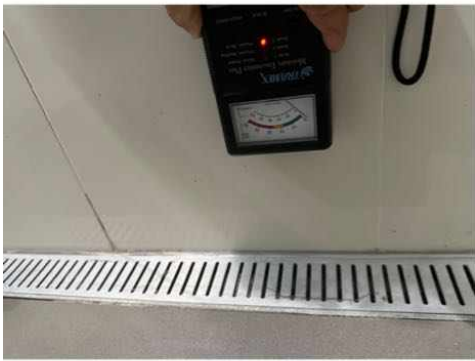
Building: Main Building
Location: Bathroom
Finding: Additional Photos
Information: Additional photos are provided for your general reference. No moisture detected.
