Pre-Sale Inspection Standard Timber Pest Detection Report

Date: 12th September 2024

Re property: 16 Amsdale Avenue, Macquarie Hills NSW 2285

Inspection number: PSBPA 0309/180

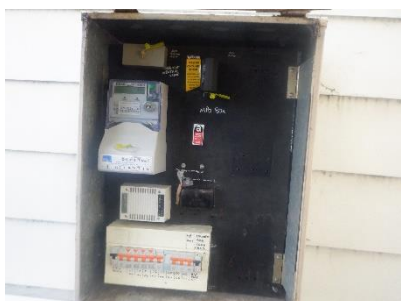
Was a durable notice found in the meterbox: No termite barrier notice was found in the meter box this does suggest no termite barrier work has been recently carried out.

No termite barrier notice

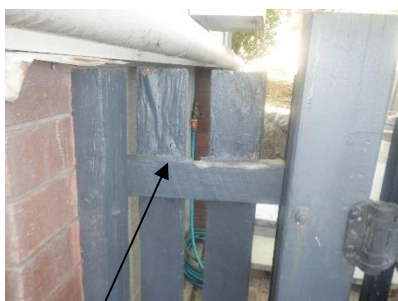
Was Decay found: Found to timber fence off the southwest corner of dwelling.

Where damage is present does the damage present a safety hazard to occupants? No safety hazards were found associated with this item.

Decay to fence

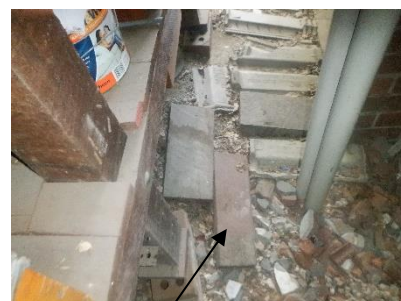
Timbers were found in ground contact in the subfloor.

Remove timber from ground

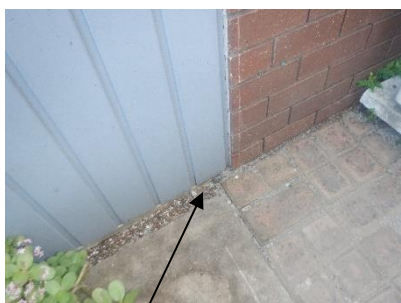
Was evidence of bridging or breaching including the condition insufficient slab edge exposure found?

Concealed edge of slab

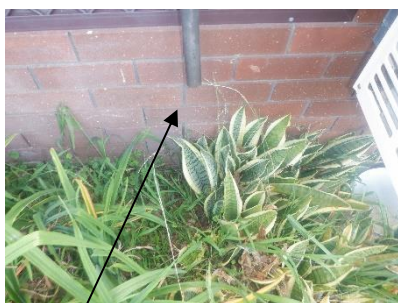
Air conditioner condensate drips to ground.

Air condition drip point

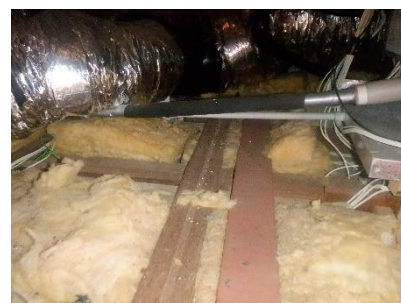
Insulation and ducts obscured timbers
