EARTHQUAKE RECOVERY (EQR) DOCUMENTATION

EQR Property Overview Report

EQC Property ID	Property Address	Vulnerable?	Property F Status	Property Finalisation Indicator		
2011045681	4 HELMSDALE STREET, BURWOOD		F3 - Complete & Finalised	Some Finalisation has taken place		
Main Contractor:	CLOSED OUT-GMK Builders Limited ***** (S449)		Property F2'd By:	System Generated Finalisation	F2 Completed Date:	22-12-2014
Cont Managing Hub:	<UNALLOCATED>	Not Vulnerable	Property F3'd By:	System Generated Finalisation	F3 Completed Date:	22-12-2014

4 Helmsdale Street, Burwood

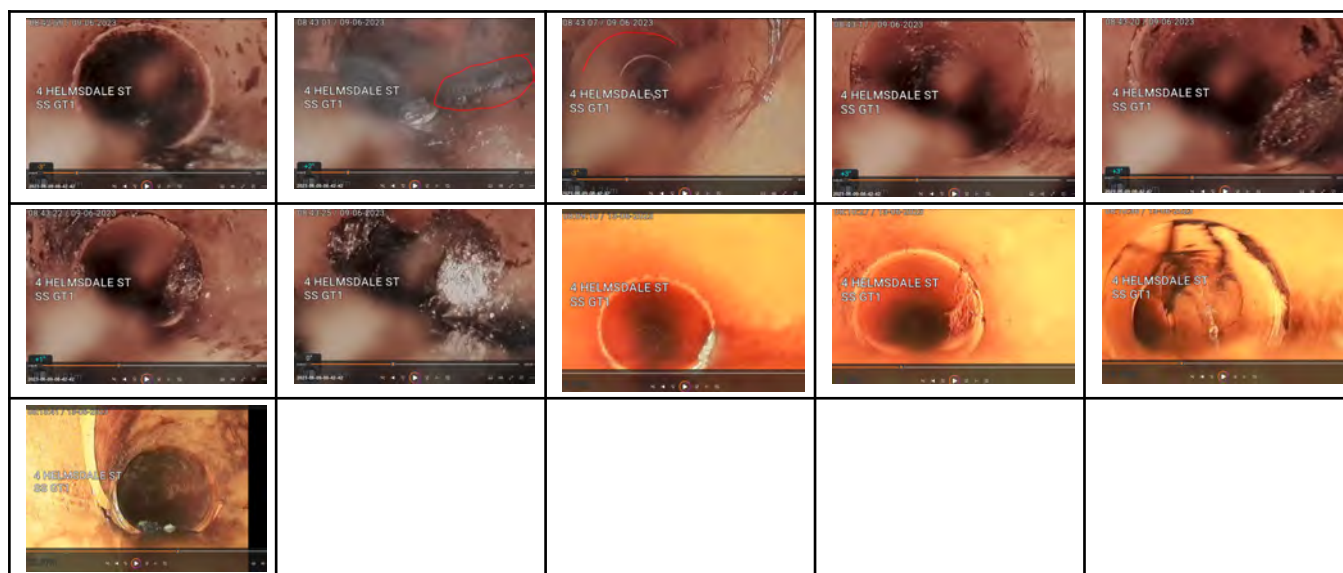
Camera access: GT1: Displaced join (DJ), encrustation 2.4m, 3.1m, 4m, 4.5m; DJ, fine Root intrusion (RI) 5.2m; DJ 5.7m, 8.4m; DJ, RI 9.1m; DJ, encrustation 10m; DJ, RI 10.7m, 12.3m, 13m; DJ, encrustation 14.5m, 15.8m, 16.8m, DJ 18.2m, 19.1m; Broken pipe 22m. Line is also holding in places.

The damage to the sewer is consistent with that seen from ground movement during the Christchurch Earthquakes. Given the extent of damage, we recommend full relay to restore integrity to the line.

29m PVC (including laterals) to replace damaged earthenware

3 x Gully trap to replace damaged

14LM Double cut concrete next to house foundations

35m² concrete path - uplift, dispose and reinstate after repairs

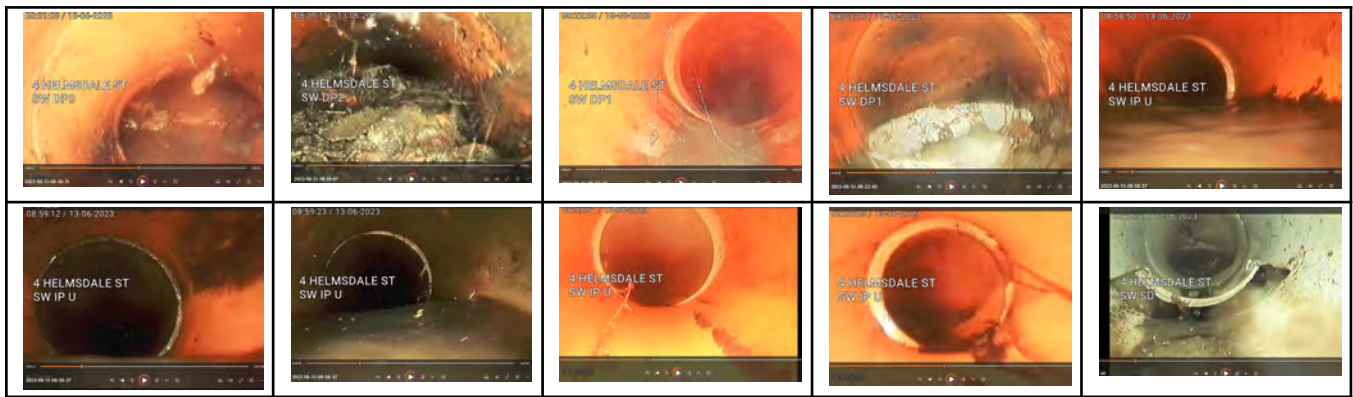
Camera access: Downpipe (DP) 3: Damage noted: Line is holding water.

Camera access: DP2: Damage noted: Root intrusion, Longitudinal cracking (LC), silt build up. Full blockage 1.4m.

Camera access: DP1: Damage noted: Displaced Join (DJ) 1.2m; DJ, encrustation 1.7m; DJ, encrustation 2.7m, 3.3m, 4m; DJ, LC, silt build up 4.8m.

Camera access IP (Downstream): Damage noted: DJ, RI 1.9m; DJ 2.6m, 3.5m, 5.7m, 7.3m Line is holding and undulating from 8m.

Camera access IP (Upstream): Damage noted: Line is holding and undulating to 8.5m. DJ 1.2m, 2m, 6.3m, 6.9m; DJ, fine RI 7.4m; DJ, encrustation 9m, 10m; DJ, RI 11.3m, 13m; DJ, LC 14m. Line is holding from 14m-15m with build up of silt and root intrusion to 17m.

Camera access: SD: Damage noted: This line is PVC. The pipe has a hole in the bottom at 1.6m. This is not consistent with Earthquake damage and looks like it may have been laid upside down. We recommend having this repaired. The remainder of damage to the stormwater is consistent with that seen from ground movement

during the Christchurch Earthquakes. Given the extent of damage seen in every access point of the stormwater line, we recommend relay of the lines servicing downpipes 1, 2, and 3 to restore integrity to the line. DP4 goes to ground.

36m PVC (including laterals) to replace damaged earthenware

26m² paving - uplift for trench access, store onsite. Reinstate after repairs

14LM concrete curbing next to pavers - uplift for trench access. Reinstate after repairs

4LM concrete curbing at boundary - uplift for trench access. Reinstate after repairs

Trellis fence - remove for trench access. Reinstate after repairs
