Pre-Sale Property Inspection Report

**33 Monte Crescent
Lincoln**

Property report number: 3922.

Inspection date & time: 06th January-2025 at 10:00 am.

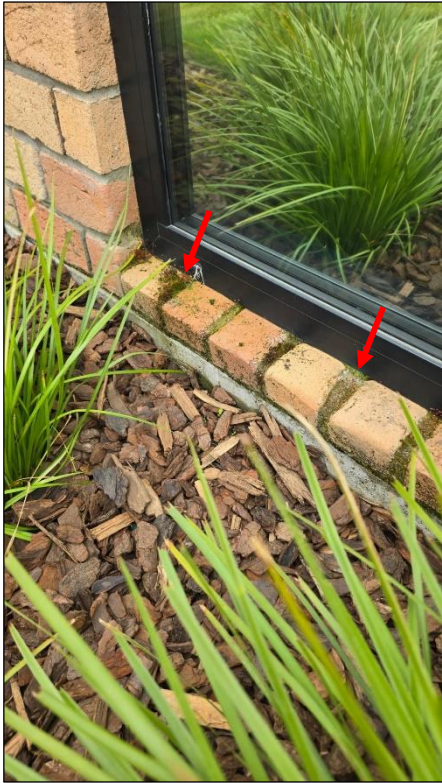
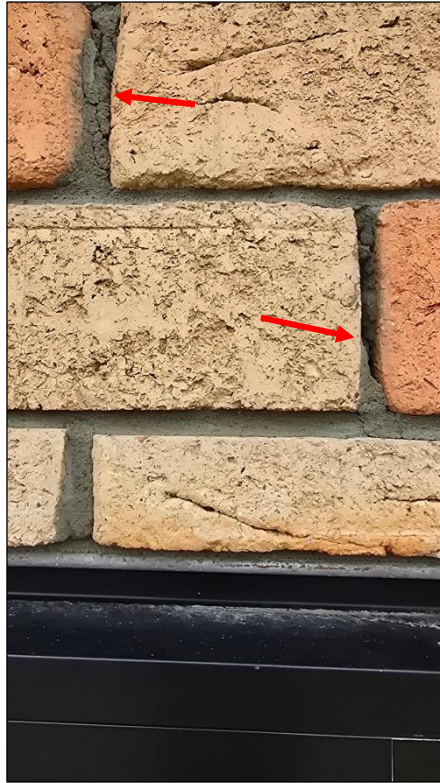
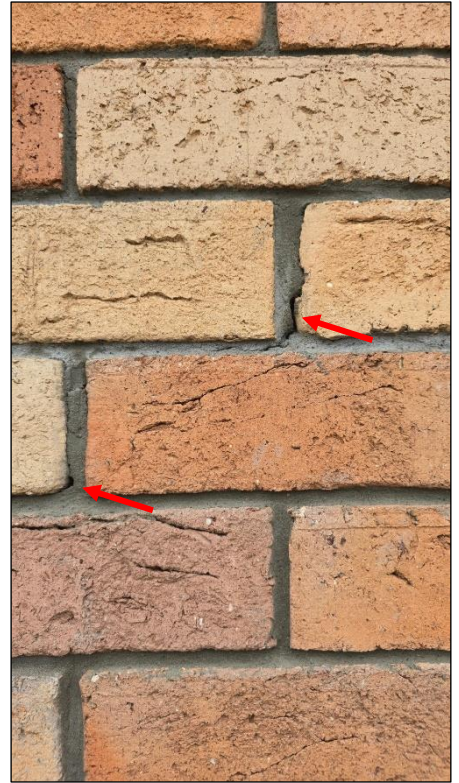
Elevations - Photos

- Moss/lichen on the brick veneer in areas, moss/lichen treatment is advised to prevent deterioration to the brick mortar.
- Missing brick mortar, and minor cracking in the mortar, repairs by a brick layer are advised.

We recommend you seek the services of a home maintenance person or an LBP / Qualified contractor to repair or replace as required.
