**BRISBANE BUILDING
& PEST INSPECTIONS**

Pre Sale Building and Timber Pest Report

Inspection Date: 4 Sep 2024

Property Address: 28 Goulburn Street Gordon Park 4031

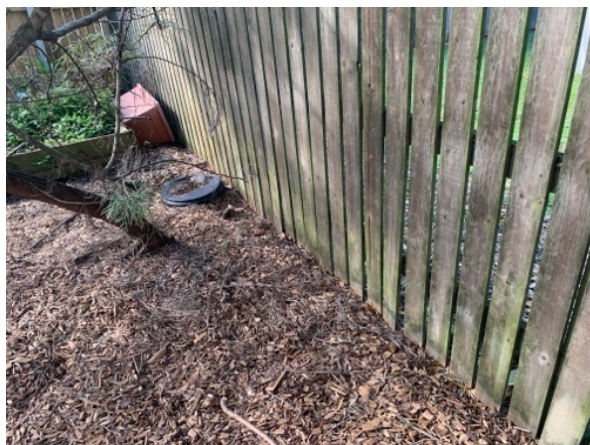
Finding: Various Fence Timbers

Various fence timbers are in direct ground contact, which is always a termite risk and promotes wood decay. Recommend cutting the bottom of the fencing 50mm above ground level.

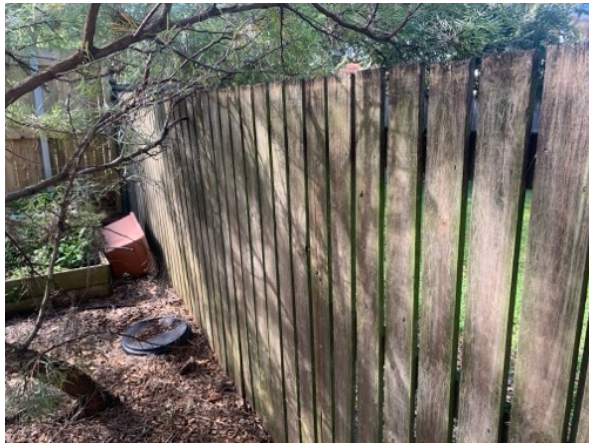
Minor Defect 1.02

Location: Rear Fence

Finding: Timber fence

There is some deterioration to the bottom of the timber posts some slight movement in the fence. I strongly recommend further maintenance replacing post where necessary or installing extra concrete to further shore up timber fencing

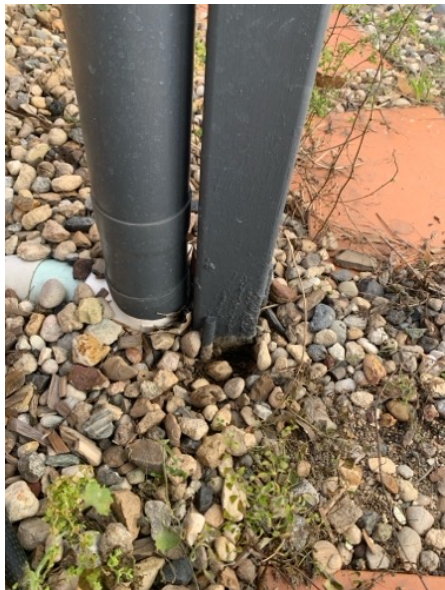
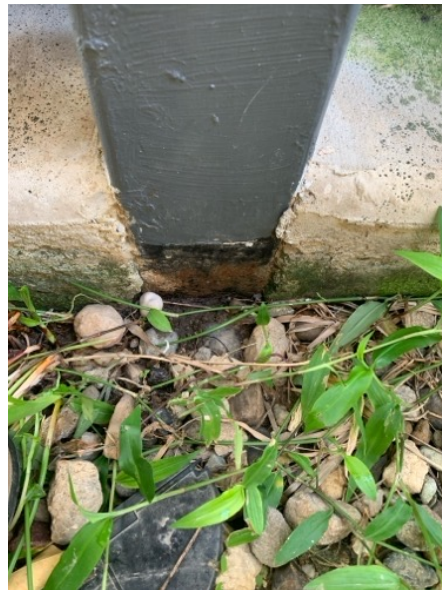
Minor Defect 1.03

Location: All External Areas

Finding: Steel posts

It was noted that the property has steel posts in direct ground contact. Inspection of the condition of the posts below the surface of the ground is excluded from the scope of this report. It is recommended that you have a rust treatment and expose 75mm mounded concrete to allow moisture runoff and prevent further corrosion.

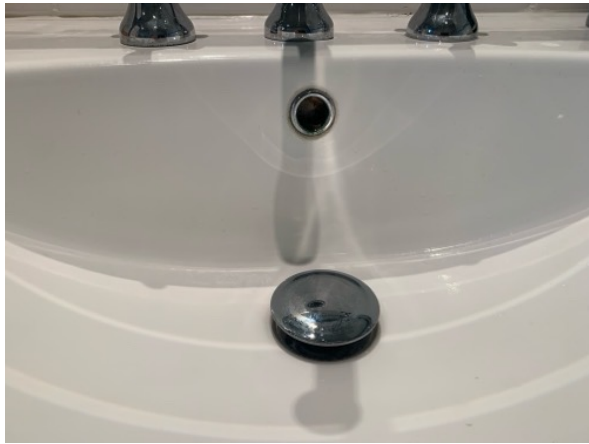
Minor Defect 1.04

Location: Ground Floor Bathroom

Finding: Plunger plug - Degraded

During the assessment of the property, it was observed that the plunger plug in the bathroom basin exhibited a defect of sticking. The plunger plug, when pressed down to close the drain, did not smoothly return to its original position upon release. Instead, it remained partially or fully depressed, impeding the proper drainage of water from the basin. This defect may result in inconvenience and potential water overflow if not promptly addressed. It is recommended that a qualified plumber be engaged to rectify this issue and ensure the proper functioning of the plunger plug in the bathroom basin.

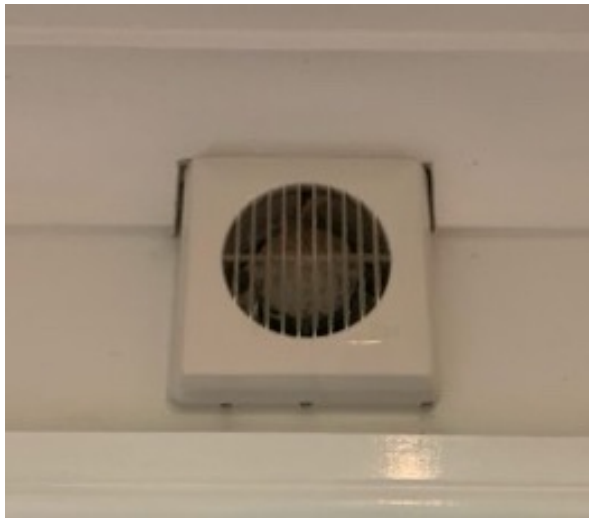
Minor Defect 1.05

Location: Ground Floor Bathroom

Finding: Exhaust fan

During the inspection of the ground floor bathroom, a significant accumulation of dust was observed on the exhaust fan above the toilet. This not only hampers the efficiency of the fan but may also pose a potential fire hazard and air quality issue. As per the Standards Australia AS/NZS 3000 (Electrical Installations), regular maintenance of electrical fixtures is required for safety and functionality. It is recommended that a licensed electrician or suitably qualified handyperson remove the fan cover, thoroughly clean the fan blades and housing, and inspect for any mechanical or electrical concerns needing further attention.

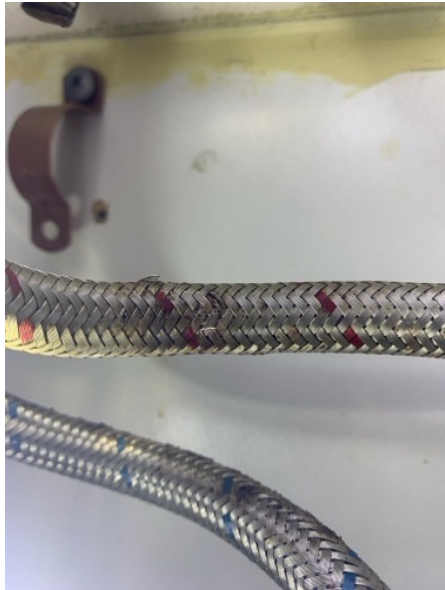
Minor Defect 1.06

Location: Kitchen

Finding: Flexible hoses - Corrosion

Some corrosion was observed to flexible water hoses which are used for connecting plumbing fixtures.

It is highly recommend getting all flexible hoses that show signs of corrosion replaced as they are under constant pressure, a burst hose can cause significant water damage.

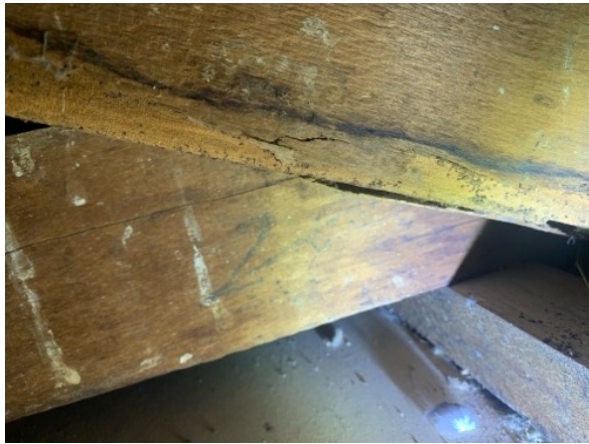
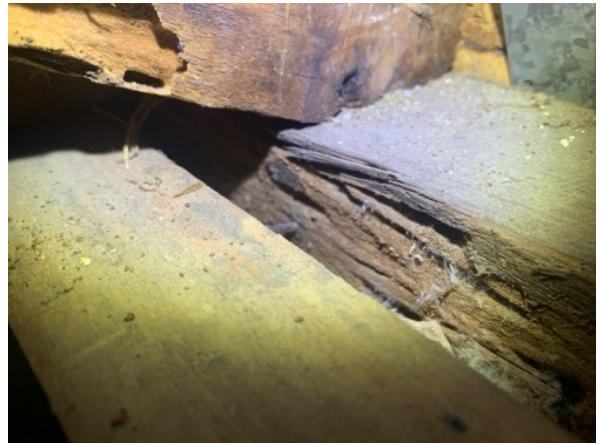
Finding: Termite damage

During the course of the inspection, it has been observed that there is evidence of historical termite damage to certain components of the roof framing, specifically to a rafter and the top plate within the roof space. The damage appears to be minor in nature and there are indications that it occurred several years ago. This is corroborated by the presence of new roof framing elements and an extension adjoining the original structure, which implies that corrective measures were implemented subsequent to the initial termite activity.

Given the age of the damage and the subsequent remedial work, it is unlikely that the integrity of the new roof structure is compromised. However, to ensure the continued structural integrity of the framing and adherence to the Building Code of Australia (BCA) and pertinent Australian Standards, a thorough assessment by a qualified structural engineer is recommended. This assessment should focus on confirming the adequacy of the existing roof framing and determining whether any additional remediation or reinforcement is required.

In addition, it is imperative to engage the services of a licensed pest management technician to conduct a comprehensive termite inspection and to establish an ongoing termite management plan. This will help to protect the property against future termite infestations, ensuring that such damage does not recur and pose a risk to the structural integrity of the building.

The homeowner is advised to prioritize these assessments and to undertake any recommended actions promptly to maintain the property in a safe and sound condition. Regular inspections and maintenance are key preventative measures that will enable the early identification and resolution of any such

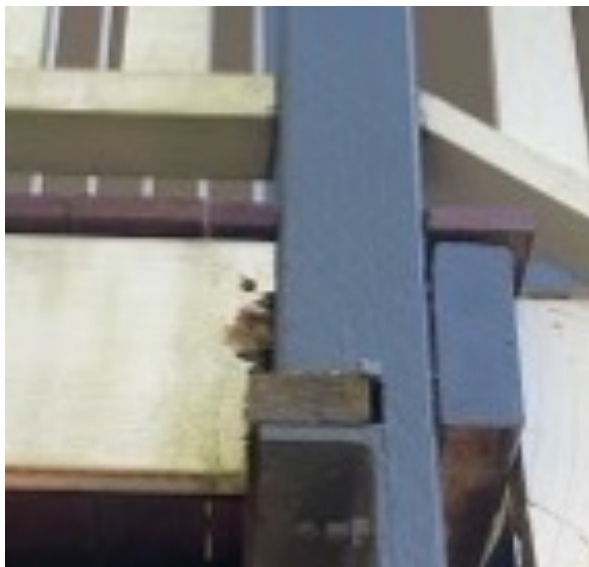
Location: The rear timber deck
Finding: Fascia board / wood decay

The fascia boards show signs of fungal decay. This wood rot is suspected to have developed over a prolonged period of time due to expected age and condition. To maintain the condition of the external wall cladding, severely affected weatherboards should be replaced.

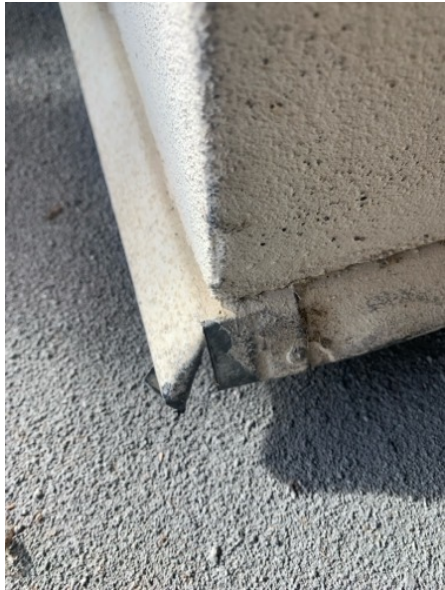
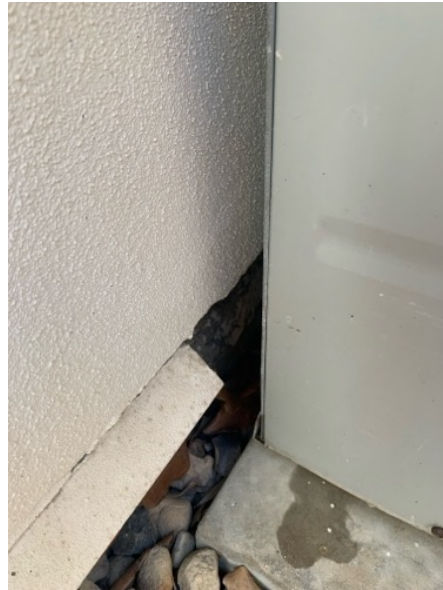
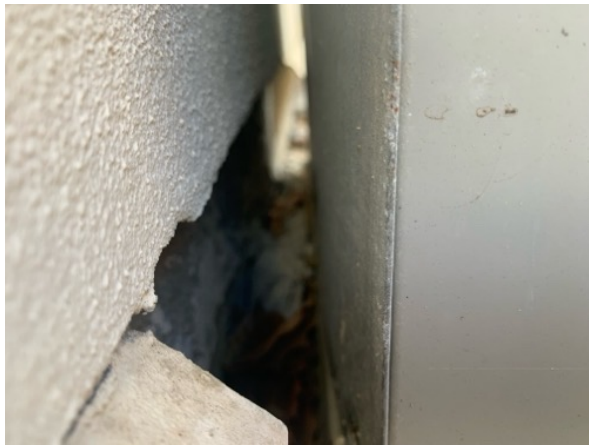
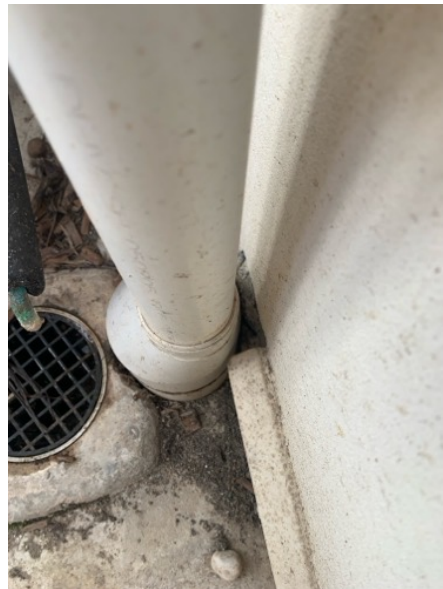
Conditions conducive to timber pest attack 2.03

During the visual inspection of the property, it was observed that the ant capping in the All External Areas is broken at the joint, resulting in the barrier no longer being one continuous unit. This defect poses a potential risk as it compromises the integrity and effectiveness of the barrier system. It is essential for the ant capping to be intact and The ant capping be returned to its original, 45° angle in all locations around the property, securely fixed to ensure the effectiveness as a termite management system especially in residential properties.

To address this issue, it is recommended that immediate remedial action be taken. This may involve engaging a qualified contractor to repair or replace the broken ant capping, ensuring it is properly aligned and securely fastened. The remedial work should be carried out in accordance with the relevant standards and guidelines.

It is crucial for the property owner to promptly address this defect to ensure the protection of the property from termite attack.

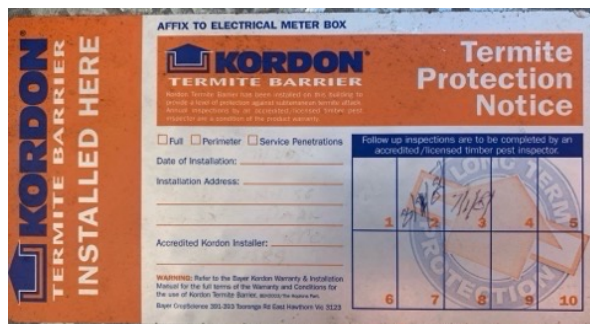
Finding: Evidence of a previous termite management system was identified

Where a Termite Management System has been identified you should refer to the type of barrier date of installation warranty conditions and any documentation provided by a past owner. Consult the company who installed the barrier to confirm whether the system is still under warranty. Most chemical termite management systems expire and require replenishment and all physical systems are primarily designed to prevent concealed entry.
