PRE-PURCHASE STANDARD PROPERTY & TIMBER PEST REPORT

Report number: 4428

Inspection date: 19 Apr 2022

Property address: 103 Victoria Avenue
Margate

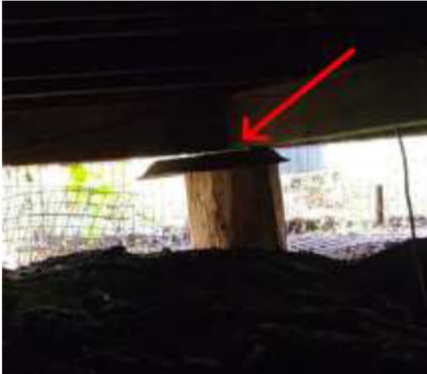
Floor of building/house is uneven in parts, this is a result of different factors; bearers have bows between stumps, stumps have moved/dropped in height, type of soil to property and wet or drought condition suffered to soil. Recommend a suitably licenced and practicing restumping contractor to further investigate the most appropriate method of rectification and the probable cost of rectification works.

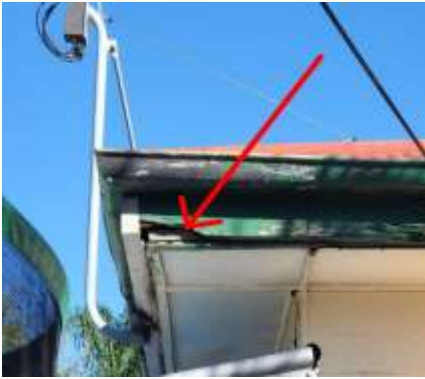
Wood decay to sections of house fascia timbers. Recommend a suitably licenced and practicing carpenter contractor to further investigate the most appropriate method of rectification and the probable cost of rectification works.

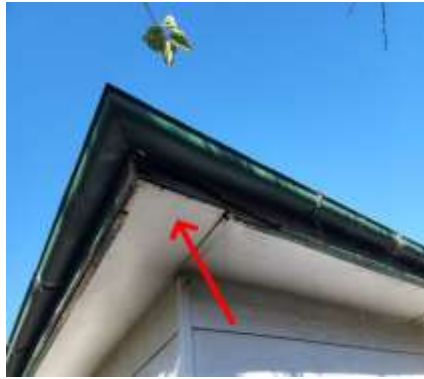
Wood decay to sections of soffit moulding timbers. Recommend a suitably licenced and practicing carpenter contractor to further investigate the most appropriate method of rectification and the probable cost of rectification works.

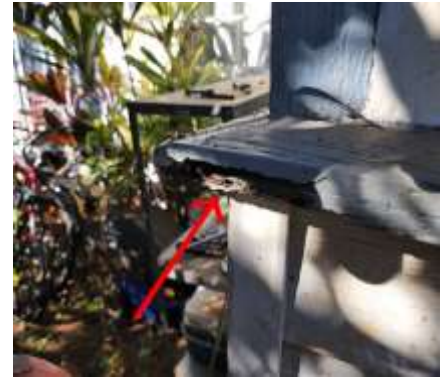
Wood decay to sections of window sill timbers. Recommend a suitably licenced and practicing carpenter contractor to further investigate the most appropriate method of rectification and the probable cost of rectification works.

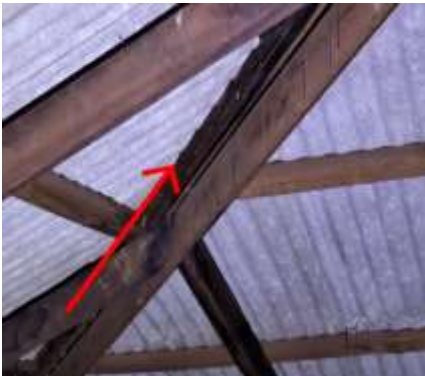
Wood decay to sections of roof batten timbers. Recommend a suitably licenced and practicing carpenter contractor to further investigate the most appropriate method of rectification and the probable cost of rectification works.

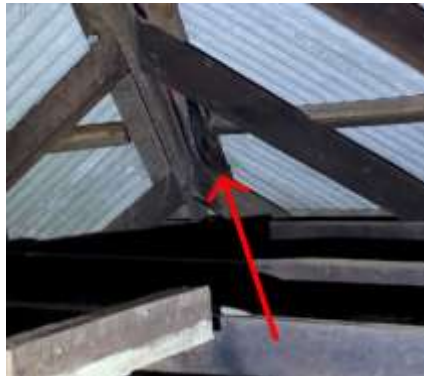
Wood decay to sections of roof batten timbers. Recommend a suitably licenced and practicing carpenter contractor to further investigate the most appropriate method of rectification and the probable cost of rectification works.

Further investigation required into the cause of decay, possible leak to roof ridge capping.

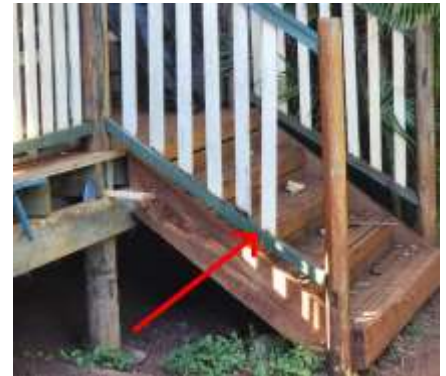
Rear handrail missing palings, maintenance required. Recommend a suitably licenced and practicing carpenter contractor to further investigate the most appropriate method of rectification and the probable cost of rectification works.

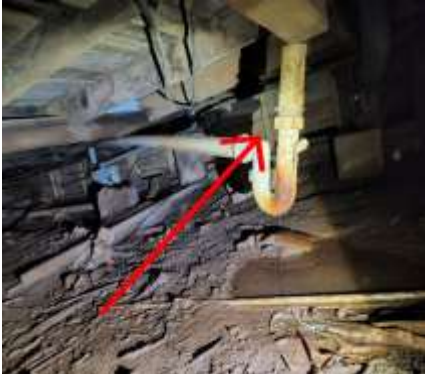
Downpipe under shower has become dislodge. Immediate repairs required. Recommend seeking further advice from a licensed and practicing plumber, for best method of rectification and associated cost.

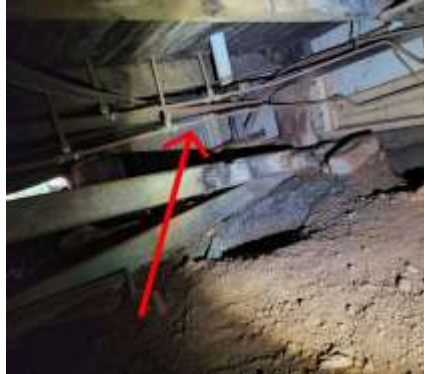
Laundry drainage not connected to grey water drainage. Recommend seeking further advice from a licensed and practicing plumber, for best method of rectification and associated cost.

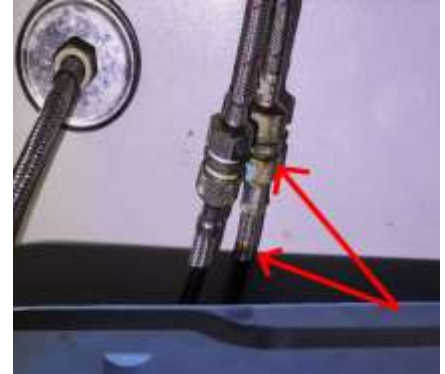
Kitchen flexible hose rusting and leaking, maintenance required. Recommend seeking further advice from a licensed and practicing plumber, for best method of rectification and associated cost.

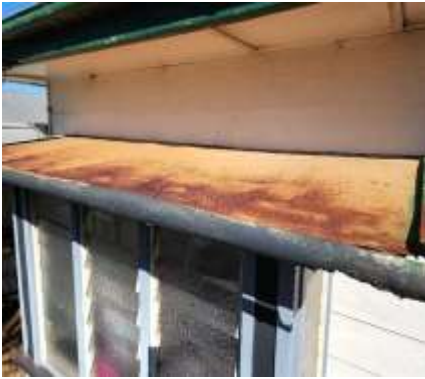
Rust to front bay window wall roof, maintenance required possible replacement. Recommend seeking further advice from a licensed and practicing plumber, for best method of rectification and associated cost.

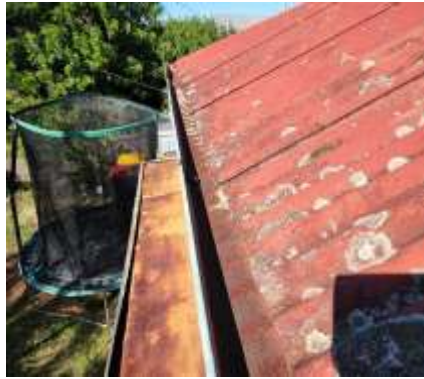
Rust and holes to sections of roof gutters, replacement required. Recommend seeking further advice from a licensed and practicing plumber.

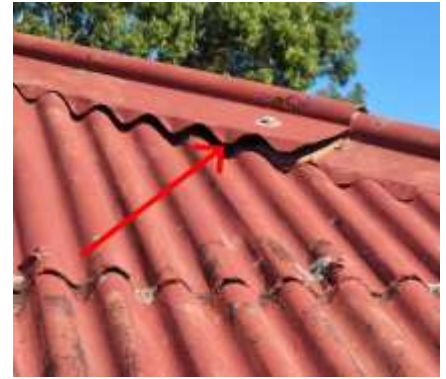
Loose damage roof flashing in sections, maintenance required. Recommend seeking further advice from a licensed and practicing plumber, for best method of rectification and associated cost.

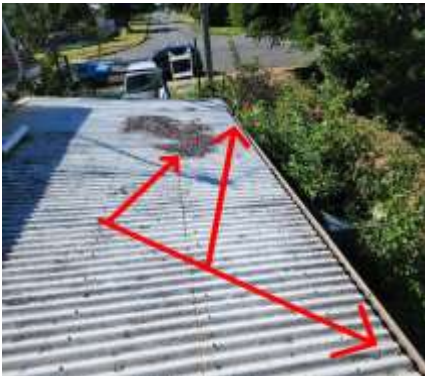
Leaf debris gutters clean out required. Recommend implementing and ongoing maintenance strategy for cleaning out gutters a other alternative is to install gutter guards.

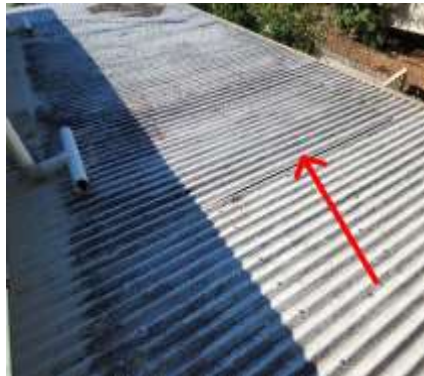
Loose roof sheeting, maintenance required. Recommend seeking further advice from a licensed and practicing roof plumber, for best method of rectification and associated cost.

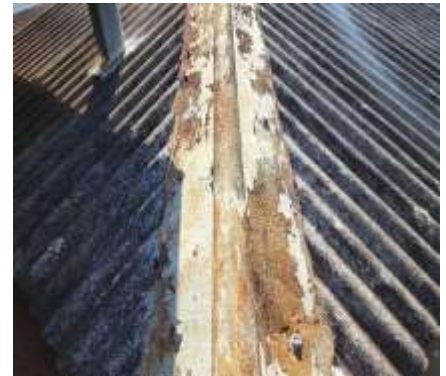
Rust scale to roof ridge capping. Rust treatment is required to prevent further deterioration.

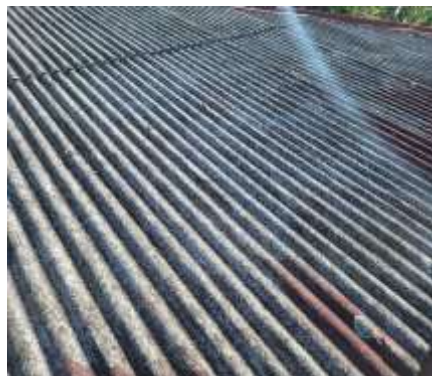
Roof paint coating has deteriorated. Recommend a suitably licenced and practicing roof restoration contractor to further investigate the most appropriate method of

rectification and the probable cost of rectification works.

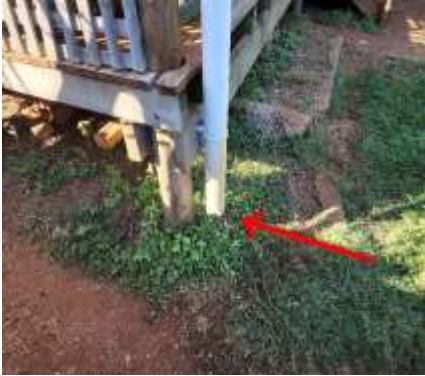
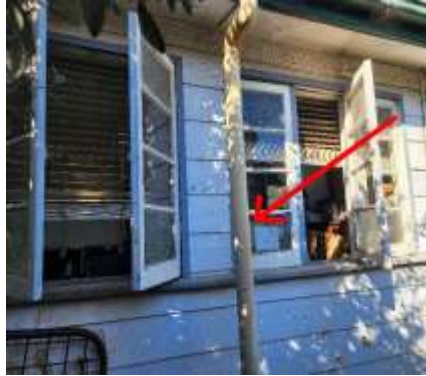
Downpipes from roof gutter are discharging onto and or close to foundations. all surface water should be diverted away from house footing/foundations. Refer to attached CSIRO information sheet,section 3 in relation to this.

Right side downpipe floating from gutter outlet.
Recommend seeking further advice from a licensed and practicing plumber, for best method of rectification and associated cost.

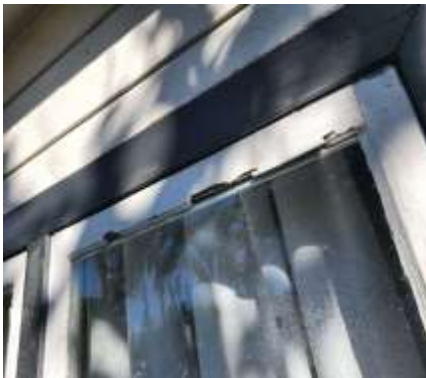
Timber windows throughout house require maintenance (eg reputty glass, Frame binding, lubes hinges, replace catches, and replace glass etc.) Recommend seeking further advice from a licensed and practicing carpenter for best method and cost of rectification.

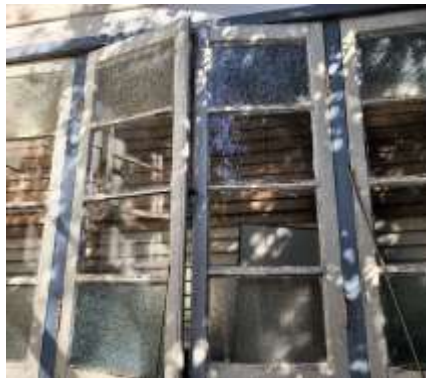
Timber windows throughout house require maintenance (eg reputty glass, Frame binding, lubes hinges, replace catches, and replace glass etc.) Recommend seeking further advice from a licensed and practicing carpenter for best method and cost of rectification.

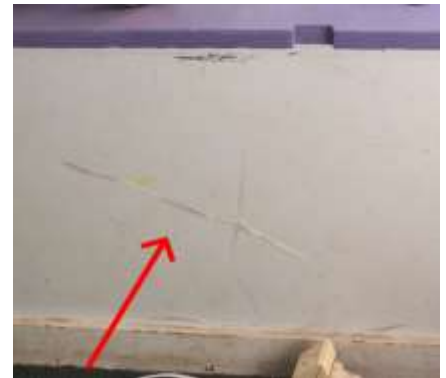
Damage crack fibre to front bedroom. Any repairs / renovations /alterations involving fibre cement products and materials required precaution to protect workers and or a specialist contractors' involvement. Recommend engaging a specialist licensed in asbestos removal and Repairs for the best method of ratification.

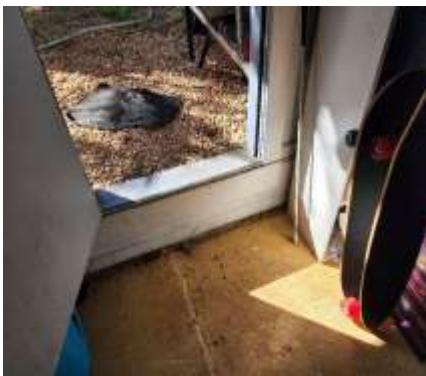
The internal floor level is less than 75mm above the adjacent external finished level. This does not conform to the current building code and may result in stormwater entering the building. If water enters drainage modifications may be required.

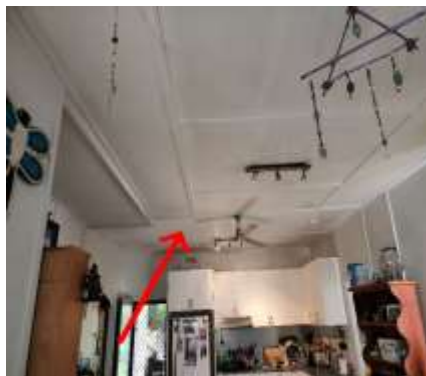
There is unevenness in the kitchen ceiling. This is due to deflection of roof timbers under load and or, due to the age of building. Recommend a suitably licenced and practicing carpenter contractor to further investigate the most appropriate method of rectification and the probable cost of rectification works.

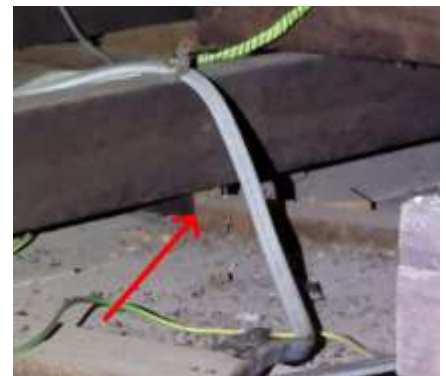
Sections of ceiling battens becoming dislodge, maintenance required. Recommend a suitably licenced and practicing carpenter contractor to further investigate the most appropriate method of rectification and the probable cost of rectification works.

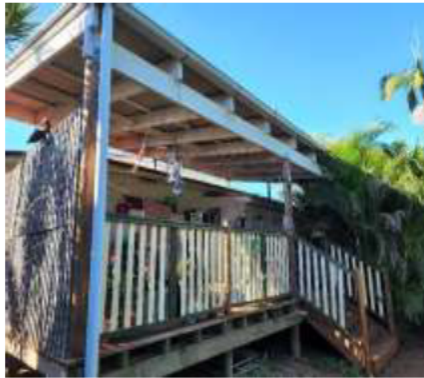
Rear deck may not have council approval. Recommend client or client's solicitor make the necessary enquiries with the local council for the possible risk of illegal structures.

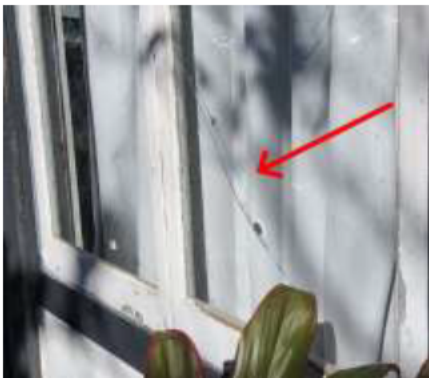
Cracked/broken glass to the lounge room window. Recommend to replace as a safety issue. Recommend a suitably licenced and practicing glazier contractor to further investigate the most appropriate method of rectification and the probable cost of rectification works.

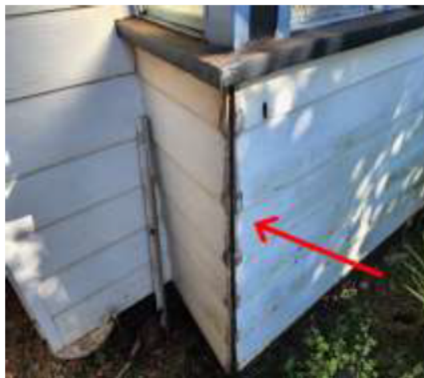
Front wall cladding corner capping missing, replacement required. Recommend a suitably licenced and practicing carpenter contractor to further investigate the most appropriate method of rectification and the probable cost of rectification works.

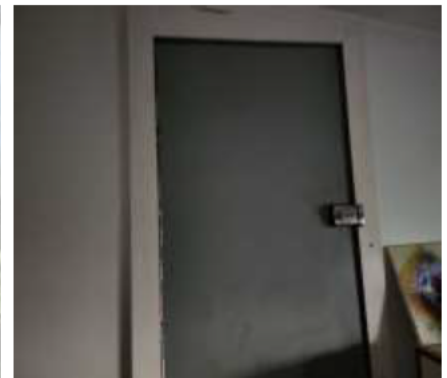
Some doors binding, adjustments are required to ensure correct operation. Planning and adjustment to striker plates required, recommend a suitably licenced and practicing carpenter contractor to further investigate the most appropriate method of rectification and the probable cost of rectification works.

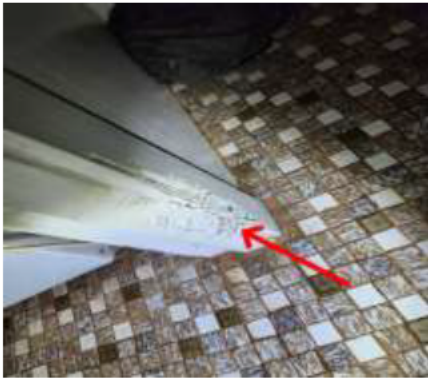
Bathroom door jambs damage, maintenance required. Recommend a suitably licenced and practicing carpenter contractor to further investigate the most appropriate method of rectification and the probable cost of rectification works.

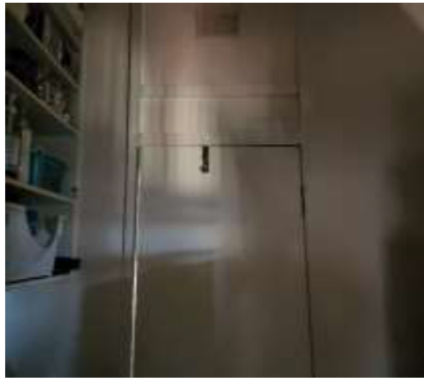
Bedroom 2 door is binding on the top/side jamb and requires easing. Recommend seeking further advice from a licenced and practicing carpenter.

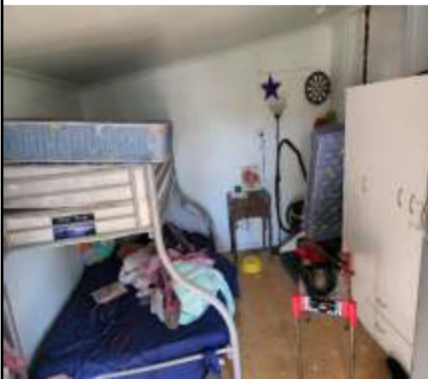
Downstairs walls and ceilings are non-conforming and unprotected from termite entry. Dew to walls built over infill slab, walls built over ant capping. And no evidence of a current termite protection program in place, it's recommended a protection program in accordance with Australian Standard AS3660 is highly recommended once all recommendations have been undertaken to control any further termite activity to the house structure.

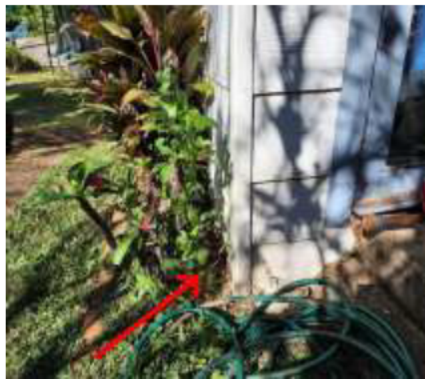
The external cladding is in direct ground contact at various locations around the dwelling and is required to have 75mm ground clearance. If cladding does not have this clearance it is considered essential to install a termite management system as a matter of urgency to control any undetected termite entry.
