EARTHQUAKE RECOVERY (EQR) DOCUMENTATION

EQR Property Overview Report

EQC Property ID	Property Address	Vulnerable?	Property F Status	Property Finalisation Indicator		
2010013897	1/126 HALSWELL JUNCTION ROAD, HALSWELL		F3 - Complete & Finalised	Some Finalisation has taken place		
Main Contractor:	CLOSED OUT-Interproducts Limited t/a Frame Contracting ***** (S049)		Property F2'd By:	Blair Jones	F2 Completed Date:	29-03-2016
Cont Managing Hub:	<MULTIPLE>	Not Vulnerable	Property F3'd By:	Blair Jones	F3 Completed Date:	29-03-2016

1/126 Halswell Junction Road

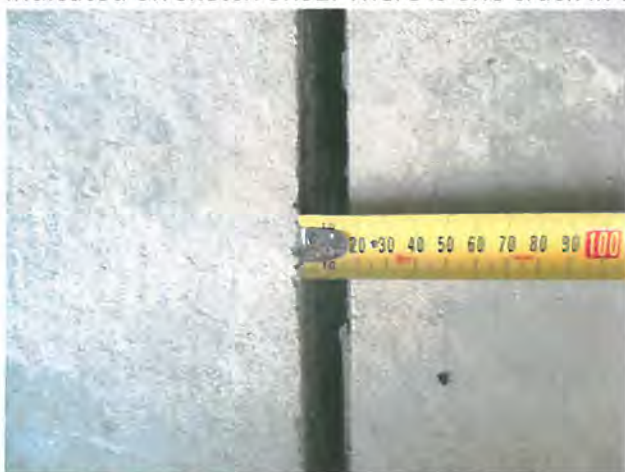
Cracking in the floor slab along the construction joints has been observed where the joints have opened by a maximum of 20mm in some areas. Refer to sketch SK02 for locations of separation in floor slab along construction joints and widths of joint openings. The concrete slab does not appear to have settled differentially across the cracks. A 2mm crack in the concrete floor slab has also been observed and indicated on sketch SK02. There is one crack in the perimeter foundation on the North-western corner.

Figure 1: Construction Joint Separated 18mm

An 800mm wide section of slab in the hallway and kitchen/dining area is to be removed and reconstructed as per the attached details in sketches SK05 and SK06. A new construction joint is to be built into the slab in the same location as the original as indicated in sketch SK03 using a MiTek Krack Mate. D10 starter bars at 600mm centres are to be epoxy grouted 150mm in to the existing foundation as per the attached details in sketches SK05 and SK06. The starter bars are to be installed into every second side of the new section of concrete slab.

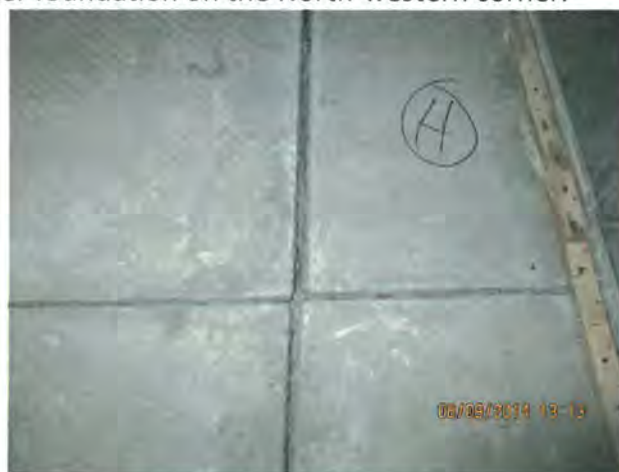
Figure 2: Construction Joints have opened

It is proposed to remove and replace two sections of the slab foundation in the areas indicated on sketch SK03 as the construction joints have opened in these areas and there are doors jamming indicating earthquake related movement. Refer to sketch SK03 for proposed target level.

The 6mm crack across the lounge floor as indicated in sketch SK02 is to have a new MiTek Krack Mate installed and filled using Ardex Crackbond JF-311 as per the attached product specifications.

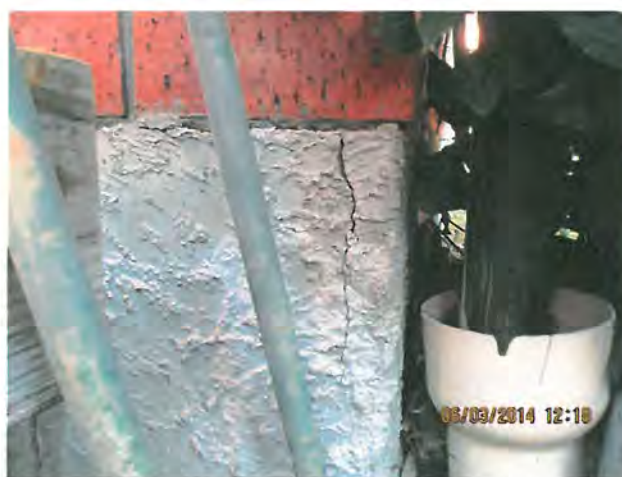
Figure 3: Crack in perimeter foundation

The crack in the perimeter foundation on the North-western corner is to be remediated as per the attached crack repair in walls and foundations specification.

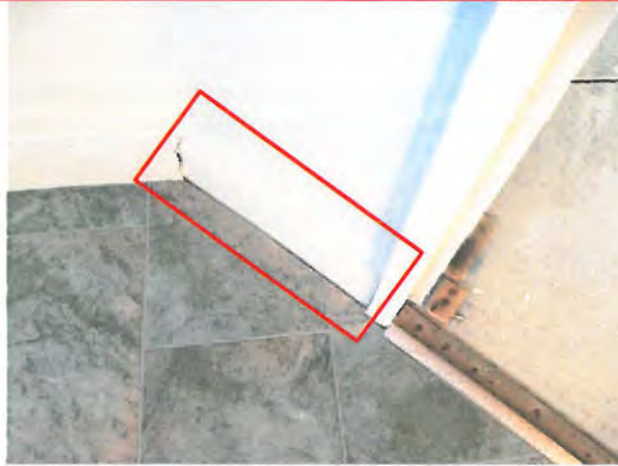
Some of the walls are out of plumb as a result of the movement in the concrete floor slab and the doors to the bathroom and North-western bedroom are jamming at the top. The bathroom door frame is out of level as it is likely that the bottom plate fixing has pulled away from the concrete slab. The wardrobe door in the North-eastern bedroom is jamming and the dining area slider is sticking. Refer to sketch SK02 for doors that are jamming.

Figure 4: Wall framing has moved

In the Northern end of the house the ceiling members are to be propped using Acrow props or a similar system and walls removed as necessary to provide access for replacing the floor slab. When replacing the section of floor slab it is to be cut out 200mm from all external walls. The replacement section of slab is to be connected back into the existing slab using D10 starter bars epoxy grouted 150mm into the existing section at 600mm centres. New construction joints in the locations indicated on sketch SK03 are to be built into the new section of slab using MiTek Krack Mates. Refer to sketch SK04 for details for undertaking this work. The bottom plate of the internal stud walls are to be connected to the foundation using GIB HandiBracs as per the attached product specification.

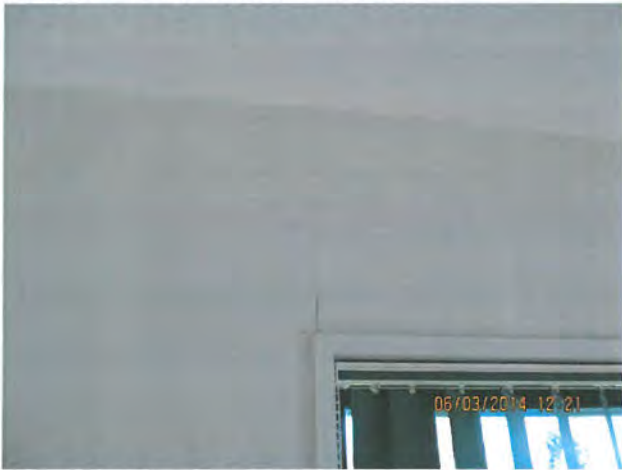
Internally there is little damage to the wall linings. Externally the mortar joints of the brick cladding is cracked on the Southern elevation.

Figure 5: Minor damage to wall linings

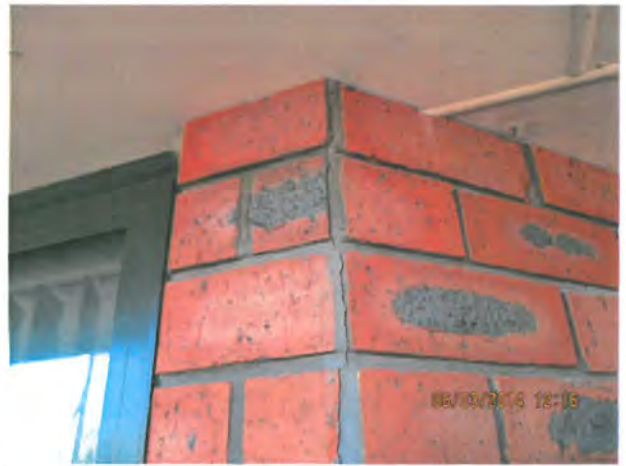
Figure 6: Crack in mortar joints of brick

The cracks in the mortar joints of the brick cladding by the Southern entrance door are to be ground out and repointed.

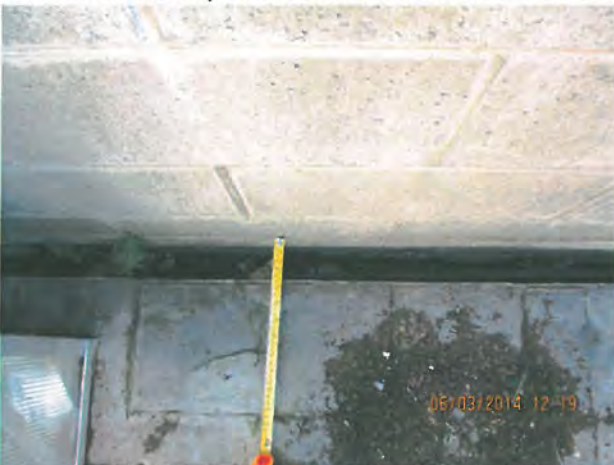
Externally there is evidence of land movement confirming the earthquake related movement in the dwelling. The concrete paving has pulled away from the neighbour's garage and also cracked in a number of areas on the Northern and Western elevations. On the Southern elevation there is cracking in the tarmac driveway and settlement in the area at the front of the garage.

Figure 6: 65mm gap between paving and garage

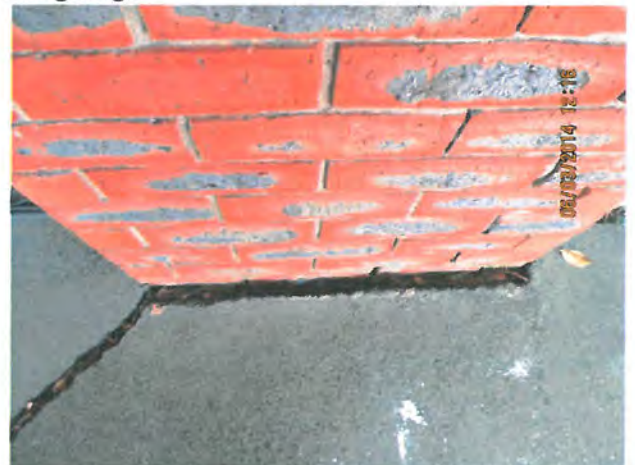
Figure 7: Movement by front entrance door

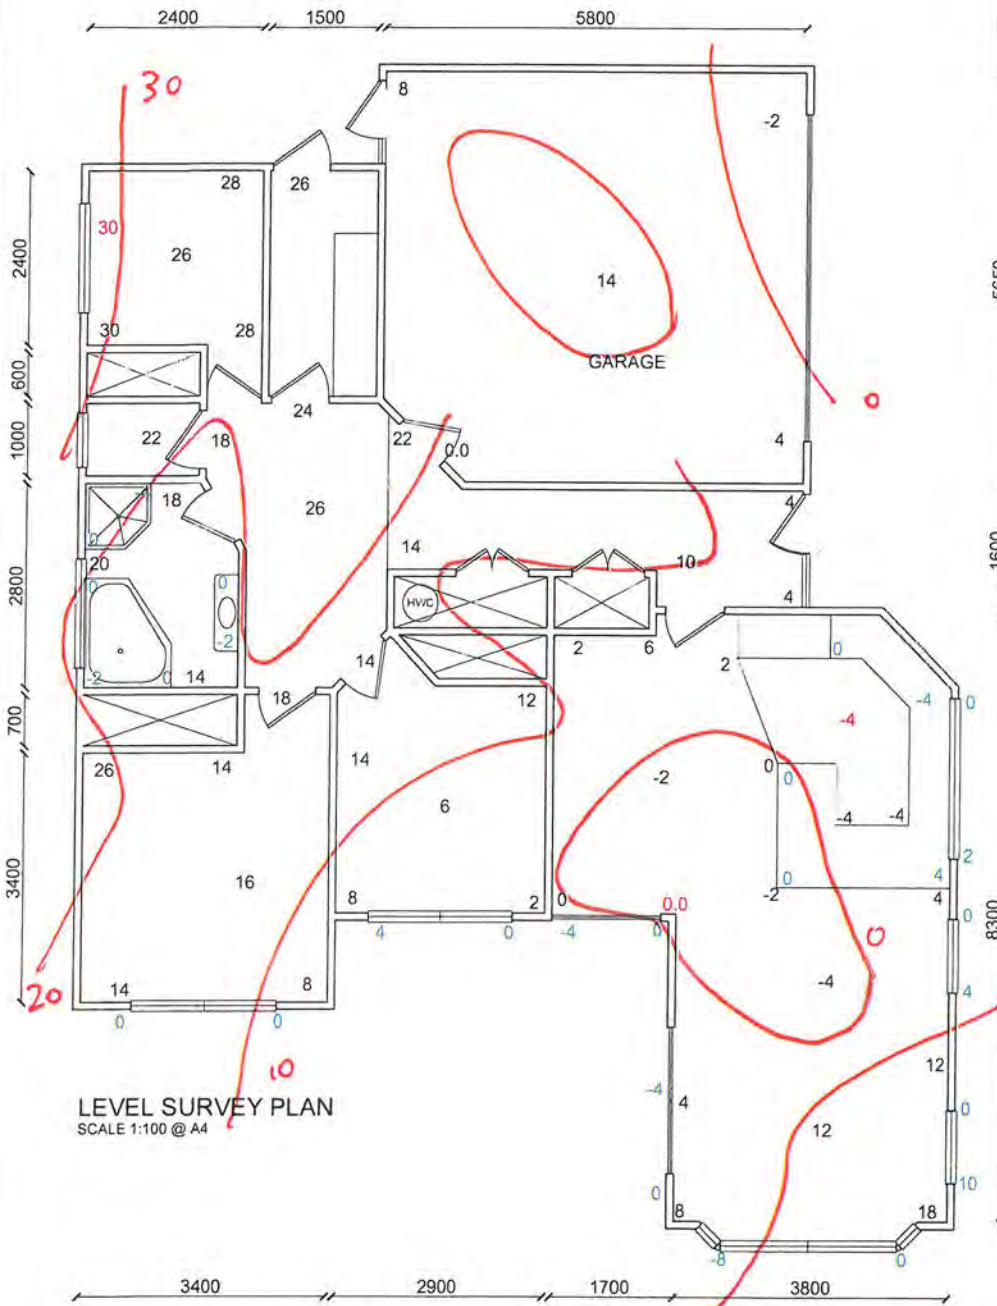
A structural assessment and level survey of the dwelling outlined above has been carried out. The levels recorded on site are shown on sketch SK01.

Levels recorded on site.

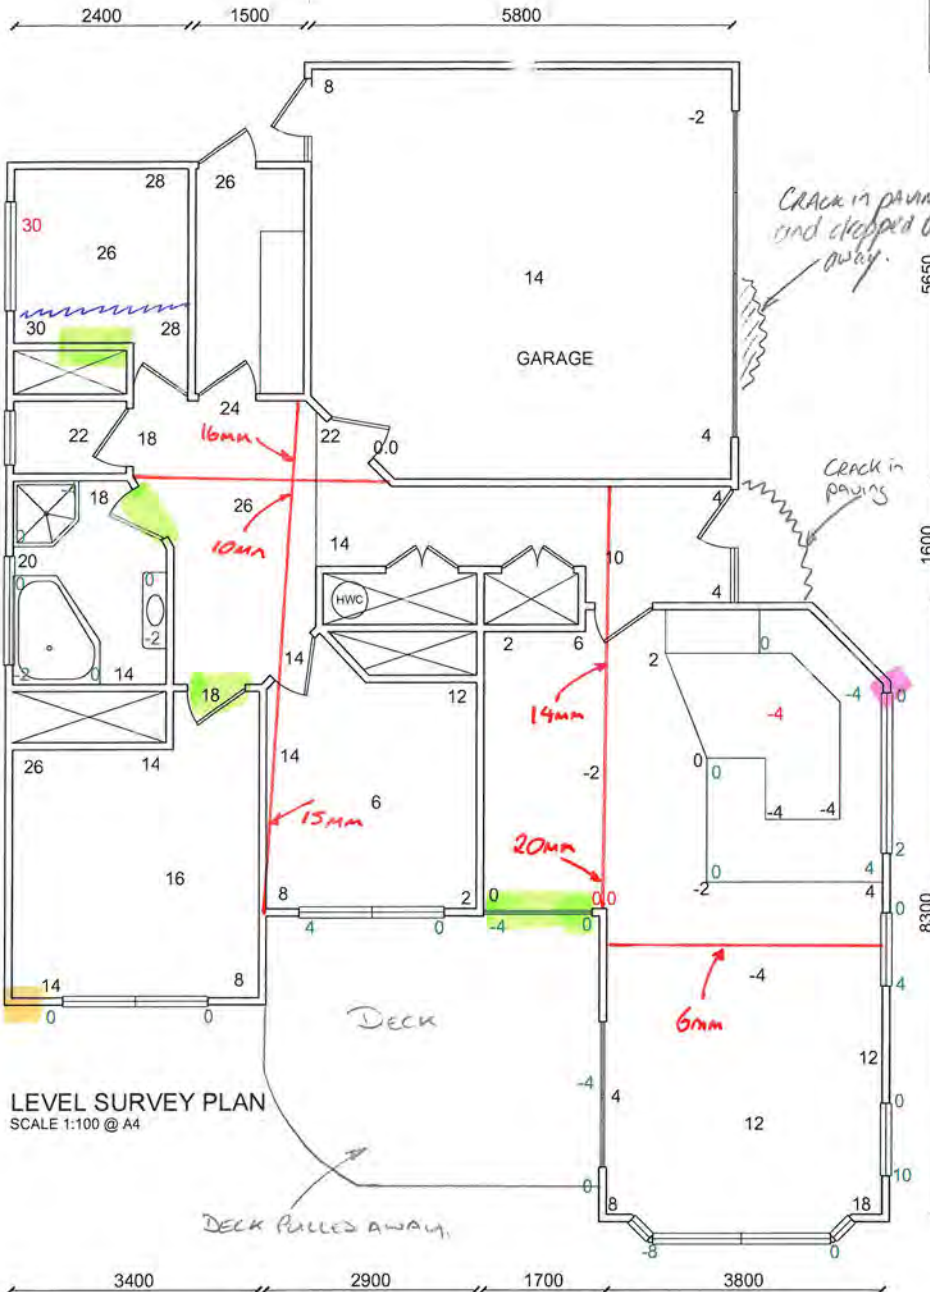
LEVEL SURVEY PLAN
SCALE 1:100 @ A4

mm Crack in SLAB.

Crack in MASONRY.

Crack in PERIMETER
FOUNDATION.
