# INSIGHT BUILDING INSPECTIONS

## RESIDENTIAL INSPECTION

1/126 Halswell Jct Rd  
Christchurch, Canterbury 8025

FEBRUARY 26, 2025

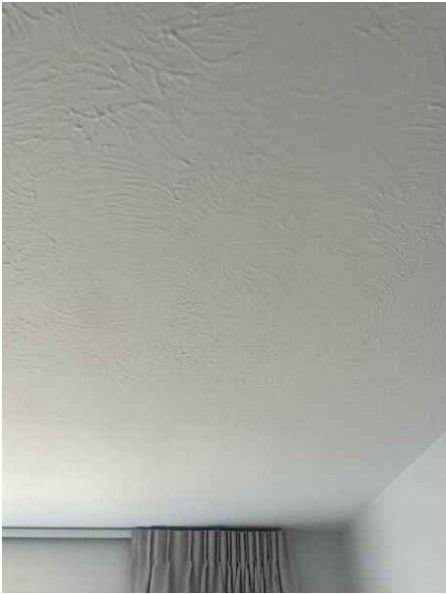
The texture on the ceiling throughout the dwelling may be the type that contains Asbestos, although this can only be determined by testing a sample.

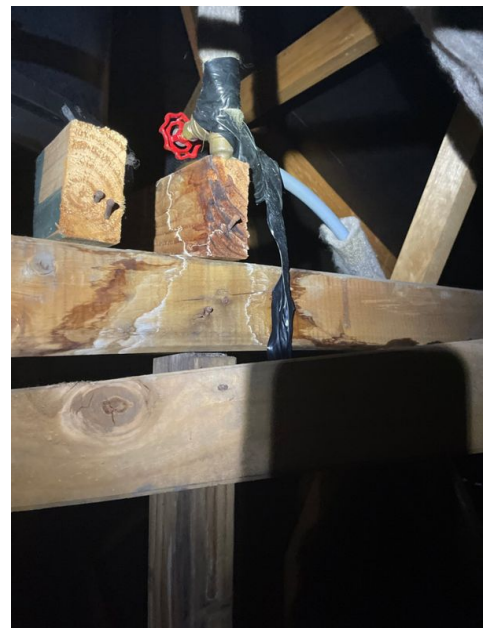
14.10.1 Evidence of Leaks

### LEAKING AT HEADER TANK

**UPDATE 25/03** - Ballcock and overflow to the header tank have been professionally repaired.

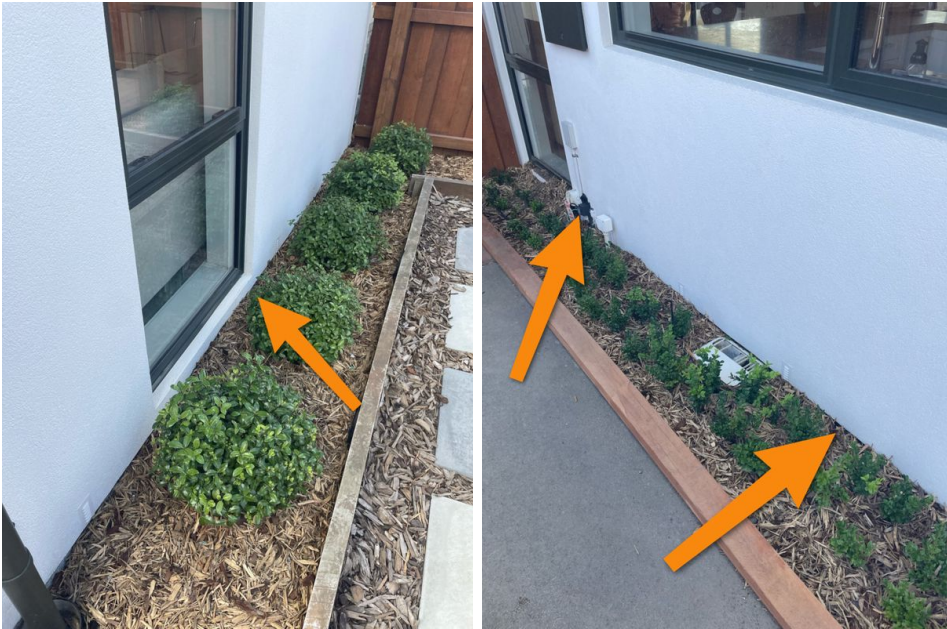
We recommend lowering the ground levels around the home as this can cause moisture damage to the cladding and possibly the internal framing. The condition of any concealed materials is unknown.

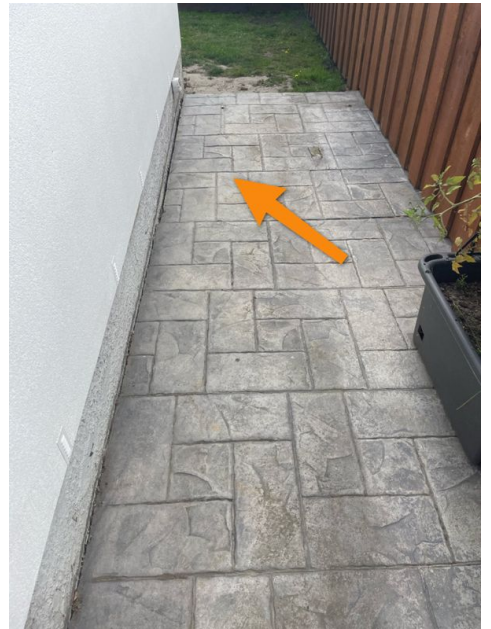
## 17.3.1 Path &amp; Patios

**SETTLEMENT OF PAVING**

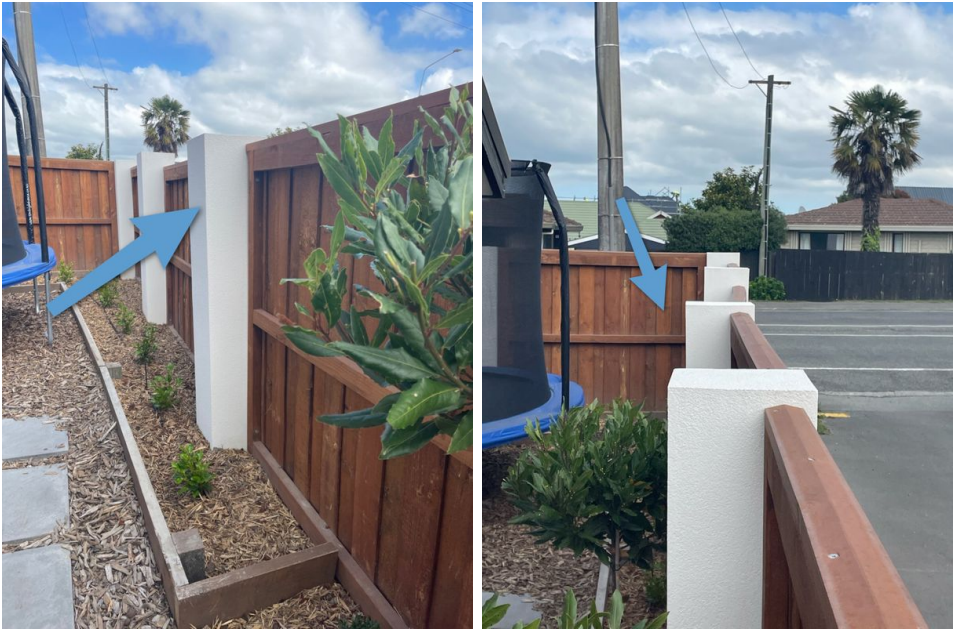
## 17.5.1 Fencing

**SUBSIDANCE TO PILLAR**

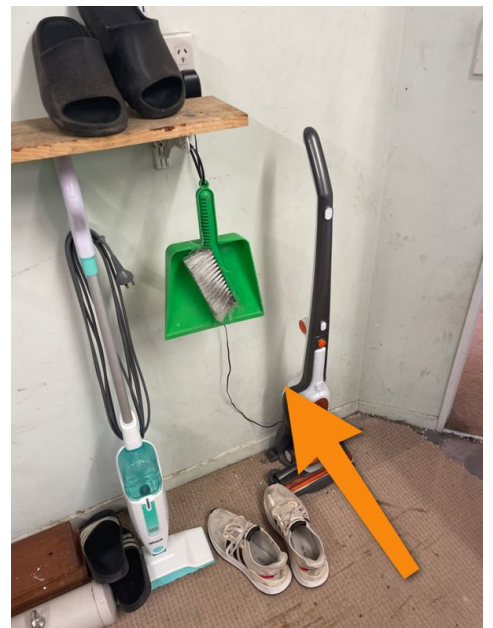
## 18.5.1 Walls

**GENERAL WEAR TO WALL LININGS**

The wall linings to the garage have general wear observed

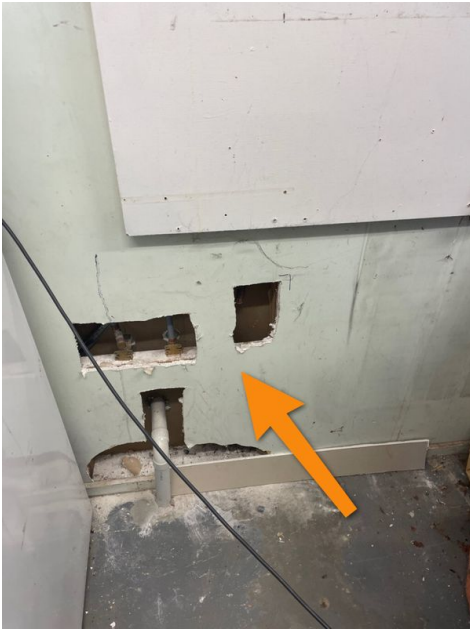
## 18.5.2 Walls

**UNFINISHED AREAS**

Unfinished areas of lining are present to the garage. This can be repaired if desired

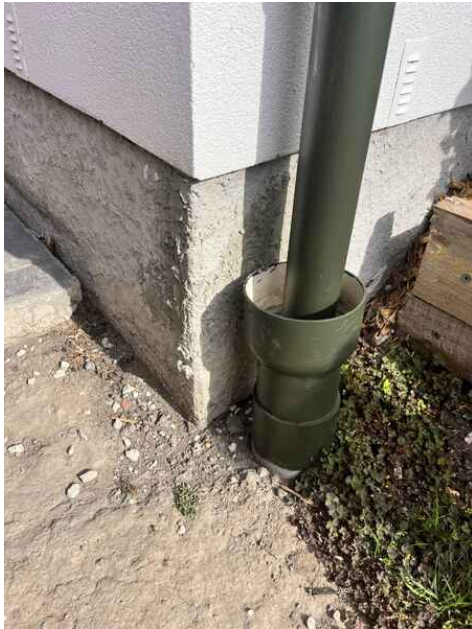
19.2.1 Foundation Type

CRACK TO CONCRETE FLOOR SLAB

There is cracking in the floor slab in the NW corner, likely caused by the Canterbury EQ sequence. Epoxy injection repair by a concrete repair specialist is recommended.

Update 04/03 - the crack has been repaired by the vendor

Repaired

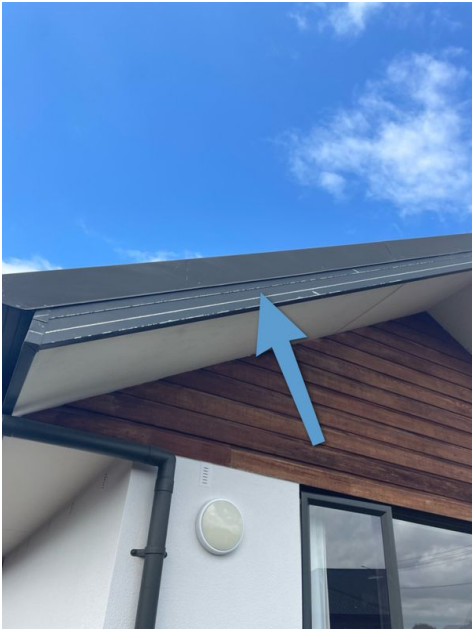
### 21.8.1 Fascias & Barge Boards

Maintenance Item
