Building and Timber Pest Inspection Report

Inspection Date: Wed, 19 Mar 2025

Property Address: 11 Somers St, Nudgee QLD 4014, Australia

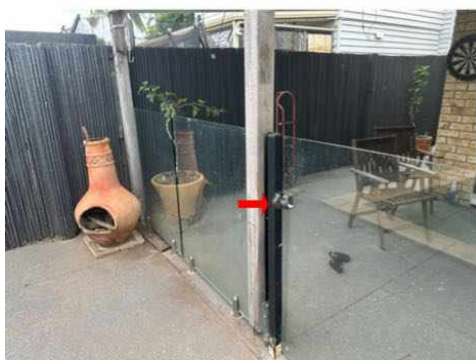
Finding 1.01

Building:	Main Building
Location:	Pool Area
Finding:	Pool fencing - Inspection required
Information:	It is suspected that areas of the pool fencing do not to comply with Australian Standards and do not appear to be safe. Assessment of the pool area is required.

Please note that this inspection does not cover pool fencing and other pool fittings and fixtures. It is highly advised that a specialist be appointed to inspect the pool and surrounding area and provide advice on rectification works that may be required.

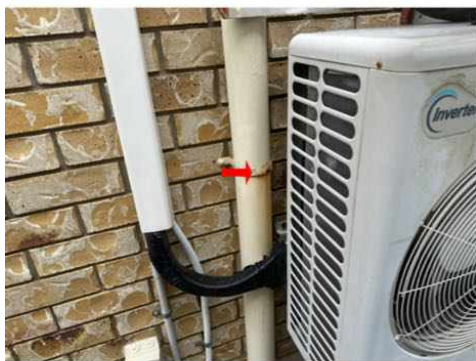
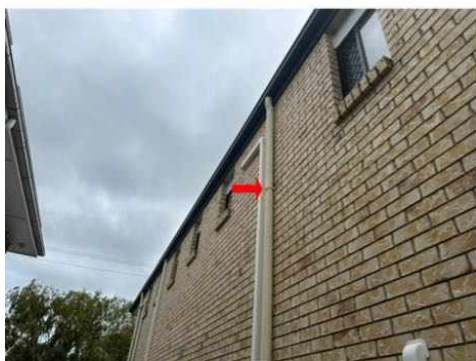
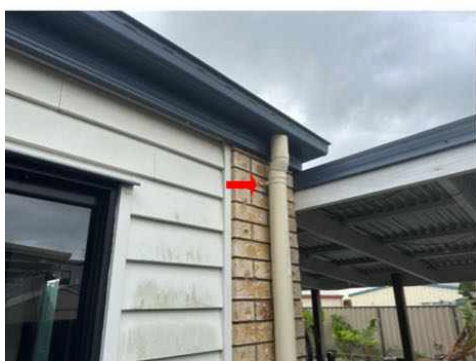
Building:	Main Building
Location:	All External Areas
Finding:	Down pipe clips - Rusted or corroded
Information:	This building element shows evidence of rusting and corrosion, which is likely to have developed as a result of inadequate coatings.

As surface rust provides no protection to the underlying iron, the deteriorating condition is likely to worsen if not addressed in the short-term future.

Where possible, the use of galvanized (treated) metals or aluminium coated metals aid in rust prevention, as does regular general maintenance. Rust formation can be controlled with coatings, such as paint, that isolate the iron from the environment.

Rusting and corrosion should be managed by ideally removing or limiting the affected surface from exposure to moisture. A registered builder may be appointed to replace any building elements that have been severely affected by rust or water damage.

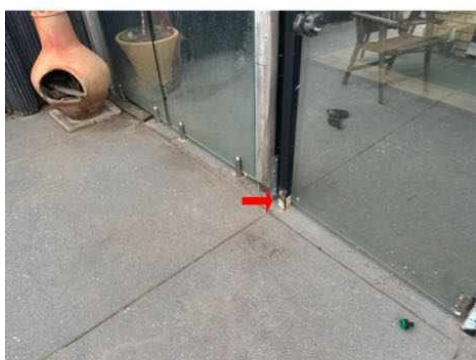
Finding 3.02

Building:	Main Building
Location:	Pool Area
Finding:	Pool fence post - Rusted or corroded
Information:	This fence post shows evidence of rusting and corrosion, which is likely to have developed as a result of excessive exposure to moisture and or inadequate coatings.

As surface rust provides no protection to the underlying iron, the deteriorating condition is likely to worsen if not addressed in the short-term future.

Where possible, the use of galvanized (treated) metals or aluminium coated metals aid in rust prevention, as does regular general maintenance. Rust formation can be controlled with coatings, such as paint, that isolate the iron from the environment.

Rusting and corrosion should be managed by ideally removing or limiting the affected surface from exposure to moisture. A registered builder may be appointed to replace any building elements that have been severely affected by rust or water damage.

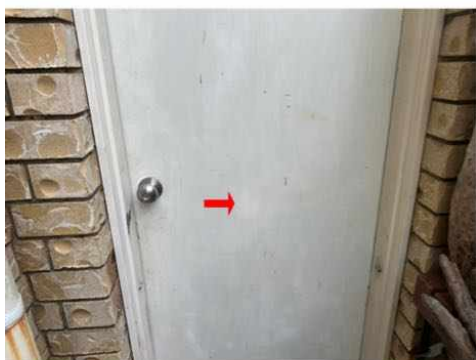
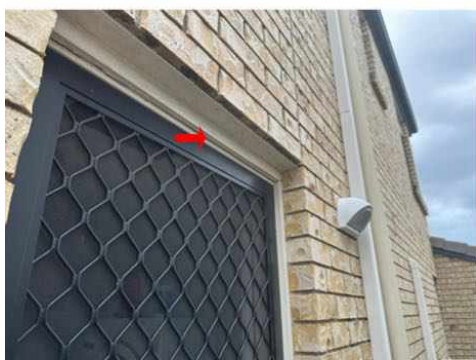
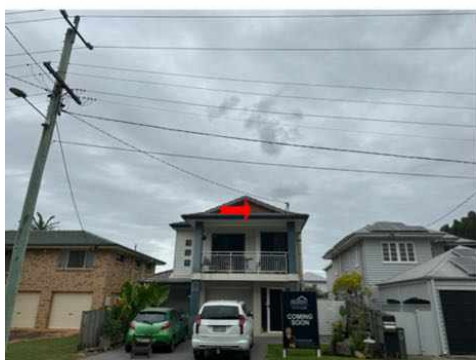
Building: Main Building
Location: All External Areas
Finding: External painting deteriorated
Information: Areas of external paintwork have been neglected and require attention to prepare and re-paint.

Whilst incomplete or missing paint finish is generally an appearance defect, it can also lead to the development of secondary building defects over time. Incomplete areas of paint finish expose the area to moisture, potentially accelerating the deterioration of underlying building materials.

Degraded paint finishes should be sanded back, filled, leveled and painted, as applicable. Where inadequate or missing paint protection has led to the deterioration of the associated building element, repair and/or replacement of this building element may be required.

A painting contractor should be appointed as soon as possible to perform necessary works to aid the appearance of the affected area and to ensure the area is protected against further deterioration. Alternatively, the homeowner following manufacturer instructions may perform these works.

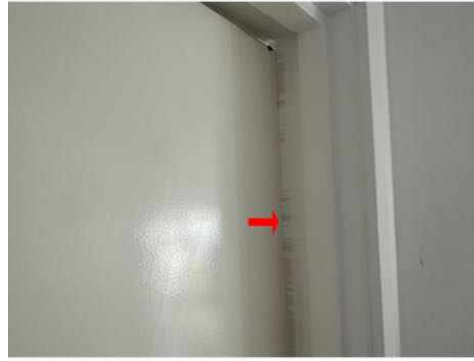
Finding 3.05

Building:	Main Building
Location:	All Internal Areas
Finding:	Doors - Binding/Jamming
Information:	Binding and/or jamming of several doors throughout the property were evident during standard operation. This defect inhibits the functionality of affected doors as well as creating potential for secondary defects to associated building elements, such as damage to the floor covering or door frame.

For minor causes, a qualified carpenter or general handyperson should be appointed to perform minor rectification works at client discretion.

Price to shave the/plane the door so that it opens and shuts freely in the Laundry	10%	60.00
Price to shave the/plane the door so that it opens and shuts freely in the Toilet upstairs	10%	60.00
Price to shave the/plane the door so that it opens and shuts freely in the Back bedroom	10%	60.00
Price to shave the/plane the door so that it opens and shuts freely in the Main bedroom doors	10%	100.00
Price to shave the/plane the door so that it opens and shuts freely in the Toilet downstairs	10%	60.00
Price above does not cover any unforeseen damages in the garage where the wood rot is. These would have to be quoted separately to the items above.		0.00
Before your job will start, we will require a 50% deposit and then the remainder of the balance to be paid when work is completed or as per invoice.		0.00

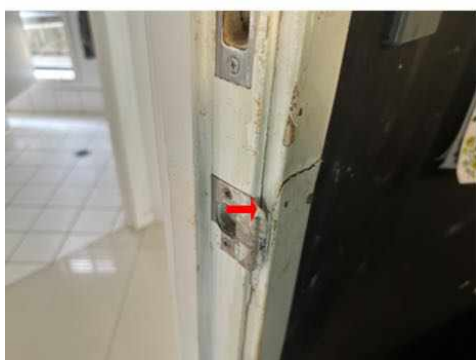
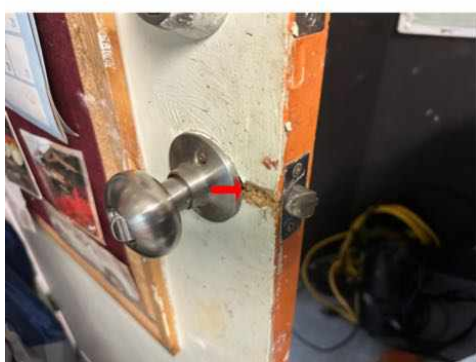
Finding: Door damage

Information: The door and door frame leading into the garage have suffered impact damage . A licensed carpenter should be engaged to replace both the door frame and door and make ready for painting.

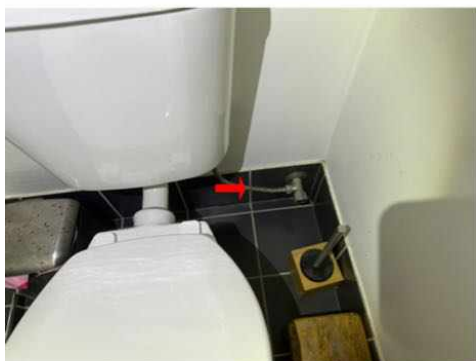
Finding 3.08

Location:	Toilet (WC)
Finding:	Flexi-pipe - Rusted
Information:	The Flexi-pipe in this area was found to have rust spots . These rust spots cause deterioration of the outer metal sleeve of the plumbing fitting which may lead to failure and the massive loss of fluid may result. A licensed plumber should be engaged ASAP to replace this pipe to avoid secondary damage from occurring.

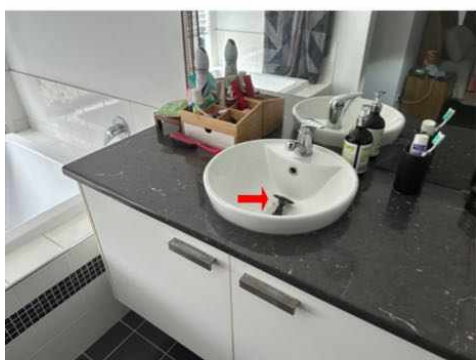
Finding 3.09

Building:	Main Building
Location:	Bathroom
Finding:	Vanity Waste plugs
Information:	The vanity basin was fitted with pop-up waste which appeared to be faulty to some degree. A licensed plumber will need to be engaged to service these wastes to ensure their functionality.

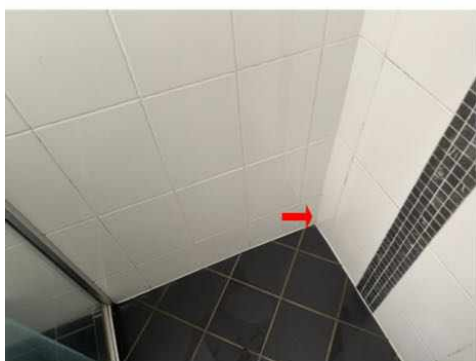
Finding 3.10

Building:	Main Building
Location:	Ensuite
Finding:	Sealant and grouting - Missing or damaged
Information:	It was noted on inspection that sealant or grout is degraded to the tiled shower alcove

Different materials and floor areas move at different rates, generally causing cracking to grout or sealant at this point. A flexible sealant is required to allow for expected expansion and contraction, while keeping the joint water tight and protective of all associated building materials.

Flexible and mould resistant materials should be applied to affected areas to prevent any subsequent water damage that is likely to occur. Regular maintenance and replacement of damage or missing or damaged sealant and grout is highly recommended to the wet areas, as this is a regular wear and tear defect. Sealant and grouting in areas that come into regular contact with water should be maintained for the long term care of your property.

A sealant specialist or tiling contractor should be appointed to complete these works as soon as possible

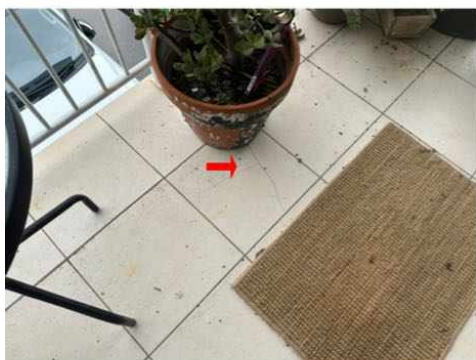
Finding: Floor tiles - Cracked

Information: Cracking in the floor tiles was evident in this area at the time of inspection. It is suspected that this cracking has occurred as a result of the floor being uneven and lacking a solid or suitable foundation for the tiles to be laid on. Settlement in the floor foundations may also have caused movement and resulted in the cracking of tiles in this area.

Cracked tiles throughout the household detract from the overall appearance of the affected areas, as well as creating potential for water penetration to adjoining building elements. If left unmanaged, water damage may occur as a result of constant water penetration over a prolonged period of time.

While not considered a matter of urgency, replacement of cracked floor tiles is advised as a solution. A tiling contractor or general handyperson may be appointed to perform these works at client discretion. Where cracks become more numerous, consultation with a registered builder specialising in re-stumping may be required.

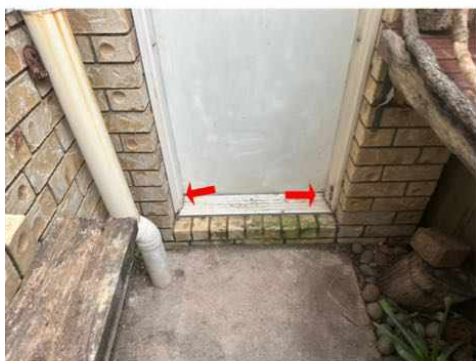
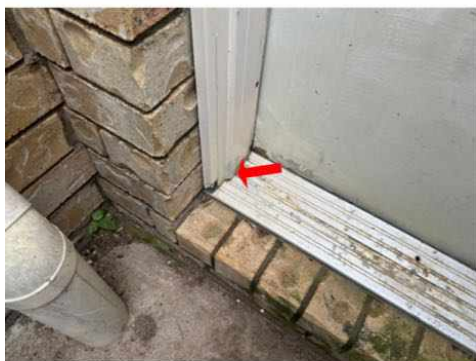
Building:	Main Building
Location:	Garage rear entry
Finding:	Wood rot
Information:	This building element shows evidence of wood rot. Wood rot, also known as Fungal Decay, occurs when timbers and other cellulose building materials are exposed to damp conditions on an ongoing basis. This could be the result of exposure to weathering over a prolonged period of time, or the attraction of excessive moisture from other abutting building materials. Contributing factors also include poor air ventilation in the area.

Wood rot is often associated with general damp problems and is evidenced by a 'musty' smell or mould and mildew occurring on surfaces. If left unmanaged, damp conditions can lead to further health problems and the decay of timbers will continue.

Early intervention and regular maintenance, particularly of exterior timbers, will prolong the useful life of these building elements. Prior to any works being performed, the cause of the moisture that has created the visible wood rot should be identified and addressed in a suitable manner. Replacement of affected timbers may then be a

necessary step in protecting surrounding building elements from such deterioration.

A qualified plumber may be appointed to assess the cause of excessive moisture and to provide advice on any remedial works as required. A qualified carpenter or registered builder may also be required to replace affected building materials.

Description	GST	Amount AUD
Job #11 Sumers St, Nudgee.		0.00
Price is to repair the wood rot in the garage at the rear door. This includes the following - Removal of some skirting and door jamb where required - Supply and install 2m of 66x18 skirting board - Supply and install of door jambs using 2100mm x 70mm timber, 2100mm x 140mm timber, 2100mm x 20mm quad timber, 2100mm x 42mm architrave timber.	10%	440.00
Price is to supply and install new external door in the garage at the rear doorway. Price includes new door handle and paint in white or unless specified by owner.	10%	1,190.00
Price is to supply and install new internal door leading into the garage. Door handle to be reused and door to be painted in colour match paint to suit other doors.	10%	690.00
Price is to supply and install new internal door to the upstairs bathroom. Door handle to be reused and door to be painted in colour match paint to suit other doors.	10%	690.00

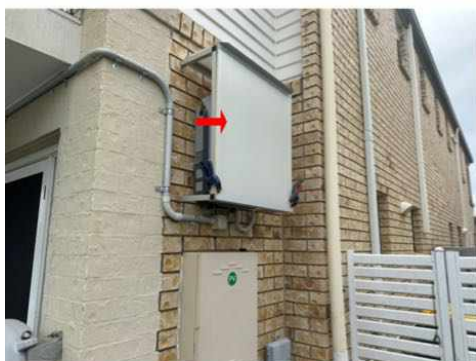
Building: Main Building
 Location: Exterior walls - right side
 Finding: Inverter cover
 Information: The inverter cover is temporarily secured by hand clamps.

It is recommended that a general handyman is engaged to secure the cover to the frame.
