Building and Timber Pest Inspection Report

Inspection Date: Mon, 30 Jun 2025

Property Address: 125 Kirby Rd, Aspley QLD 4034, Australia

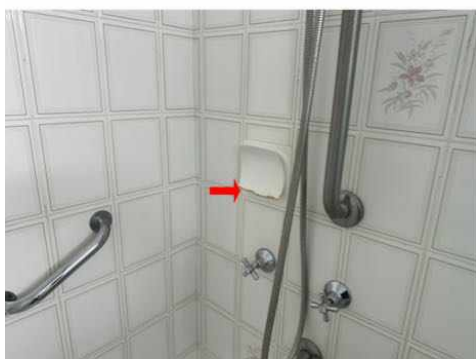
Finding 3.01

Building:	Main Building
Location:	Bathroom
Finding:	Soap Dish
Information:	The Soap dish in the shower cubical has been damaged . A licensed tiler should be engaged to replace this soap dish asap.

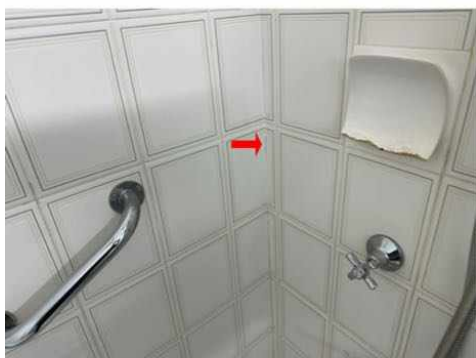
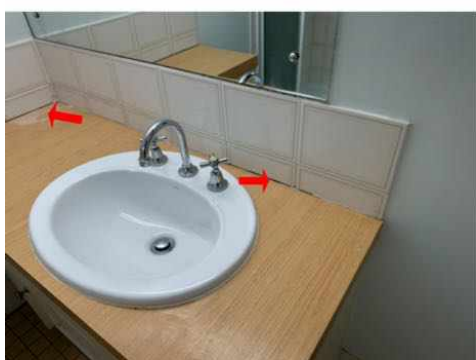
Finding 3.02

Building:	Main Building
Location:	Bathroom
Finding:	Sealant and grouting - Missing or damaged
Information:	It was noted on inspection that sealant or grout is degraded to the tiled shower alcove and or other areas of the bathroom.

Different materials and floor areas move at different rates, generally causing cracking to grout or sealant at this point. A flexible sealant is required to allow for expected expansion and contraction, while keeping the joint water tight and protective of all associated building materials.

Flexible and mould resistant materials should be applied to affected areas to prevent

any subsequent water damage that is likely to occur. Regular maintenance and replacement of damage or missing or damaged sealant and grout is highly recommended to the wet areas, as this is a regular wear and tear defect. Sealant and grouting in areas that come into regular contact with water should be maintained for the long term care of your property.

A sealant specialist or tiling contractor should be appointed to complete these works as soon as possible

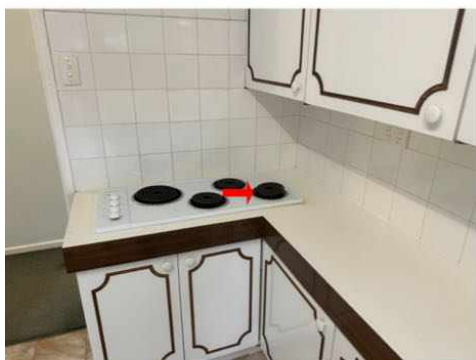
Finding 3.03

Building: Main Building

Location: Kitchen

Finding: Cook Top - Faulty

Information: A cook top element was found to be faulty at the time of inspection. A licensed appliance technician should be engaged to service the unit.

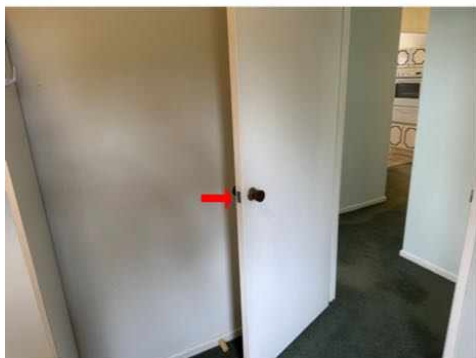
Finding 3.04

Building: Main Building

Location: Bedroom

Finding: Door - Broken handle

Information: The door handle in this area was found to be broken at the time of inspection. Breakage occurs generally when the building materials have aged and decayed, but may be indicative of impact damage (accidental or deliberate).

Repair and/or replacement of the broken door handle is advised to improve the operational state of the associated door.

A qualified carpenter or general handyman should be appointed to repair/replace the door handle at the client's discretion.

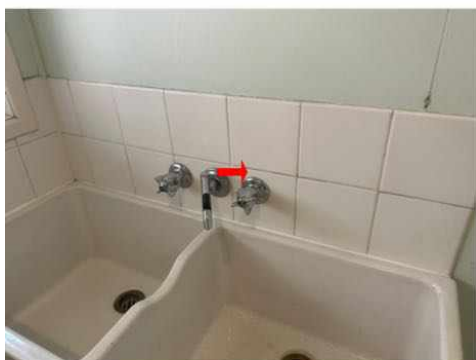
Finding 3.05

Building: Main Building

Location: Laundry

Finding: Tiles - Cracked or damaged

Information: Cracking was evident to the tiling in this area at the time of inspection. While the cracking appears to be minor, this area is frequently exposed to water, allowing potential for water penetration into adjoining sections of walls or flooring.

If left unmanaged, water penetration to these areas may lead to subsequent water damage, which is likely necessitate repair work to affected building elements.

A tiling contractor should be appointed to ensure that no further water damage occurs. The re-application of silicone and grouting throughout remaining tile work is also advised, to further protect the area against water penetration.

Where water penetration has led to water damage, appointment of a relevant tradesperson may be required to repair damaged building elements.

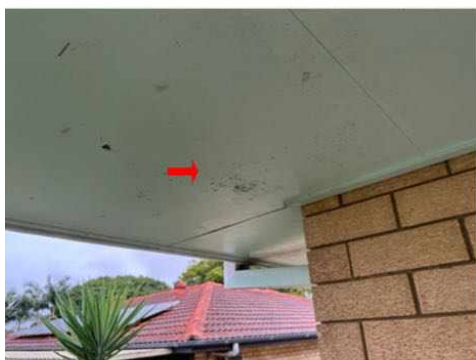
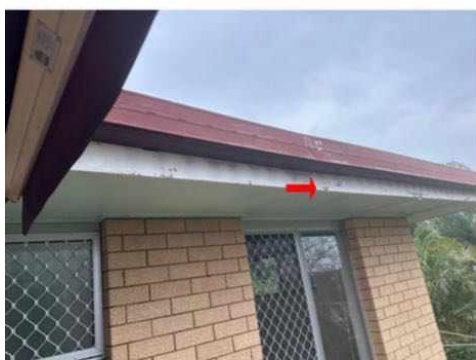
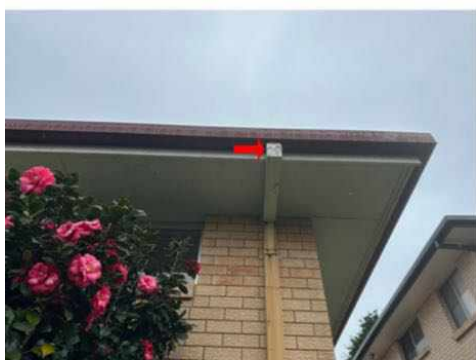
Finding 3.06

Building:	Main Building
Location:	All External Areas
Finding:	External painting deteriorated
Information:	External areas of paintwork including but not limited to fascias, guttering, veranda and other external fitments have been neglected and require attention to prepare and re-paint.

Whilst incomplete or missing paint finish is generally an appearance defect, it can also lead to the development of secondary building defects over time. Incomplete areas of paint finish expose the area to moisture, potentially accelerating the deterioration of underlying building materials.

Degraded paint finishes should be sanded back, filled, leveled and painted, as applicable. Where inadequate or missing paint protection has led to the deterioration of the associated building element, repair and/or replacement of this building element may be required.

A painting contractor should be appointed as soon as possible to perform necessary works to aid the appearance of the affected area and to ensure the area is protected against further deterioration. Alternatively, the homeowner following manufacturer instructions may perform these works.

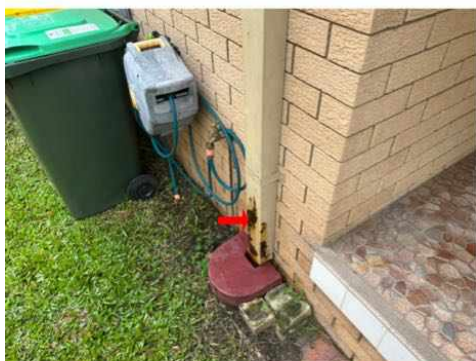
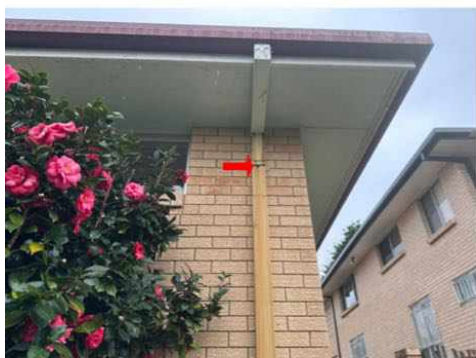
Finding 3.07

Building:	Main Building
Location:	All External Areas
Finding:	Roof plumbing - Rusted or corroded
Information:	The roof plumbing has areas of rust and corrosion. It is suspected that this has been caused by blockages, resulting in pooling or standing water, that have prematurely rusted elements of the roof plumbing.

Rusted roof plumbing will generally develop holes and leaks that can affect other building elements with poor drainage of storm water. Poorly drained roof areas will also lead to damp conditions surrounding the base perimeter of the building which, if left unmanaged, can lead to a range of secondary building defects.

Repair and/or replacement of rusted roof plumbing is highly required in order to reinstate the roof drainage system to a fully operational level. To further maintain these areas, gutters should be cleaned frequently, allowing the avoidance of any partial blockages.

A licensed plumber or specialist roof restoration company should be appointed to undertake these works. It is advised that such works be completed as soon as possible to prevent any further damage and deterioration.

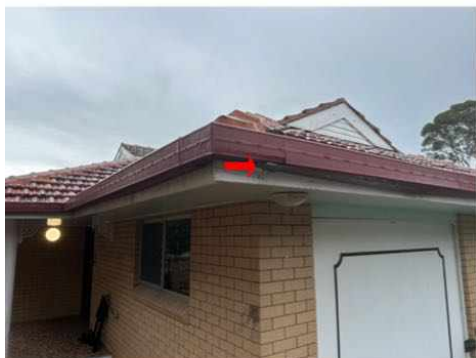
Finding 3.08

Building:	Main Building
Location:	Front Elevation
Finding:	Gutter - Poorly repaired
Information:	The guttering in this area has been poorly repaired and was leaking at the time of inspection. A licensed plumber should be engaged to carry out necessary repairs or replacement of affected areas.

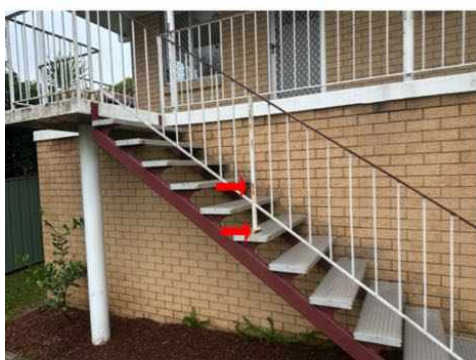
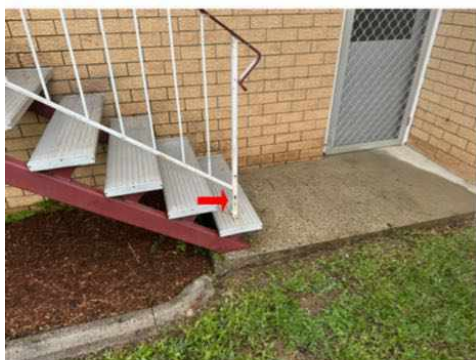
Finding 3.09

Building:	Main Building
Location:	Rear Elevation
Finding:	Balustrade- Rusted or corroded
Information:	This building element shows evidence of rusting and corrosion, which is likely to have developed as a result of excessive exposure to moisture and or inadequate coatings.

As surface rust provides no protection to the underlying iron, the deteriorating condition is likely to worsen if not addressed in the short-term future.

Where possible, the use of galvanized (treated) metals or aluminium coated metals aid in rust prevention, as does regular general maintenance. Rust formation can be controlled with coatings, such as paint, that isolate the iron from the environment.

Rusting and corrosion should be managed by ideally removing or limiting the affected surface from exposure to moisture. A registered builder may be appointed to replace any building elements that have been severely affected by rust or water damage.

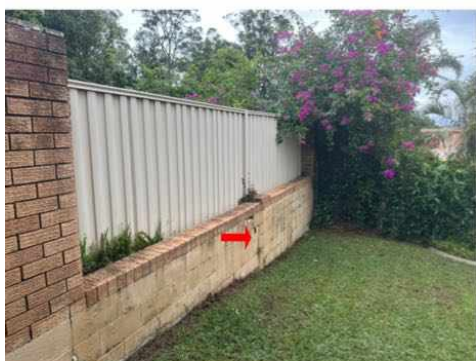
Finding 3.10

Building: Main Building

Location: Yard - Back

Finding: Retaining wall - Defective

Information: The retaining wall in this area was found to be defective at the time of inspection. Generally, defective retaining walls are caused by poor original design or material use. However, deteriorated retaining walls may also be a result of substandard construction, poor site drainage or unmanaged stormwater flows.

A landscaper or retaining wall installer may be appointed to repair or replace the wall, at the discretion of the client.

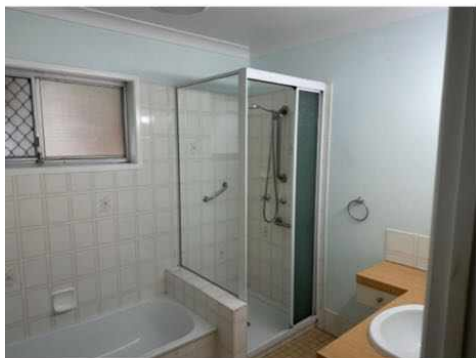
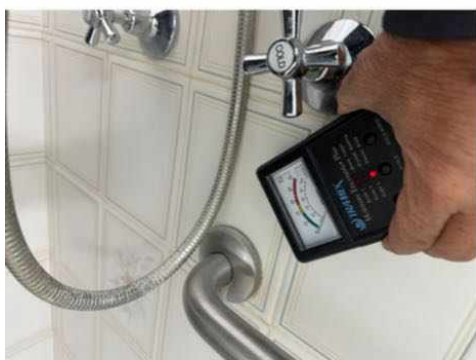
Building: Main Building
Location: Bathroom
Finding: Additional Photos
Information: Additional photos are provided for your general reference. No moisture detected.

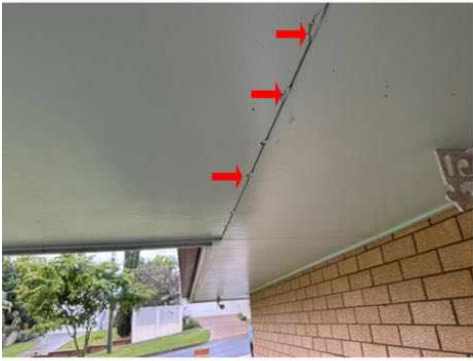
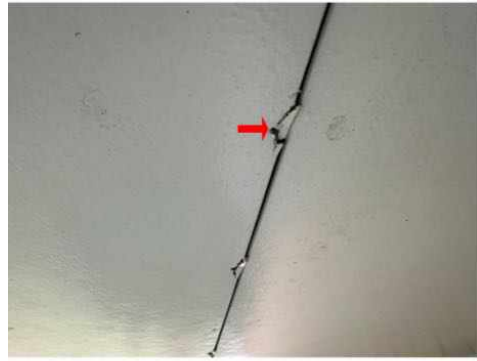
Building:	Main Building
Location:	Eaves
Finding:	Asbestos - Suspected ACM Identified on Site
Information:	Reporting on Asbestos is outside the Scope of this Report. This suspected defect is highlighted as a caution only. We suspect, based on our experience in the building industry, that there is a higher risk of the identified building element containing asbestos.

As Asbestos Reporting is outside the scope of this report, we advise that you consider a separate Asbestos Inspection and Condition Audit, which can include the taking of samples for definitive confirmation of the presence of Asbestos.

In the interim, the client is advised to act with caution, especially when considering any damage to building materials general wear and tear renovations extensions demolition and general maintenance activities due to the suspected presence of Asbestos.
