Visual Building Inspection Report

15 Glenhaven St, Kedron

31/03/2025.

10149 b

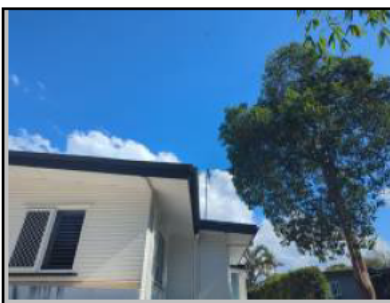
All elevations:

Appear to be in serviceable condition. Water staining was noted to sections of the gutter and fascia. Recommended to monitor when raining. Leaves and debris are present in gutters. These should be cleared.

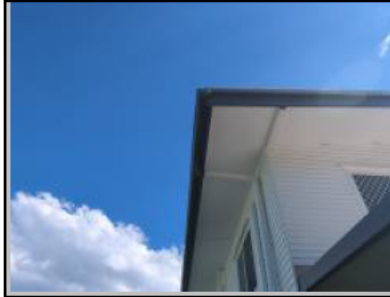
All elevations:

The eaves are lined with asbestos cement sheeting. The overall condition of the eaves lining is good.

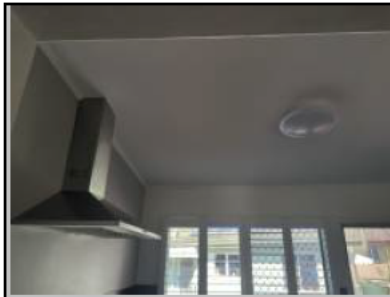
Various areas.

The condition of the ceilings is generally fair. General wear and tear is noted. Evidence of current water penetration through the ceiling in bedroom two and the kitchen. See notes in roofing section.

A licensed roofing contractor should be called to make a further evaluation and repairs or rectification as needed.

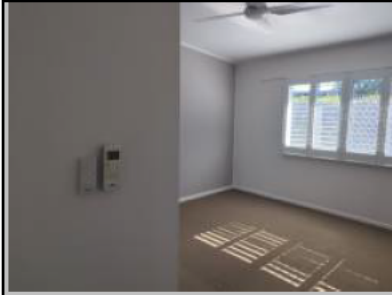
Location/area	Various areas.

Internal Walls Condition:	
The condition of the walls is generally fair. General wear and tear is noted. Minor cracking is evident to wall linings. Periodic maintenance may be required.

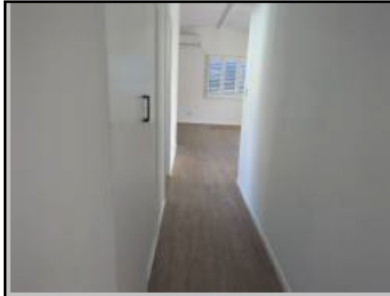
Throughout.

Floors are concealed by floor coverings, The condition of the floors is generally fair. Evidence of subsidence/ floor not being level was noted. This is considered a serviceability defect. Floor of building/house is uneven in parts, this can be a result of different factors; bearers have bows between stumps, stumps have moved/dropped in height, type of soil to property and wet or drought condition suffered to soil. This is consistent with age and type of construction and periodic maintenance may be required to support/re level floor structure, and allow smooth operation of door and windows.

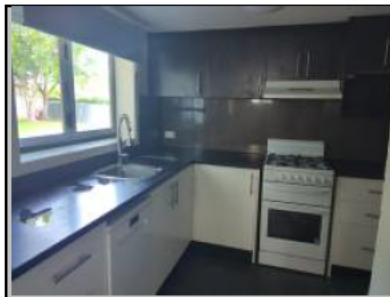
The condition of the fixtures is generally fair. General wear and tear is noted. The laminate is lifting and/or damaged in some areas.

Maintain all sealants and grouting to prevent moisture penetration and damage.

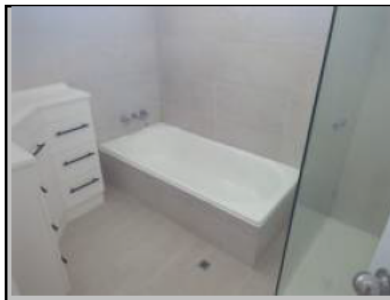
The condition of the fixtures is generally fair. General wear and tear is noted.

Shower and Bath appears to be in a serviceable condition. Staining noted to grouting and silicone sealants, clean, re-grout and replace sealants as required.

Maintain all sealants and grouting to prevent moisture penetration and damage.

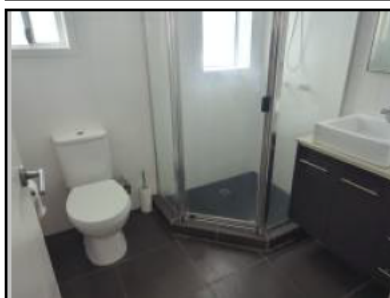
The condition of the fixtures is generally fair. General wear and tear is noted.

Shower appears to be in a serviceable condition. Staining noted to grouting and silicone sealants, clean, re-grout and replace sealants as required.

The toilet appears to be in working order. Dual flush. The Flush button to toilet is faulty and requires repair or replacement.

Maintain all sealants and grouting to prevent moisture penetration and damage.

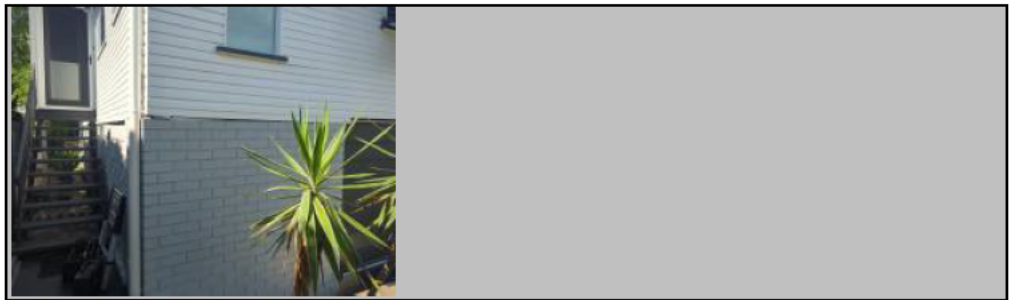
cracking is evident to sections of exterior wall. Visible cracking is considered to be a serviceability defect. Serviceability cracks noted to areas of external walls indicates that settlement/movement to structure has occurred. This is possibly due to climatic conditions suffered by foundation soils, downpipe leaks, mature trees close to building or poor surface drainage. The area(s) where cracking was noted is listed below. Recommend to seal / fill cracks. Monitoring for changes is required, any significant changes should be referred to a suitable and experienced structural engineer.

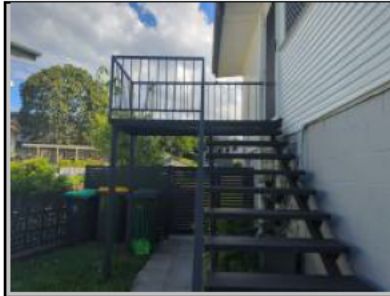
The stairs are constructed primarily from timber and steel. The overall condition of the stairs is fair. The handrails and balustrades do not appear to comply with the current BCA Standards for height and spacing. Although this report does not generally comment on items of compliance, this issue may become a safety issue and therefore was included in this report. Recommend you further investigate this matter and upgrade if necessary. Rust scale to stair supports/stringers and balustrade, maintenance required. Minor wood decay is noted.

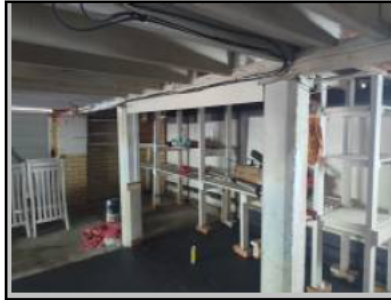
The floor framing and subfloor area appears to be generally sound, typical and consistent compared with buildings of similar age and construction. The building is constructed on a concrete slab. The building is constructed on concrete stumps. The building is constructed on Combination Brick Base and Piers. Floor of building/house is uneven in parts, this can be a result of different factors; bearers have bows between stumps, stumps have moved/dropped in height, type of soil to property and wet or drought condition suffered to soil. This is consistent with age and type of construction and periodic maintenance may be required to support/level floor structure, and allow smooth operation of door and windows. Packers have been used under bearers, these packers have possibly been installed due to subsidence in stumps or in relation to leveling, if these packers come loose they may cause floor to 'drop'. Some stumps have dropped and presently not supporting building, these stumps should have packers installed or replace stumps. Some stumps are presently not plumb or supporting the structure, these stumps should be packed or straightened, if this in not achievable replacement is required.

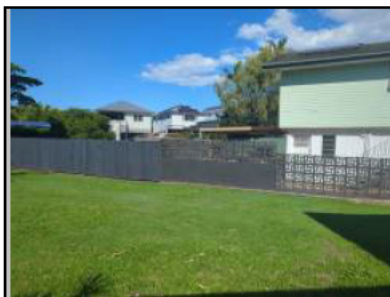
Dividing fence section:

The fences are constructed from a combination of timber, brick and metal. The fences are generally in fair condition but some repairs or maintenance is required. Minor wet rot or defects were noted to the wooden fences and minor repairs maybe needed.

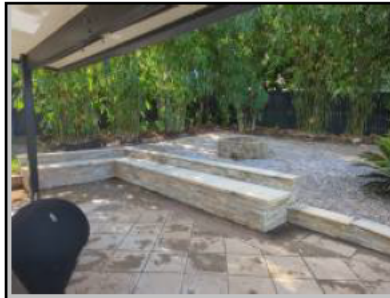
Various Elevations.

The timber retaining walls show normal deterioration and should be monitored. The masonry retaining walls show normal deterioration, cracks etc, and should be monitored for any movement.

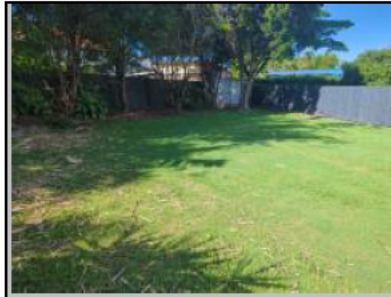
Due to inadequate drainage, ground water is ponding or flowing within the subfloor area. Inadequate site drainage can create unstable foundations that may have an adverse structural effect over time. Rectification is required. Drains should be installed to divert seepage and surface runoff water away from the house. The drains should be connected to the existing stormwater drainage system. Please contact a Licensed Landscaper or Builder for further information. External soil levels appear to have shrunk/moved. This appears to be consistent with soils suffering from climatic conditions such as drought. Services to building eg, downpipe connections at ground level, inspection points to both sewer/septic and stormwater pipes, conduits for electrical or phone services may require on going maintenance.
