Visual Pest Inspection Report

15 Glenhaven St, Kedron

31/03/2025.

VISUAL TIMBER PEST INSPECTION REPORT as per AS4349.3-2010

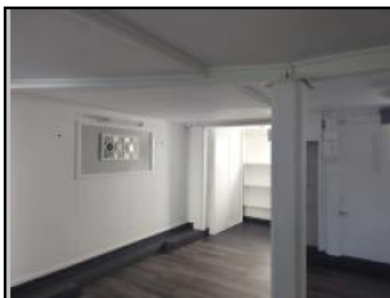
Fungal Decay Caused by Wood Decay Fungi found

Yes - Fungal Decay (wood rot) was noted to the following timbers/areas.

Visible timber damage appears minor to moderate. Refer to the definitions section of this report - Section 1.6 - Timber Damage.

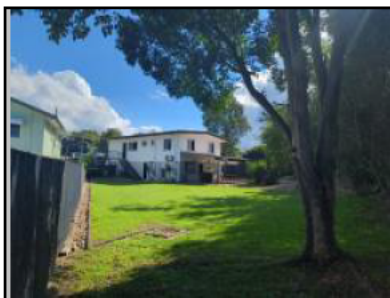
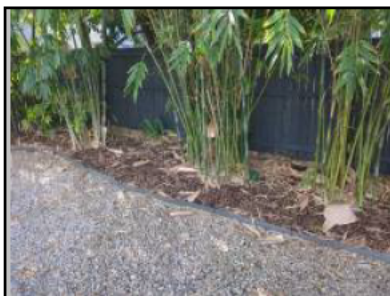
Fungal Decay Caused by Wood Decay Fungi found

Yes - Fungal Decay (wood rot) was noted to the following timbers/areas.

Affected external timbers

Steps/stair timbers: Sleepers or timber landscaping materials:

Visible timber damage appears minor to moderate. Refer to the definitions section of this report - Section 1.6 - Timber Damage.

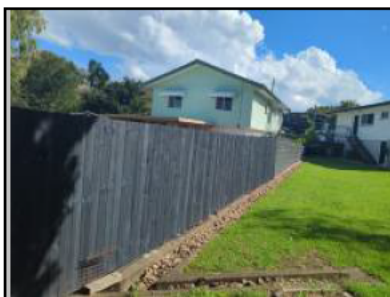
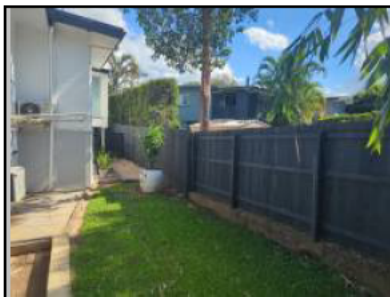
Wood decay damage found

Yes - Wood decay damage was noted to the following timbers/areas.

Affected fence timbers

Various fencing timbers:

Visible timber damage appears minor to moderate. Refer to the definitions section of this report - Section 1.6 - Timber Damage.
