# Earthquake Claims and Insurance Information

Property Address: 2/85 Trafalgar St, St Albans

**Information request – CLM/2010/086160 - 2/85 Trafalgar Street, Saint Albans, Christchurch 8014**

# Geotechnical Investigation Report Units 1 and 2, 85 Trafalgar Street, St. Albans

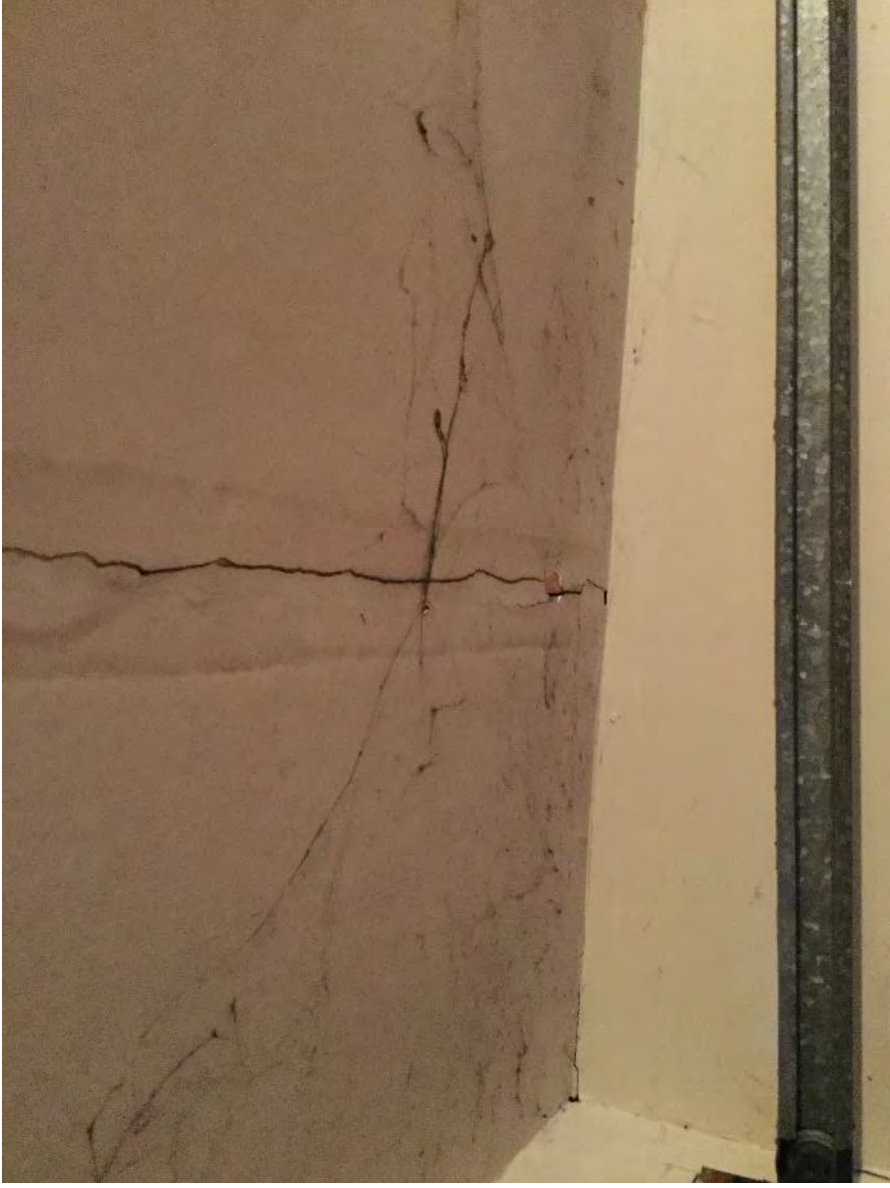
Garage- Pre Kaikoura event damage

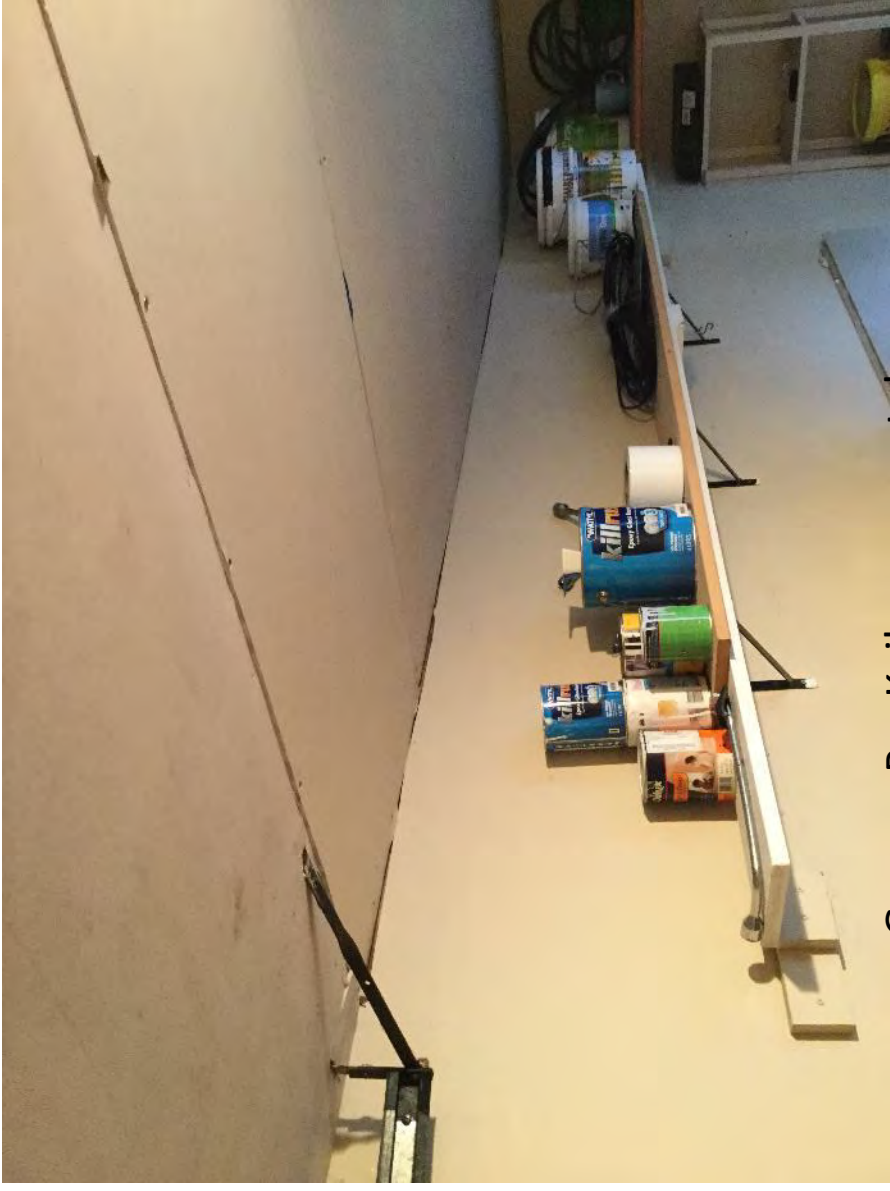
Garage- Pre Kaikoura event damage

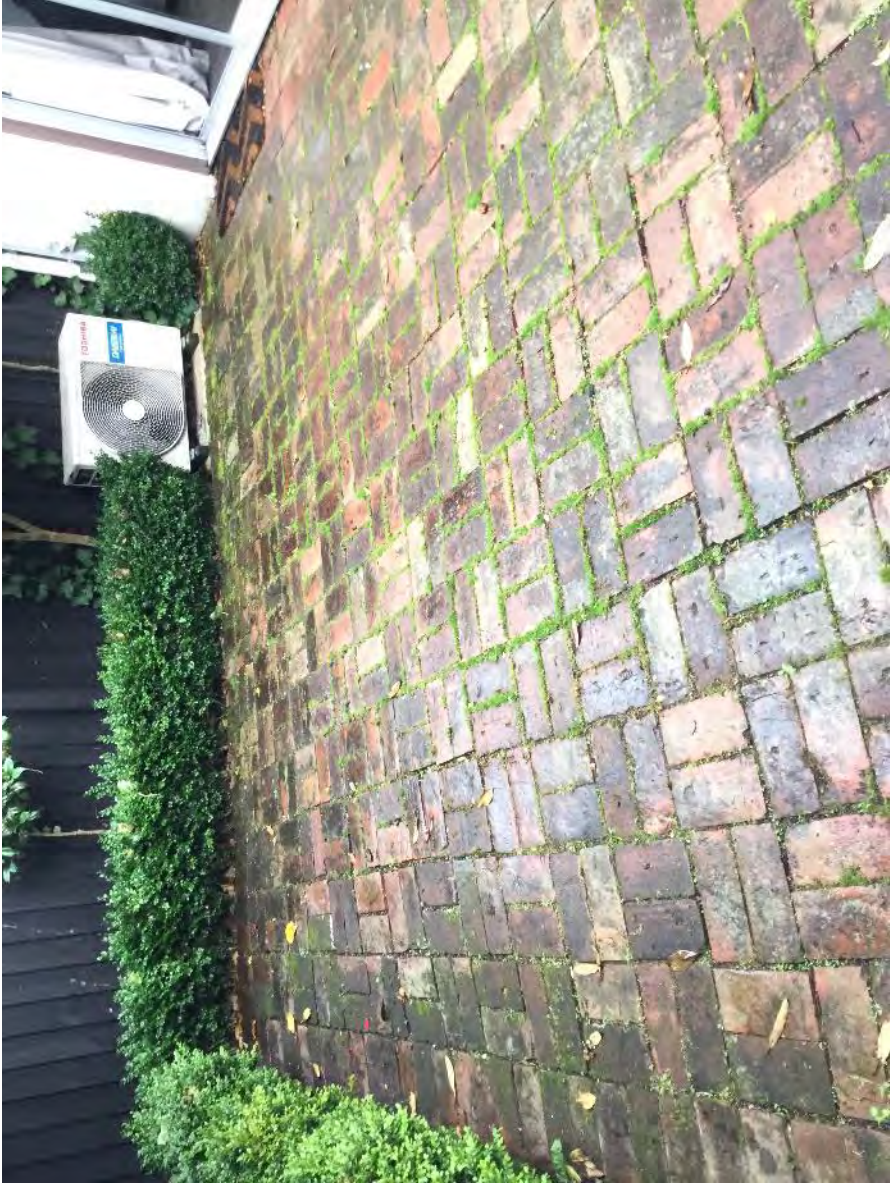
No damage to paved area

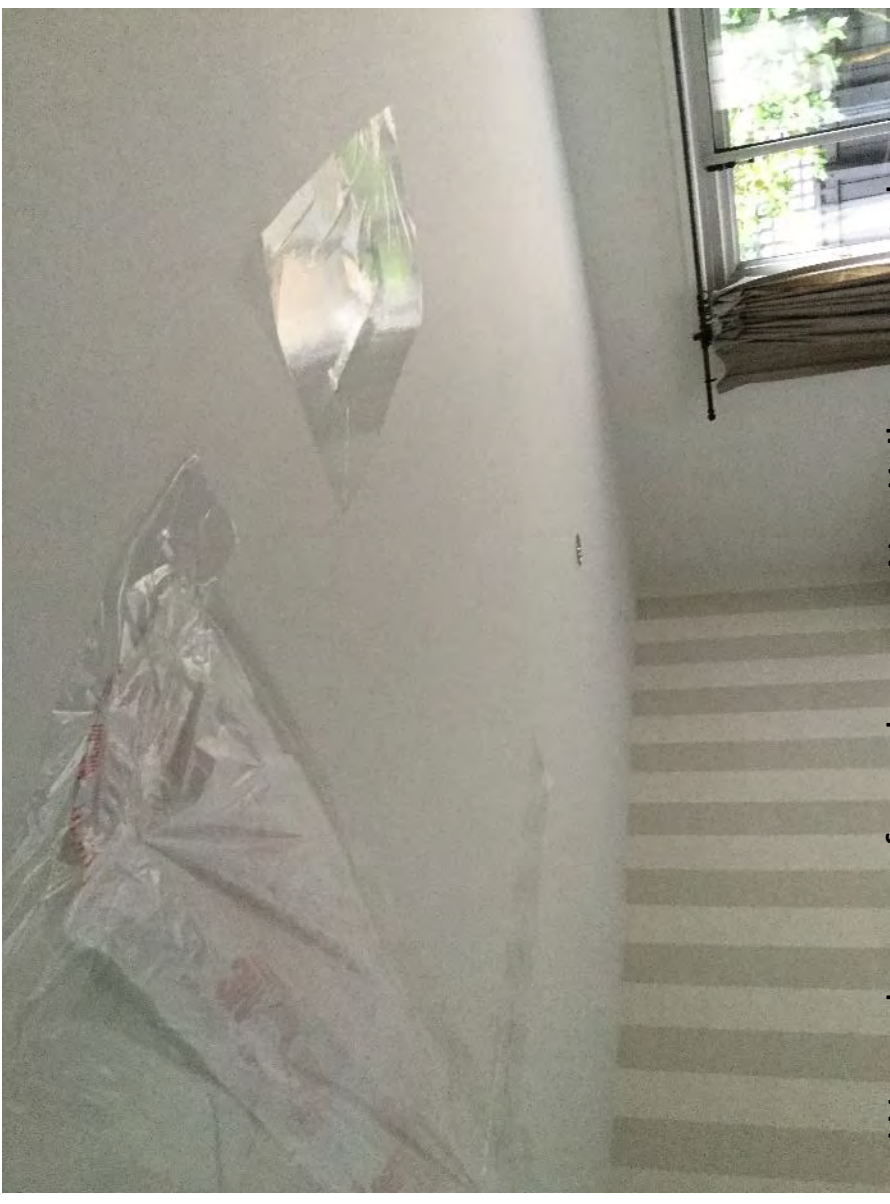
Water damage from shower – Not Kaikoura event damage

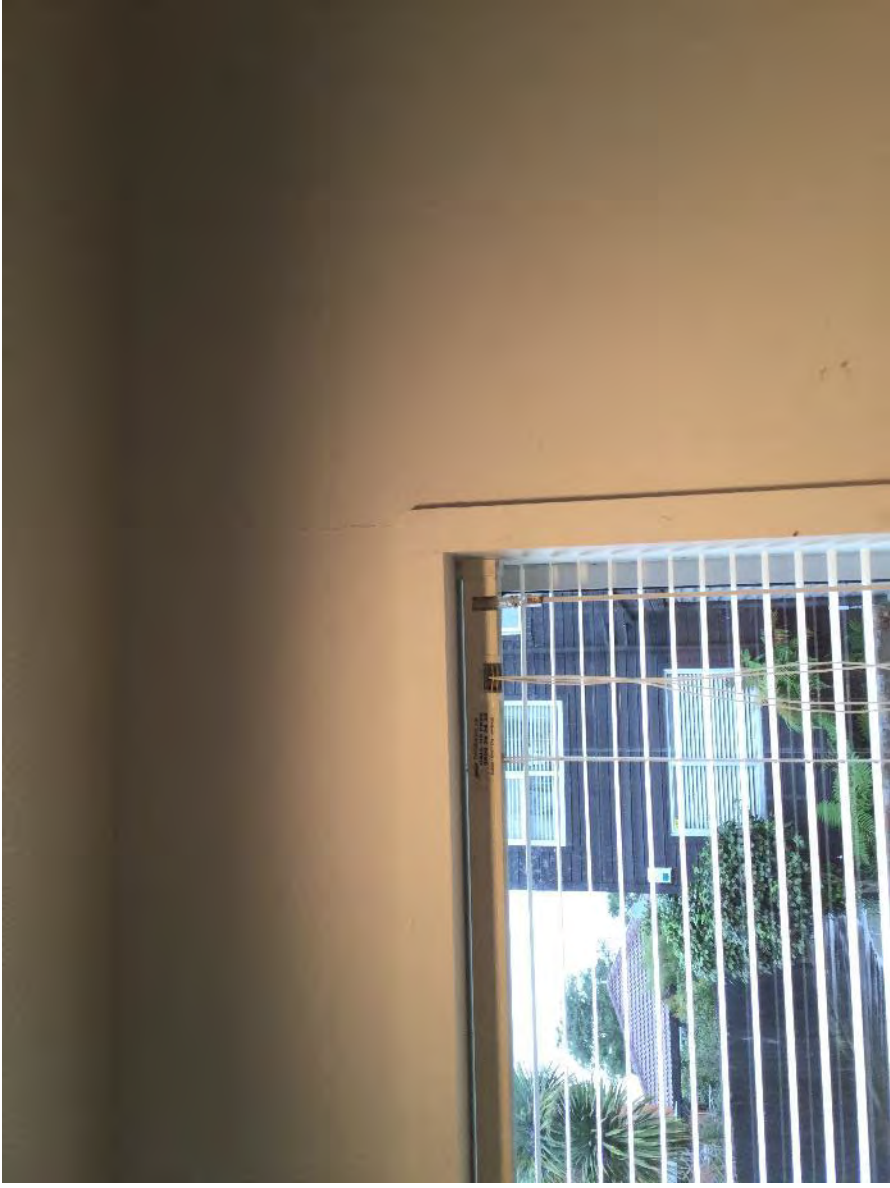
Kitchen - cracks

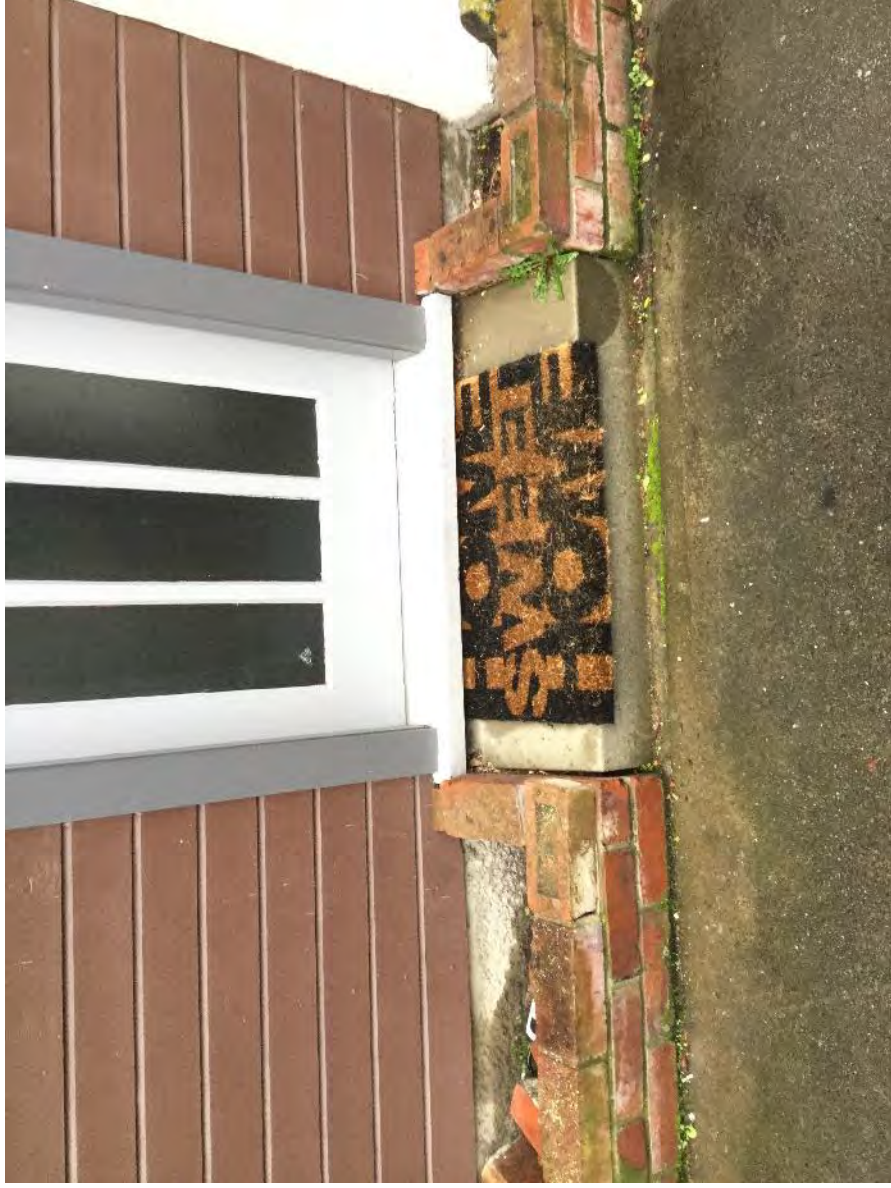
No damage to Exterior

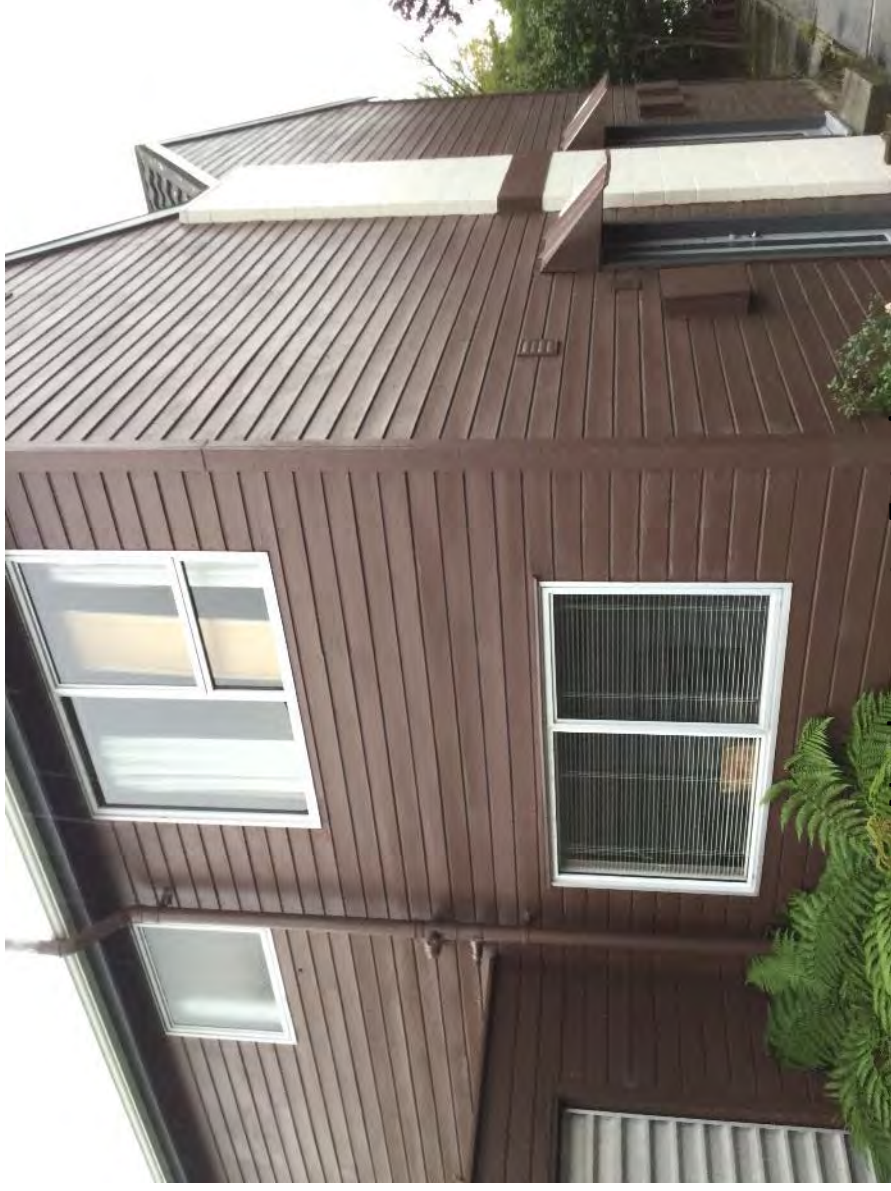
No damage to Exterior

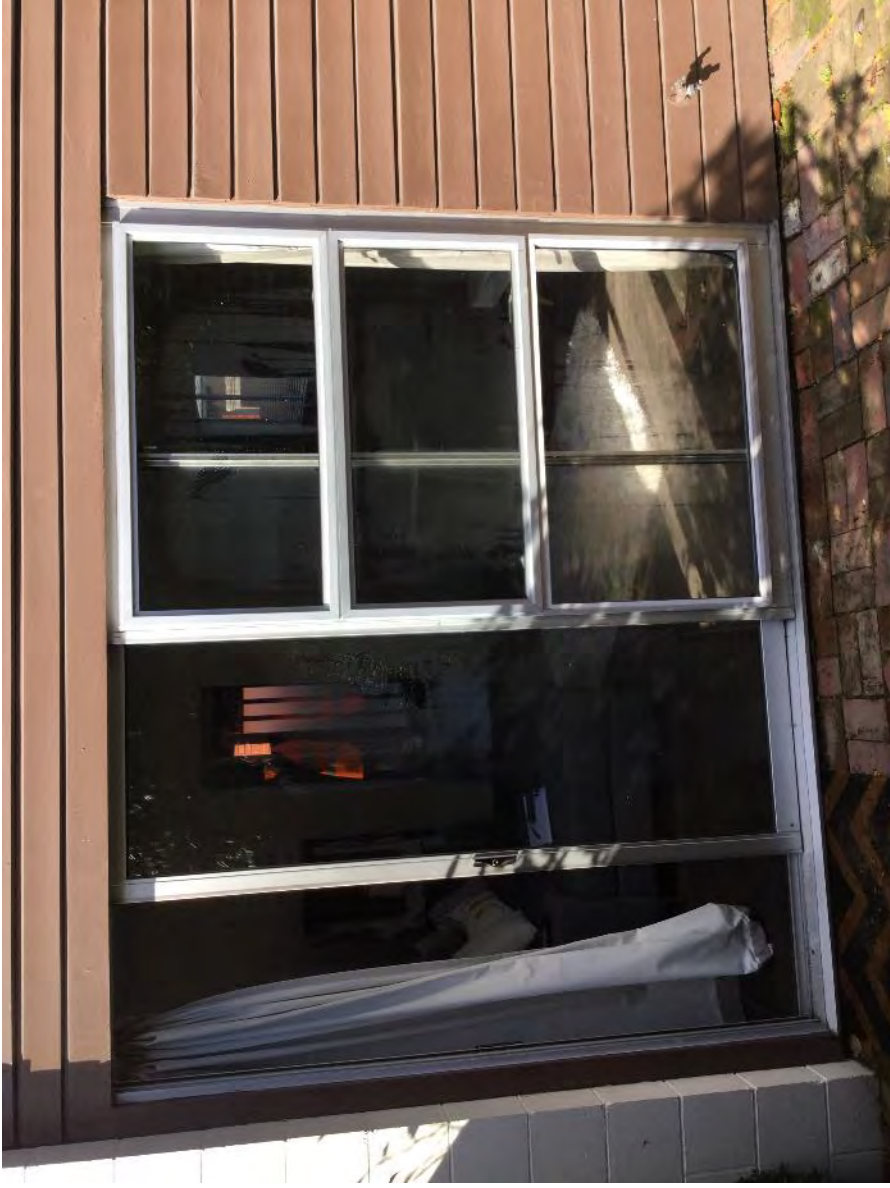
Glass slider – repaired with glass installed out of square

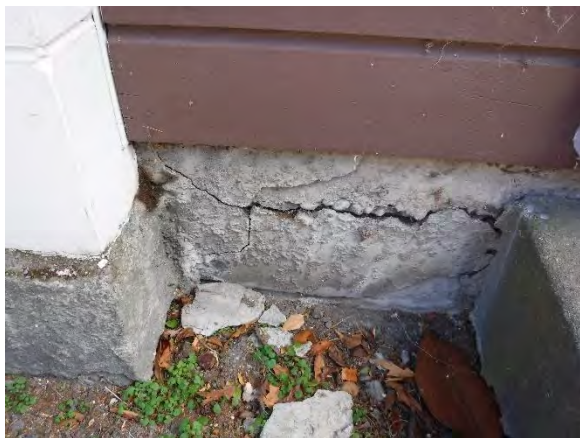
Photo 4. Cracking damage to the concrete perimeter foundation.

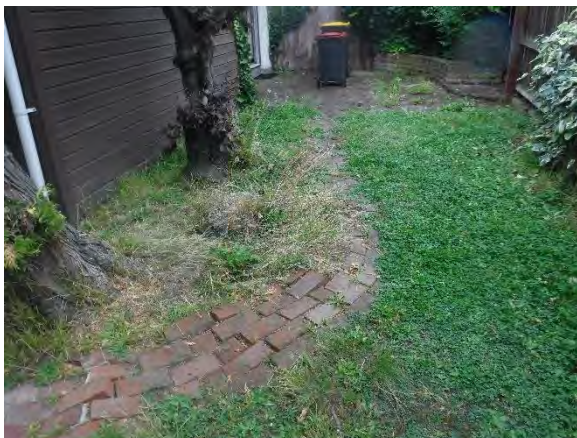
Photo 5. Undulation to the concrete pavers.

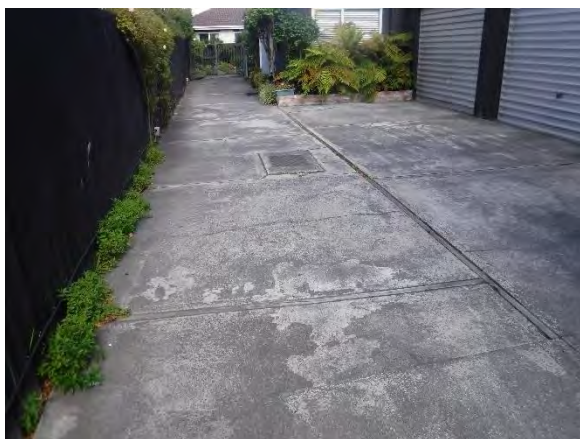
Photo 6. Cracking damage to the concrete driveway.

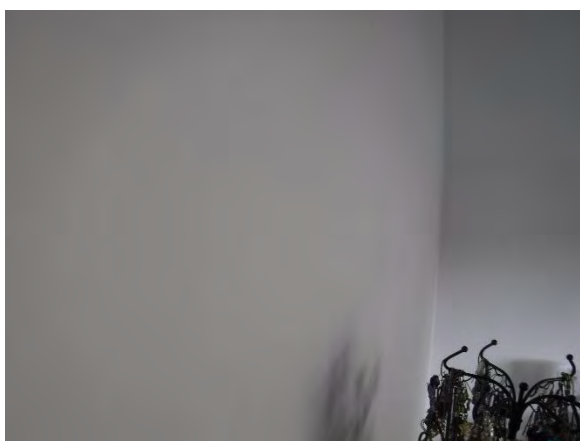
Photo 8. Internal view 2 – Minor bowing to the plasterboard linings (Unit -2).

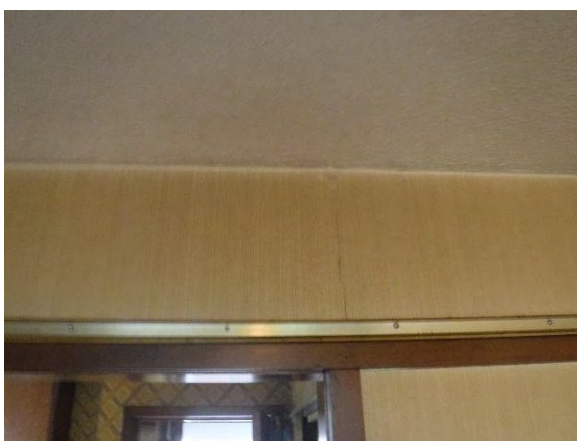
Photo 9. Cracking damage to the internal wall linings (Unit -1).

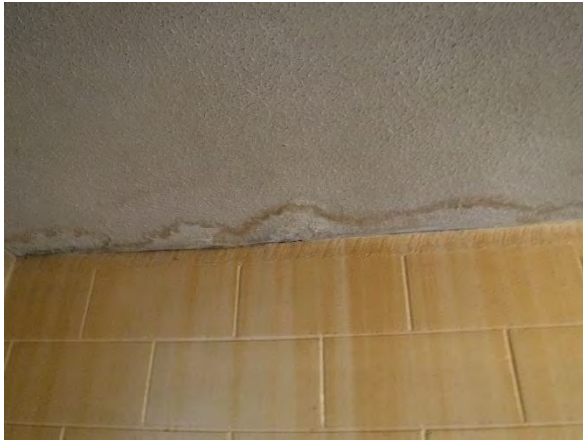
Signs of moderate water ingress were identified to unit 2. However, according to the owner, the water ingress issues are not directly related to the earthquake related movements.

Photo 10. Water ingress identified to the unit 2.

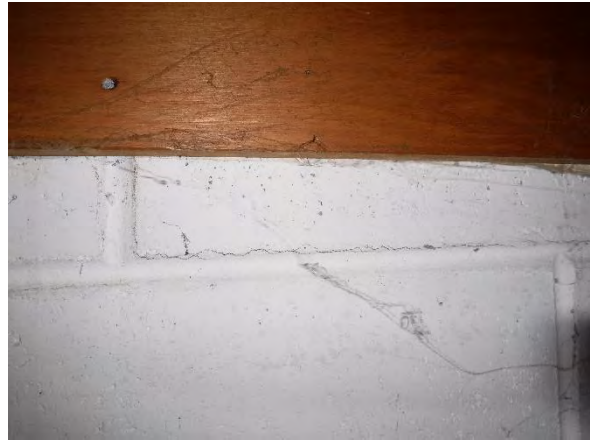
Photo 11. Minor step cracking to the block wall.

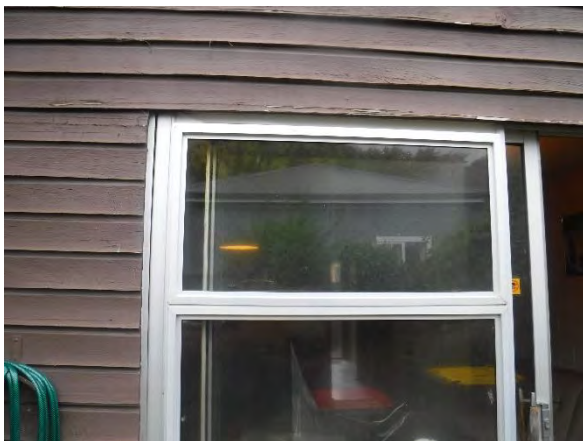
Photo 12. Door misalignment view -1 (Unit -1).

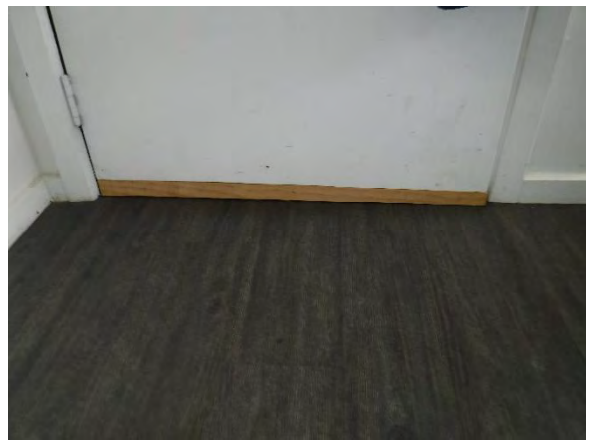
Photo 13. Door misalignment view 2 (Unit -2).

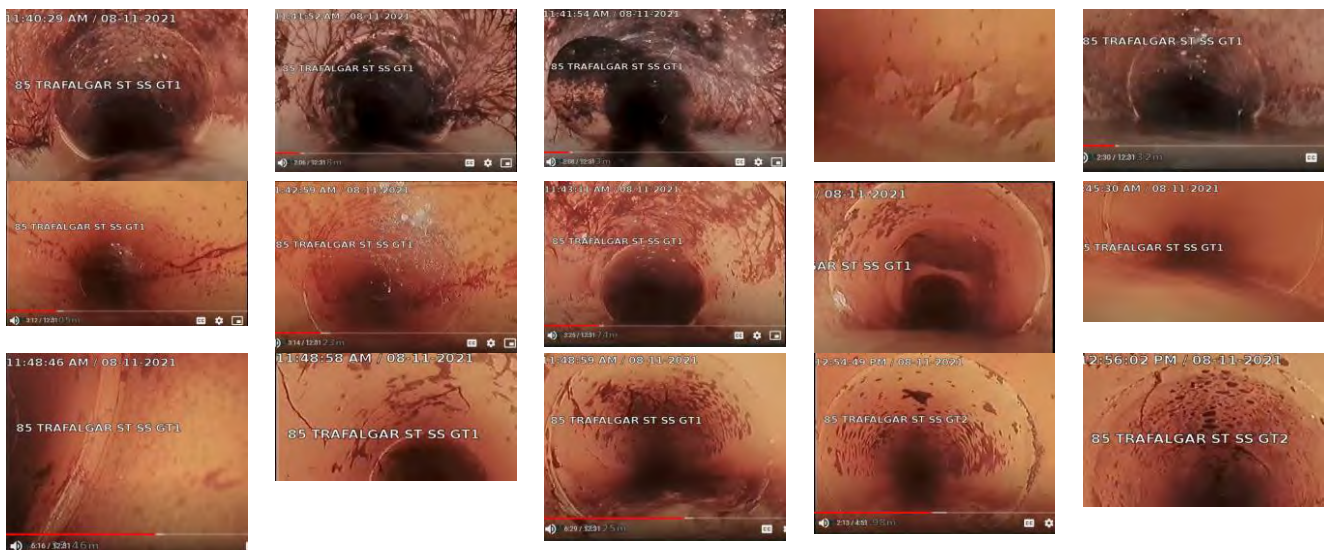
All damage noted is result of the Canterbury sequence of earthquakes. The sewer line needs repair.

### Included in Repair Strategy

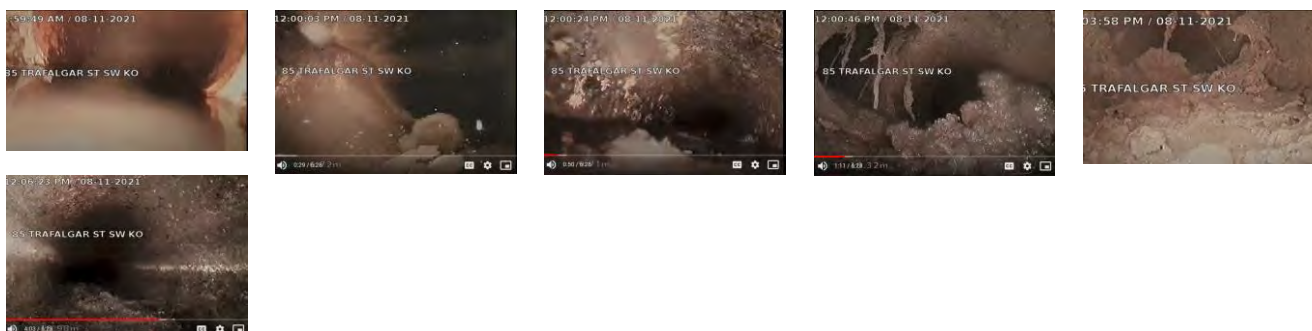
All damage is from the Canterbury sequence of earthquakes. Based on what we could see and the condition of the sewer line, we believe the entire stormwater will need repair.

| <p><u>1/85 Trafalgar</u><br/> <b>100% share</b><br/> 1m PVC to replace damaged earthenware lateral</p> <p><b>25% share</b><br/> DP3 lateral is shared equally as it services the garages<br/> 11m damaged earthenware to repair<br/> 8m PVC to replace damaged earthenware<br/> 2m Pipe line under tree<br/> 1m PVC - DP3 lateral</p> <p>1x Bubble up sump<br/> 20m2 bricks on dirt – uplift, store on site and reinstate after repairs<br/> Hydroseeding above trench line</p> | <p><u>2/85 Trafalgar</u><br/> <b>100% share</b><br/> 3m PVC to replace damaged earthenware lateral</p> <p><b>33% share</b><br/> 9m PVC to replace damaged earthenware – DP2 to DP1, divert line to avoid large tree &amp; stump<br/> 2m Fence – remove for access and reinstate after repairs</p> <p><b>25% share</b><br/> DP3 lateral is shared equally as it services the garages<br/> 11m damaged earthenware to repair<br/> 8m PVC to replace damaged earthenware<br/> 2m Pipe line under tree<br/> 1m PVC - DP3 lateral</p> <p>1x Bubble up sump<br/> 20m2 bricks on dirt – uplift, store on site and reinstate after repairs<br/> Hydroseeding above trench line</p> |
