RED LBP PRE-PURCHASE REPORT

PRE-PURCHASE BUILDING REPORT

Property Address	7 Hulme Way Raumati Beach
Client	Terry Wilson
Date of Inspection	28th July 2025
Time	1:00 pm
Inspector	Trevor Garrett MSc, LBP, Advanced Trade Cert Carpentry, Nat Diploma Construction Management. Member of NZIOB.
LBP Number	131790
People Present	Owner
House Occupied	Yes

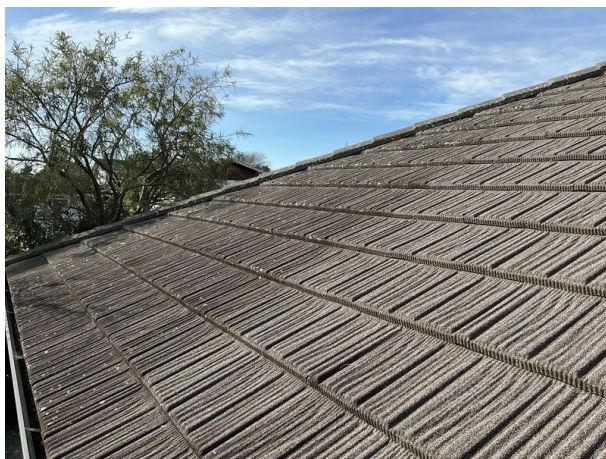
Photo 3

Moss, mould or lichen - Areas noted, refer to the photos below.

The roof displayed visible signs of moss, mould, or lichen growth in certain areas, and it is advised to address this issue as part of regular maintenance. Failure to do so could cause deterioration of the coating.

West side lichen starting to form.

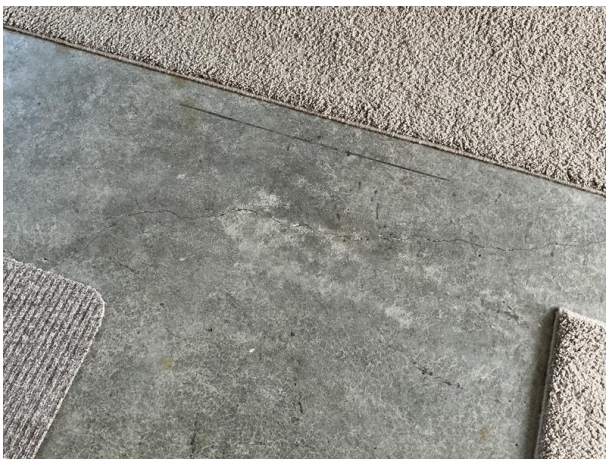
Cracking - As observed in the garage.

Photo 19
Crack in the garage slab, no issue.

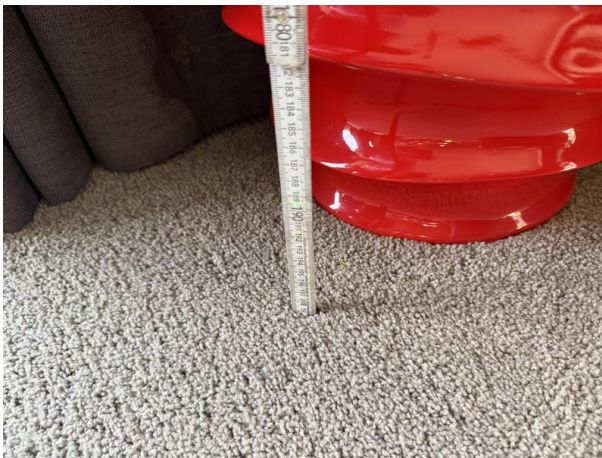
Photo 21

Floor level is within tolerance.

Reading is 105mm, making it 10mm lower than the datum level, this is within reasonable tolerance.

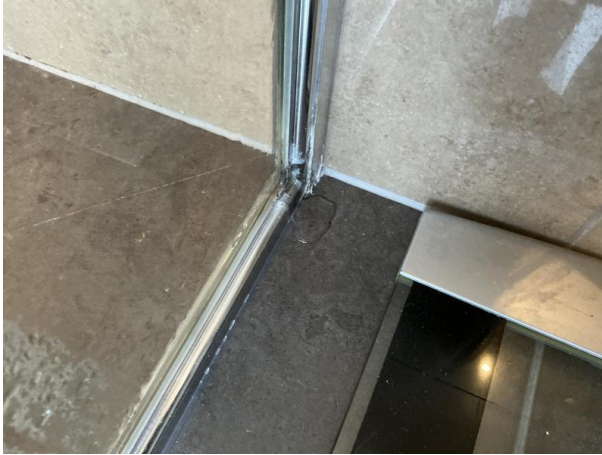
Photo 32

Shower - Enclosure. Water leaking through the corners of the shower.

Leak to the corner of the shower.

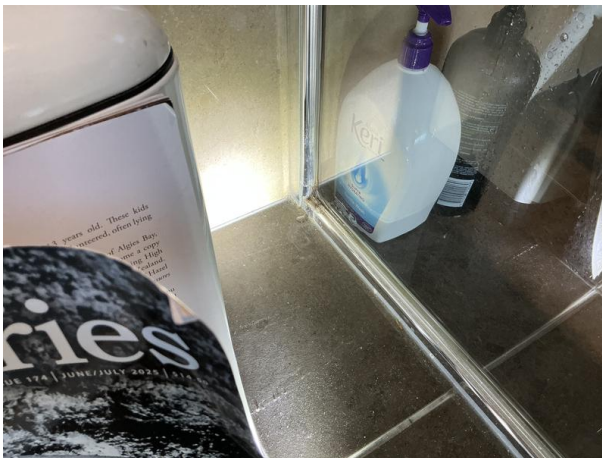
Photo 33

Leak to the corner of the shower.

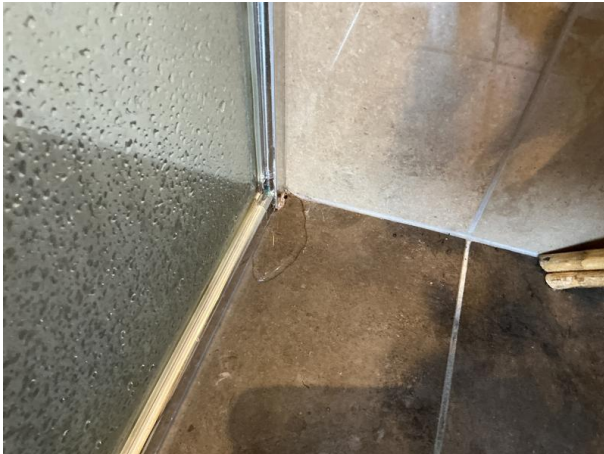
Photo 40

Shower - Enclosure. Water leaking through the corners of the shower.

Leak to the corner of the shower.

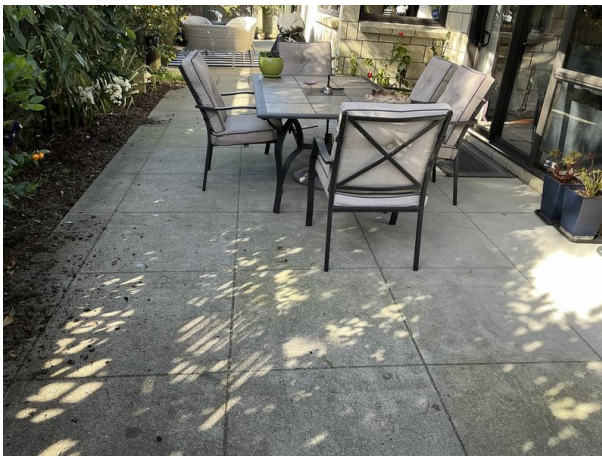
The path on the north side has slumped and has separated from the house slab. This is cosmetic. The house slab level is within reasonable building tolerances. Recommend the vent pipe on the north side and downpipe on the northwest corner are separated from the path.

Photo 55
North side has settled on the boundary side.

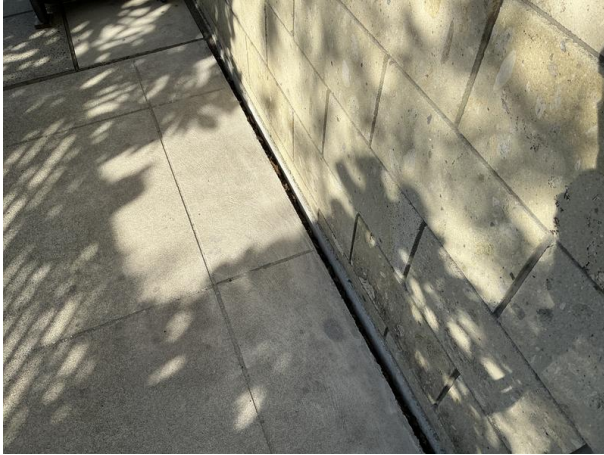
Photo 56

Gaps visible between the path and house.

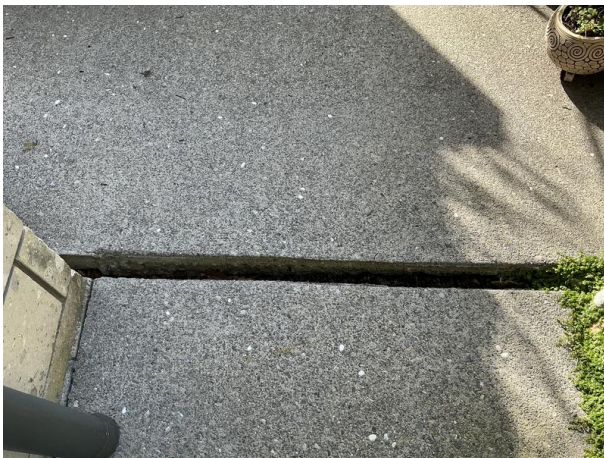
Photo 57

Northeast corner gap between the north path and the east path.

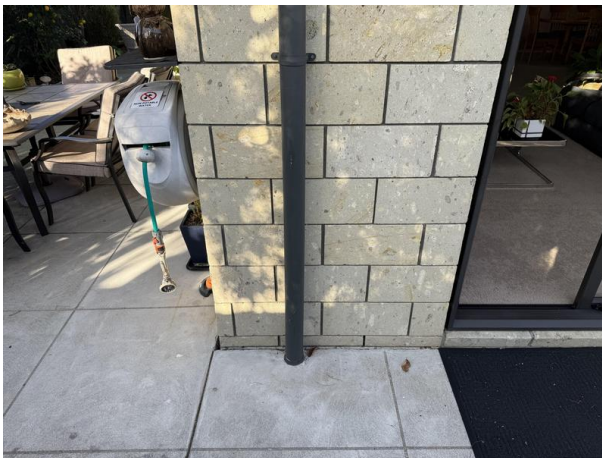
Photo 67

West side downpipe connection visible.
The pipe has moved two to the north with the path.

Recommend 'releasing' the two pipes affected by the path settlement to reduce the pressure on them.
