All Building Inspections Limited

Building Report

11 Harry Shaw Way
Raumati South

*This report has been updated as recommendations from the initial inspection have been implemented.

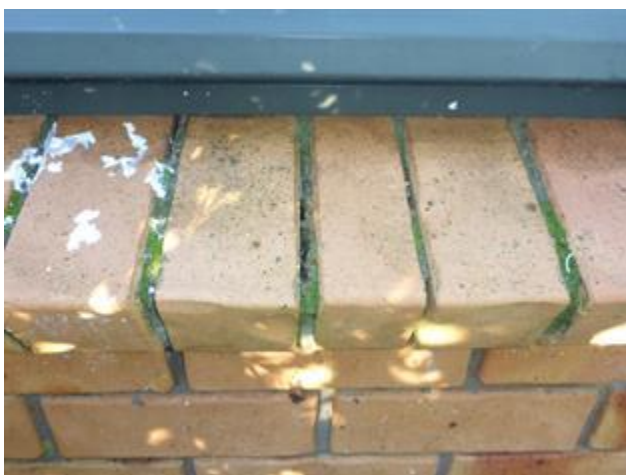
Toilet window sill

No gaps or cracks were detected in the exterior walls of the brick but the mortar to the toilet windowsill has aged with repair and a new mortar recommended as part of the dwelling's maintenance planning.

The mortar to the toilet windowsill has aged with repair and a new mortar recommended.

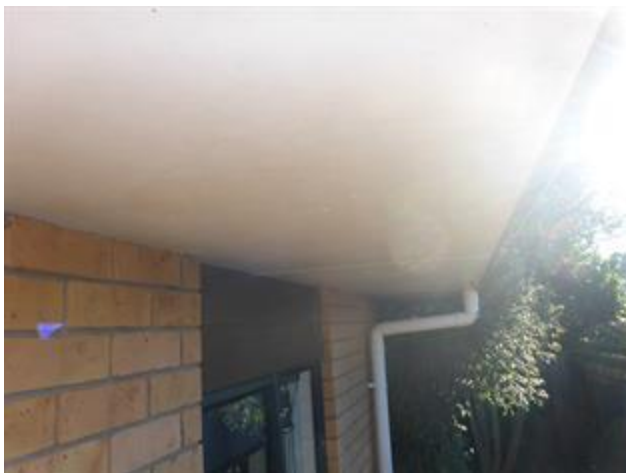
Cement board soffits

The cladding was in good condition. Cement board's maintenance requirement is to ensure a good level of paint finish to protect and seal the cladding and the paint finish was of a good standard.

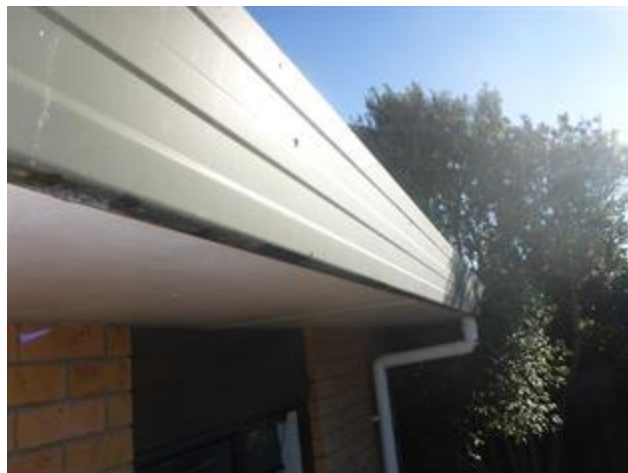
Metal fascia

The fascia is known as Gerard Klass fascia. The fascia is designed to complement the pressed steel roof while it provides support for the spouting system. The fascia is pre-painted with corrosion-resistant coatings.

Regular cleaning of the fascia especially the lower edge where it meets the soffit is recommended as corrosion can form where the fascia doesn't get rain-washed.

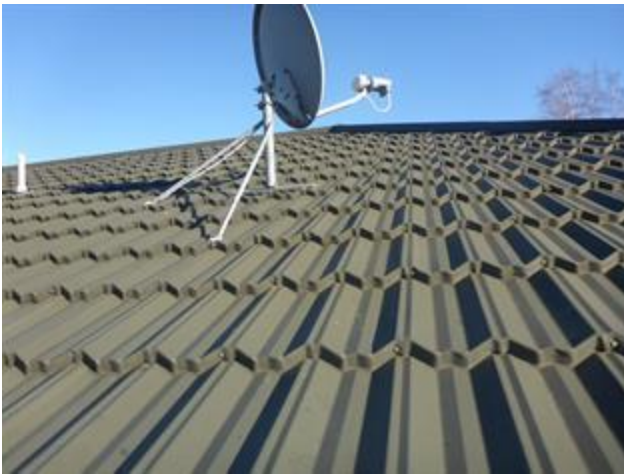
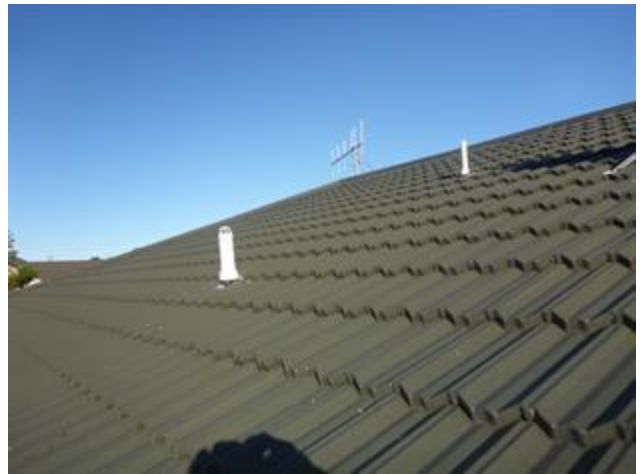
Lower run

The tiles of the lower run above the spouting have been fixed through the tops of the tiles without rubber washers. This would have been compliant at the time of construction but does not meet today's standards as this can allow moisture ingress issues.

I recommend that the roofing material have further appraisal by a licensed roofer to give you advice on the degree of fastener replacement, washer upgrades and potential costs.

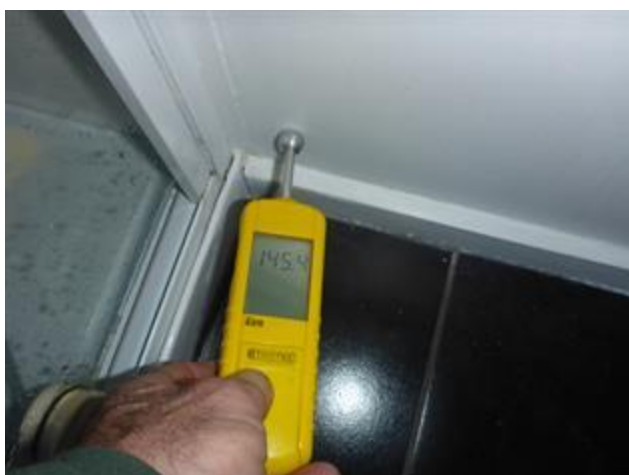
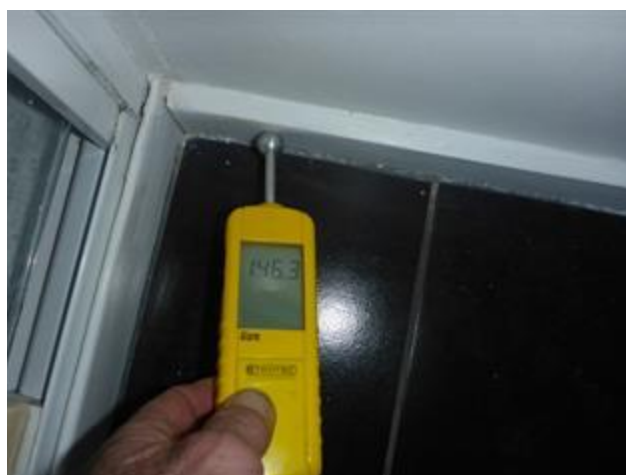
High moisture levels

All moisture readings were within acceptable parameters except to the wall lining to the right side of the en-suite shower. As moisture retention can lead to deterioration, I recommend further invasive appraisal of the area showing high moisture levels.

I suggest first removing the skirting to assess the wall lining to ensure there are no further indications of moisture issues. If further indications are present a small piece of wall lining could then be removed to determine the extent of the moisture damage.

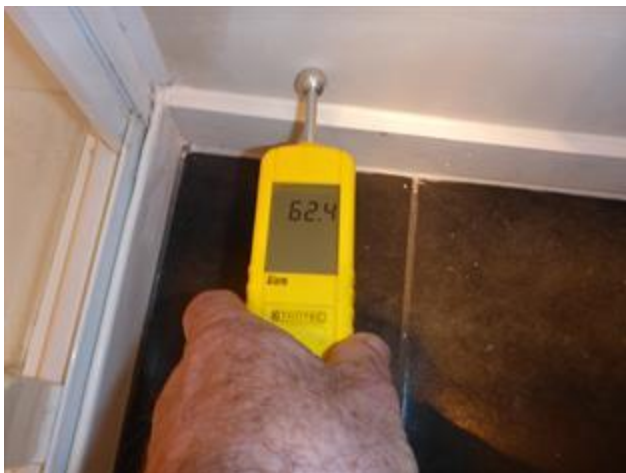
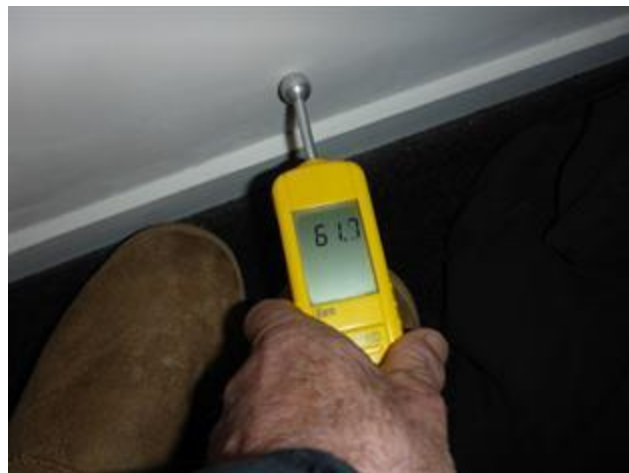
Acceptable parameters

***Update 1/8/25 Moisture levels were within acceptable parameters after invasive investigation and repair had been carried by a LBP carpenter..**
