Exemption from building consent

Project Address
1-2/85 Trafalgar Street, Saint Albans

PROJECT : STRUCTURAL REPAIR ASSESSMENT

REVIEW OF EXISTING STRUCTURAL ENGINEERS' REPORT – UNITS 1 & 2 / 85 TRAFALGAR STREET, SAINT ALBANS, CHRISTCHURCH.

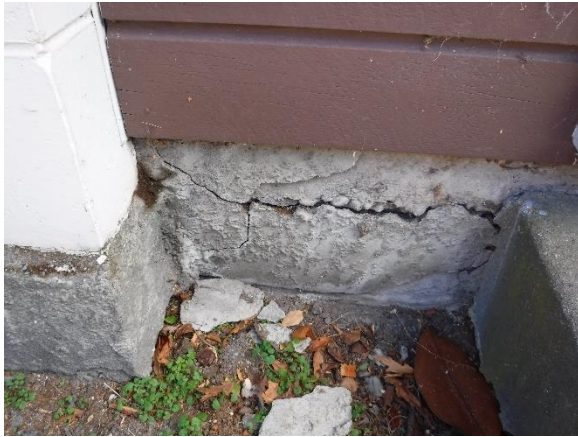
Moderate horizontal cracking damage was observed to the concrete perimeter foundation wall besides the firewall at the front of unit 1. Minor horizontal cracking damage was observed to the concrete perimeter foundation wall at the rear of unit 1. The pattern of the cracking damage to the exterior were considered to be a typical result of the ground movement and/or settlement from the Canterbury Earthquake Sequence (CES). Therefore, Cephas Rock considers that the damage to the exterior of the building is attributed to the seismic events.

Photo 4. Cracking damage to the concrete perimeter foundation.

- **Option 1:** Where the concrete perimeter foundation and firewalls have settled (dropped), the concrete perimeter foundation and firewalls can be re-levelled by mechanical lifting using portable jacks as per Option 1 of the MBIE Guidance: Part A, Appendix A1.1.3. The foundation re-levelling shall be designed, approved and monitored by a qualified structural engineer. The soil conditions need to be confirmed by a geotechnical engineer prior to any construction.

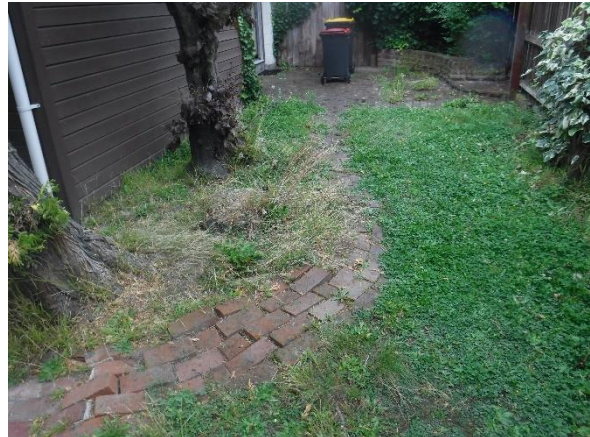
Evidence of ground movement was observed through cracking in the concrete driveway and undulations in the footpaths around the building.

Photo 5. Undulation to the concrete pavers.

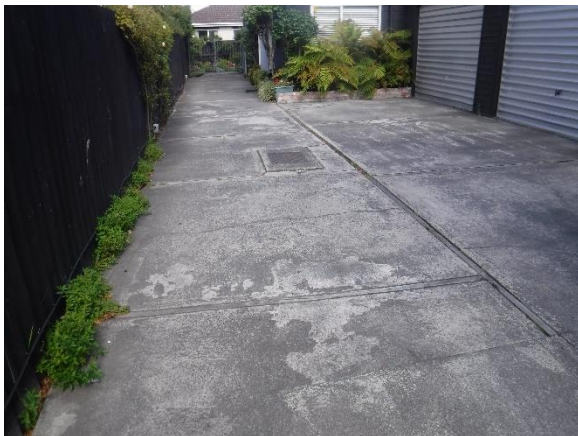
Photo 6. Cracking damage to the concrete driveway.

- Once the foundations have been re-levelled and repaired, the non-structural elements, such as doors, windows, driveway, external amenities etc., should be assessed and remediated by a suitably qualified person as required.

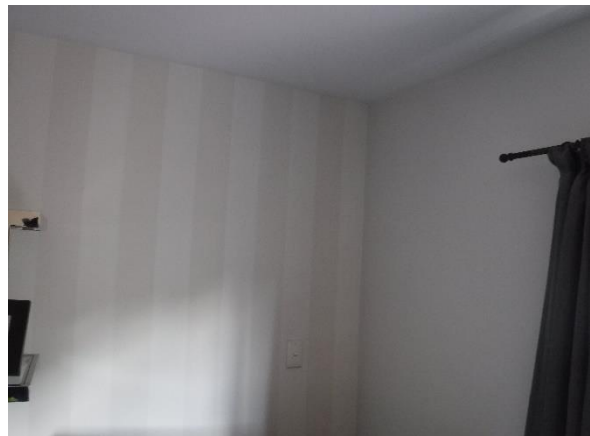
Photo 7. Internal view 1 (Unit -2).

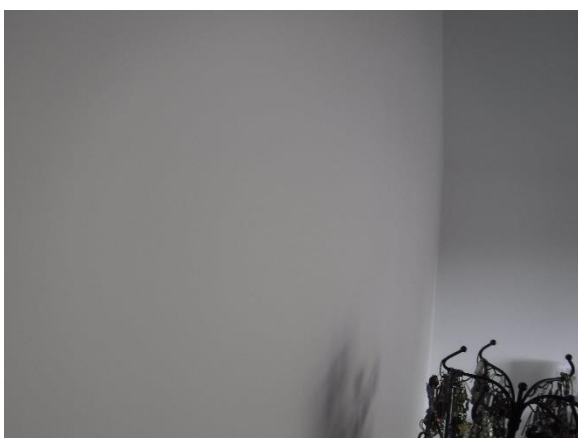
We were informed that repairs to the unit-2 had been carried out prior to our inspection. No major cracking damage was observed to the plasterboard wall and ceiling linings throughout the unit-2 at the time of our inspection. However, minor bowing to the plasterboards identified at one location on the first floor.

Photo 8. Internal view 2 – Minor bowing to the plasterboard linings (Unit -2).

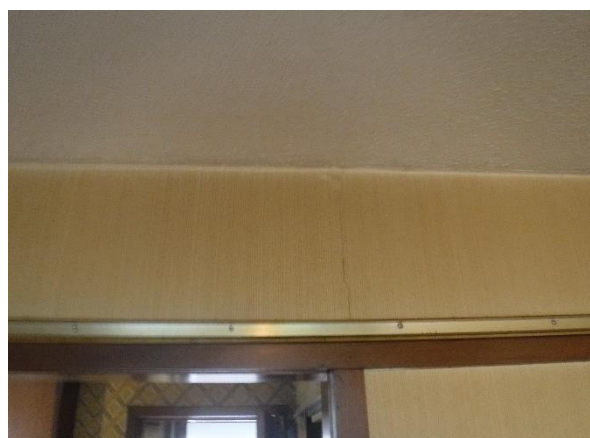
- Minor vertical cracking damage to the wall linings along the sheet joints. The majority of these cracks were around the window and door opening corners.
- Minor cracking damage to the ceiling linings.
- Minor wall-to-wall and wall-to-ceiling juncture movement.
- Minor step cracking to the block wall.
- Door misalignments.

Cephas Rock considers that the earthquake-related damage to the internal linings is consistent with level 1 damage category as per Table 7.1 of the MBIE Guidance.

Photo 9. Cracking damage to the internal wall linings (Unit -1).

- Re-stopping to wall (Fibafuse) and ceiling plasterboard where diagonal cracks from the corners of openings are less than 50mm long and cracks or separation are typically vertical along sheet joints. Installation of new fasteners is required around the plasterboard sheet perimeter where fasteners have pulled through or plaster bulges around fastener heads.

- Where diagonal cracks from corners of openings are exceeding 50mm length and panel fractured, replacement of wall and ceiling plasterboard with equivalent bracing elements (GIB Braceline) is recommended. Installation of new fasteners shall be in a bracing pattern around the plasterboard sheet perimeter in accordance with manufacturer's guidelines.

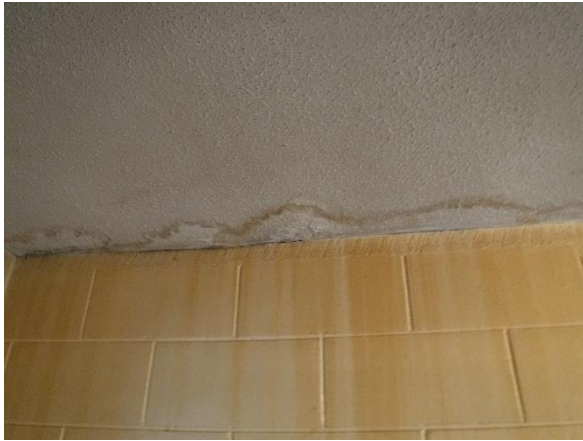
Photo 10. Water ingress identified to the unit 2.

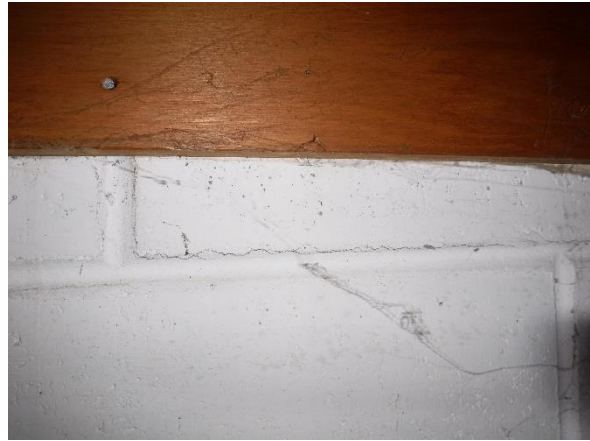
Photo 11. Minor step cracking to the block wall.

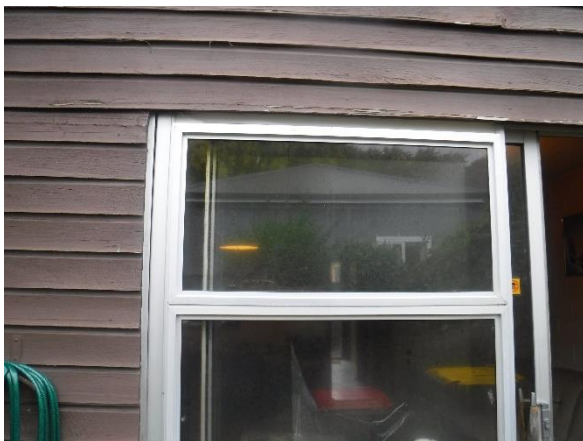
Photo 12. Door misalignment view -1 (Unit -1).

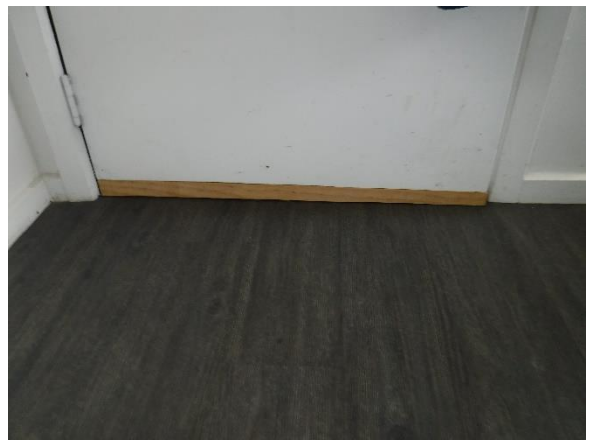
Photo 13. Door misalignment view 2 (Unit -2).

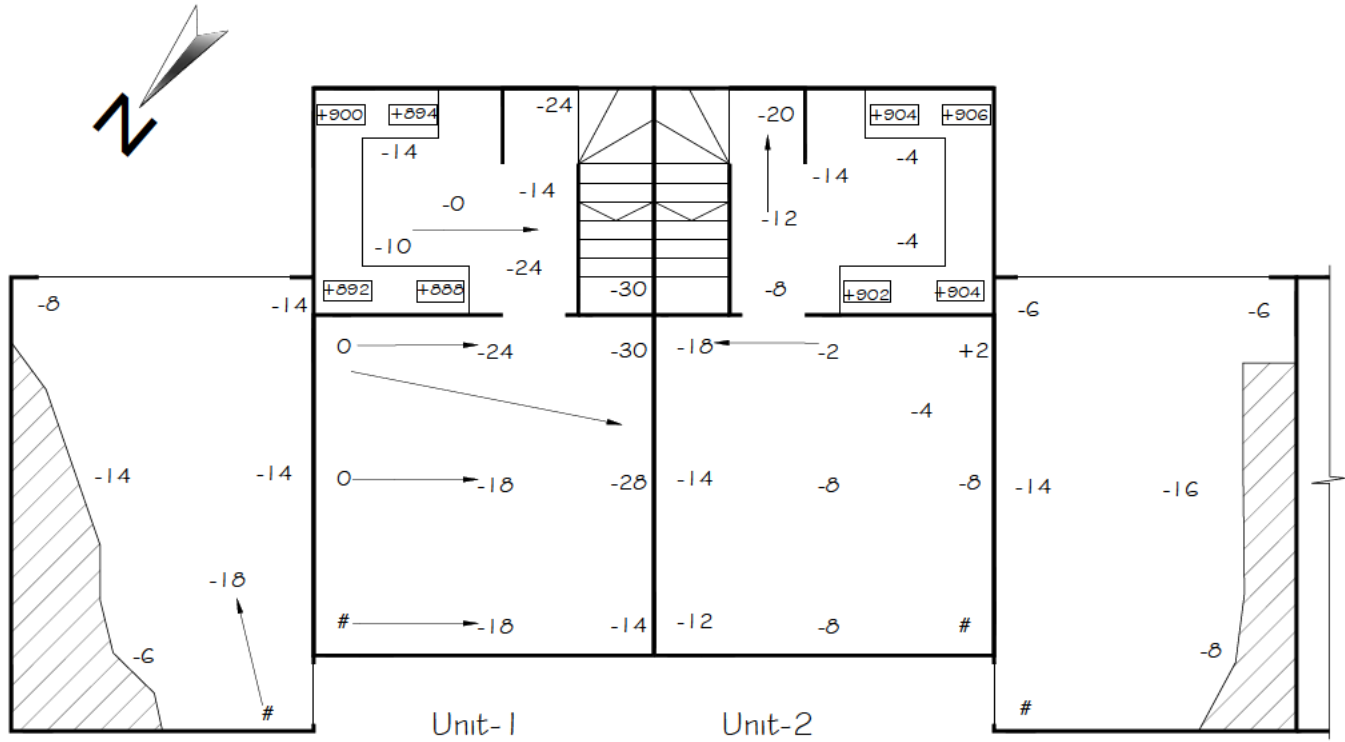
**FLOOR LEVEL SURVEY PLAN (NTS)
(SEPARATE DATUM)**

The floor levels measured across the entire building footprint (floor levels across the 2 units based on one datum) showed a maximum floor level variation of 36mm (-36, 0). The general trend of the floor level variations on the ground floor was sloping towards the middle of the building, indicating the foundation damage mechanism may be combination of case 5 and 6 ("Firewall settlement" and "Dishing (sagging)"), as per Table 18.4 of the MBIE Guidance, which is shown below, and the foundation re-level is also recommended in this table.

- 1) Measurements location are approximate and indicative only and not to scale.
- 2) Levels indicated are in millimeters.
- 3) Instrument used for measurement has a rated accuracy of +/- 3.0mm (ZIP level Pro 2000). Other sources of variation to the measurements can include construction tolerances, carpet, wear, and atmospheric temperature changes.
- 4) All measurements have been adjusted to the floor covering type at the datum.
- 5) Reference point zero millimeter denoted as "#".
- 6) Benchtop levels indicated as "+xxx".
- 7) The Floor slope exceeded 1/200 tolerance denoted as "—" (indicative only).
- 8) The relative floor level differences between the highest and lowest points are as follows:
Ground Floor Unit 1 : 30mm (-30, 00)
Ground Floor Unit 2 : 20mm (-20, 00)
First Floor Unit 1 : 40mm (-40, 00)
First Floor Unit 2 : 28mm (-24, +04)

Garage Floor Unit 1 : 18mm (-18, 00)

Garage Floor Unit 2 : 16mm (-16, 00)
