BUILDING INSPECTION REPORT

PROPERTY CHECK EXPRESS REPORT

Job Number	53995
Client	[REDACTED]
Property Inspected	252 Waimairi Road, Ilam, Christchurch
Inspection Date	26 March 2025
Building Surveyor	Darin Devanny
NZIBS Registration Number	BSI0100
Weather Conditions	Fine
Scope of Report	Visual inspection of the buildings that are listed in this report for the purpose of a residential inspection in accordance with NZS4306: Residential Property Inspections.
Report Ordered By	[REDACTED]
Orientation	For the purpose of this report, the elevation of the house facing Waimairi Road is considered to be the west elevation.

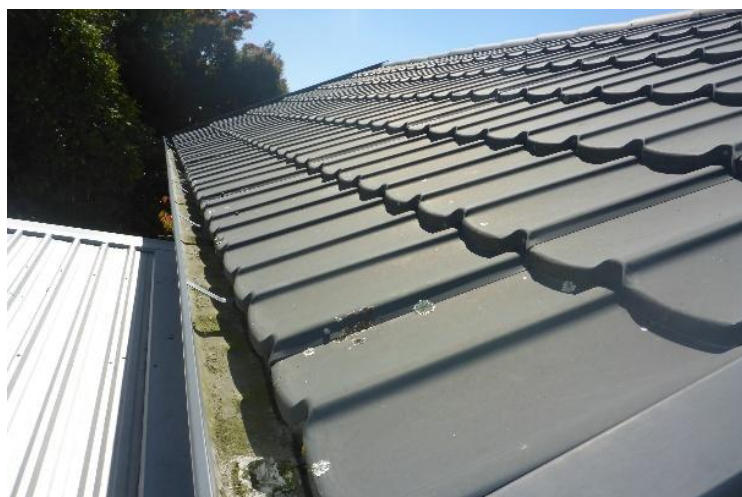
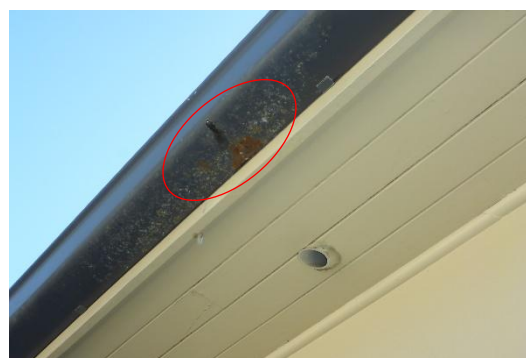
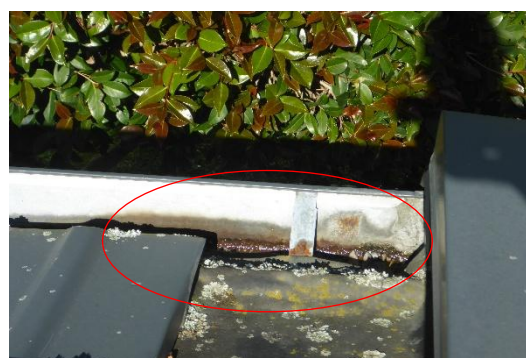
RAINWATER COLLECTION – *External pre-painted steel spoutings*

Two sections of spouting on the south elevation have corroded and are leaking and require replacing.

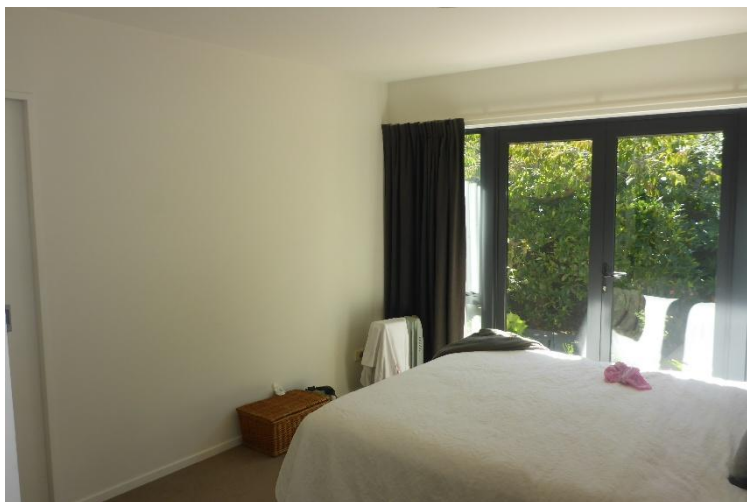
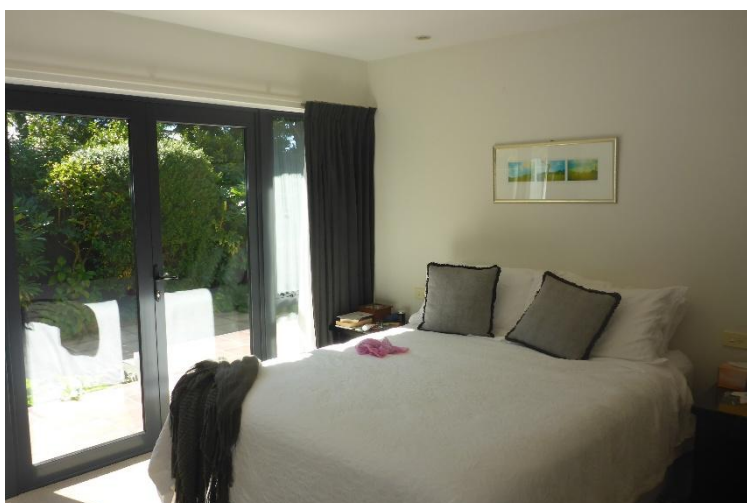
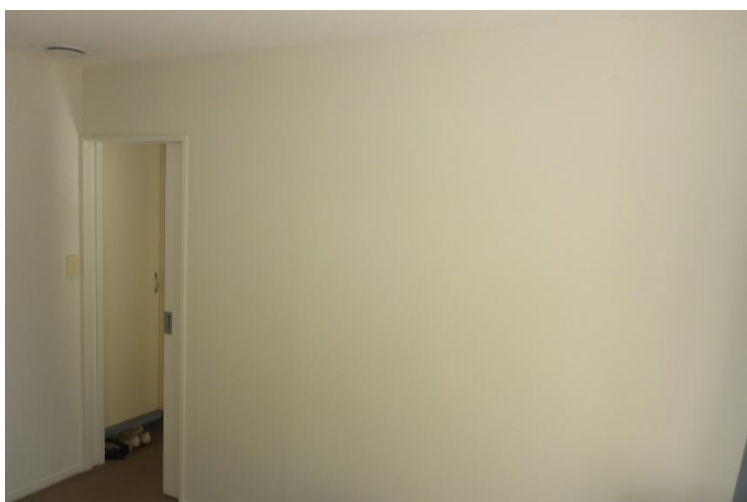
BEDROOM 1 – Next to the main entrance

The French doors are not opening and require adjustments.

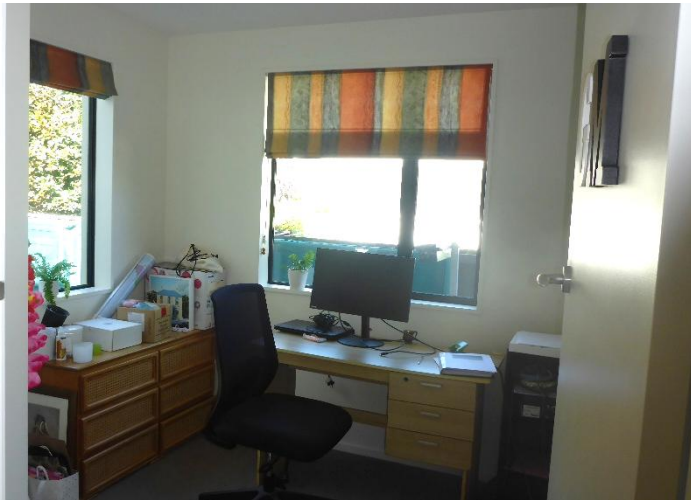
OFFICE – Next to the family room

The wardrobe door rubs heavily on the floor coverings and may require planing back.

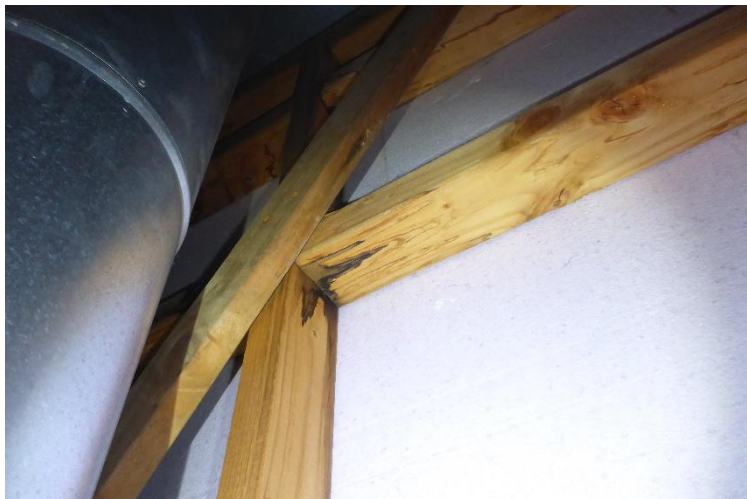
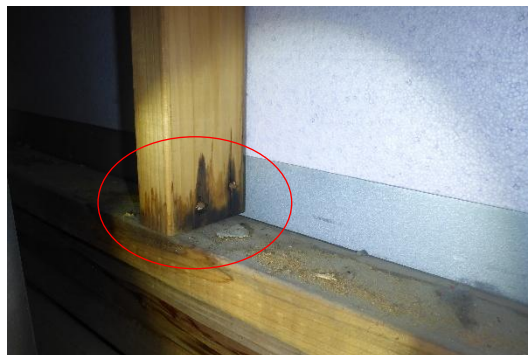
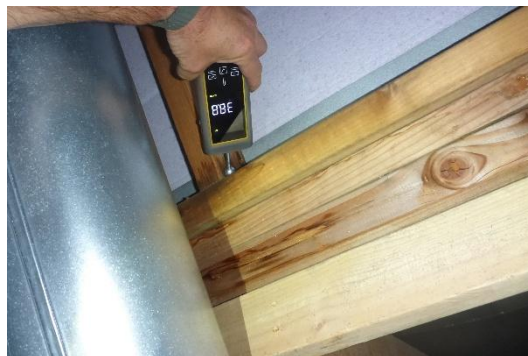
There are signs of historical leaks around the chimney structure. Moisture scans to this area returned normal moisture readings and there were no signs of current leaks.

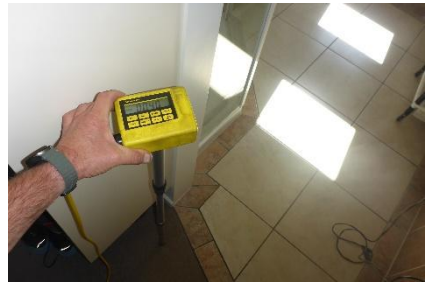
Floor Level Survey

Highest reading: Ensuite (+40mm)

Total variation across entire floor of dwelling: 58mm		
Slopes Found > 0.5%	None found.
