BUILDING INSPECTION REPORT

RESIDENTIAL HOUSE INSPECTION

70 Landsdowne Terrace
Christchurch, Canterbury Region 8022

06/08/2025

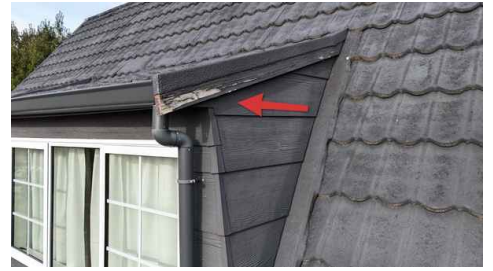
FASCIA

Deterioration of the painted surfaces is noted, general maintenance is recommended.

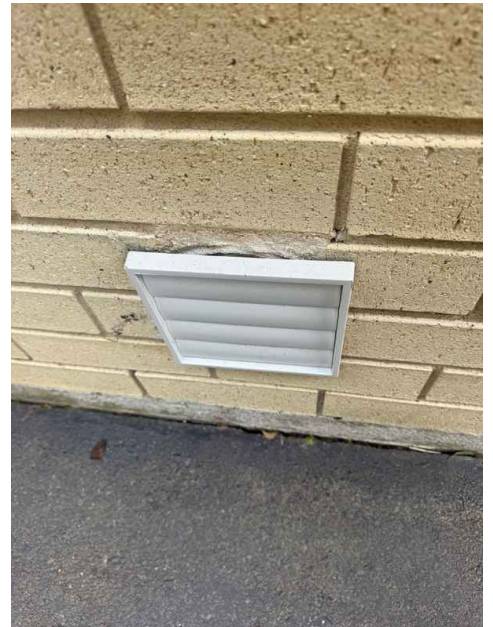
UNSEALED PENETRATIONS

It is recommended that penetrations are sealed to prevent water ingress occurring.

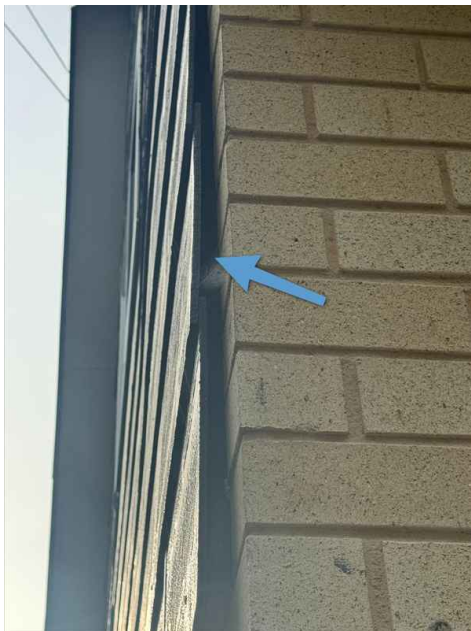
north west

SCRIBER OF FLASHING RECOMMENDED TO SEAL OFF GAPS BETWEEN CLADDING AND FIBER CEMENT

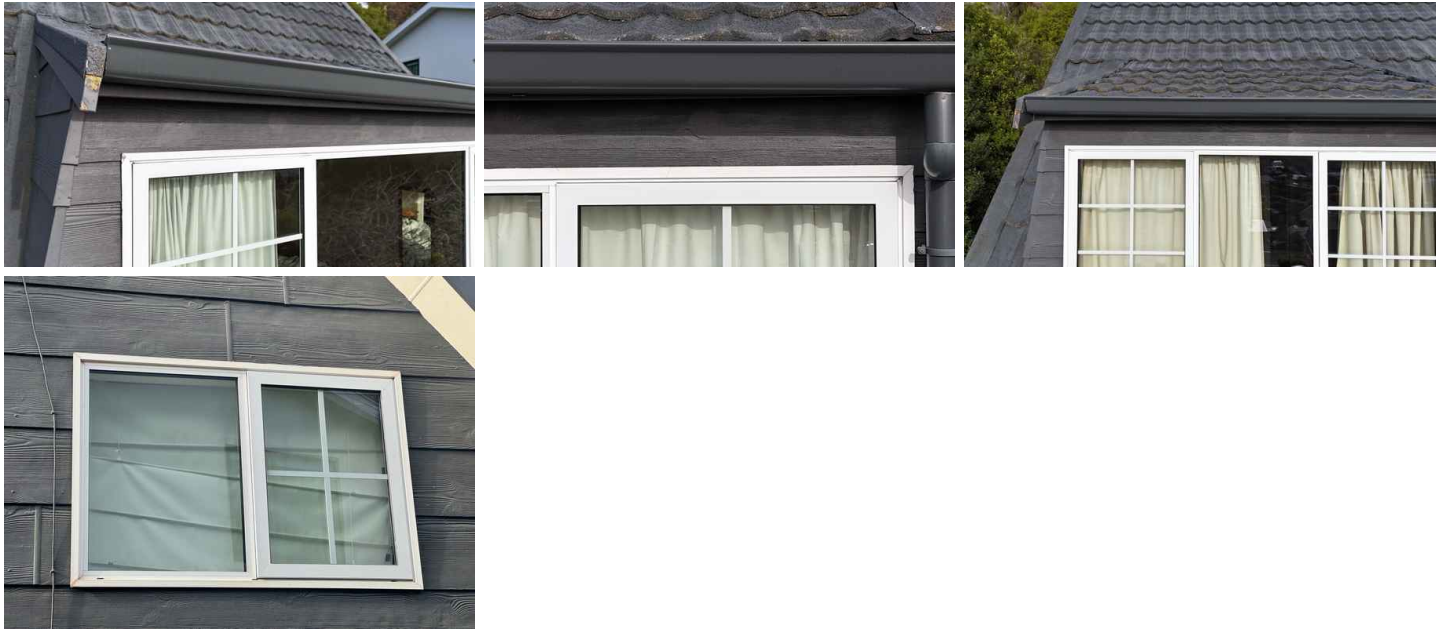
**NO HEAD FLASHINGS TO SECOND FLOOR WINDOWS**

The installation of head flashings is recommended and will minimize the risk of water ingress occurring.

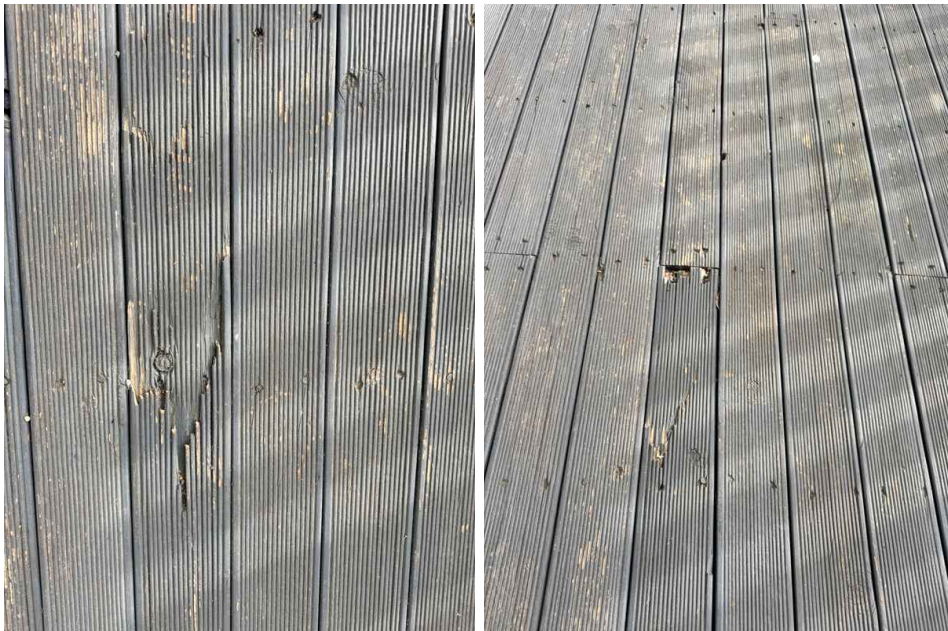
The decking is showing its age.

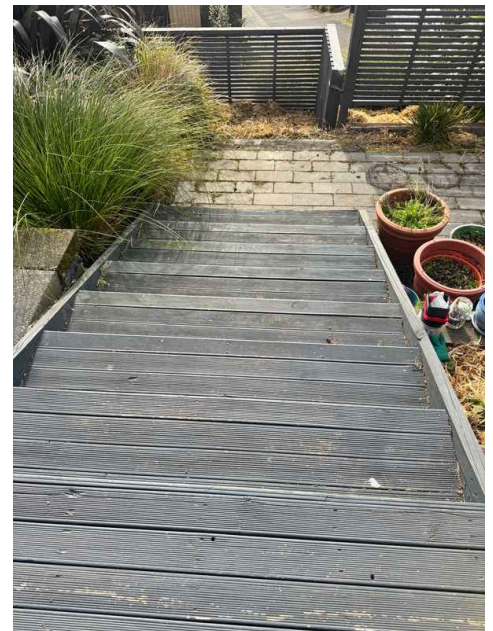
HANDRAILS

It is recommended that where more than 3 stair risers are constructed that handrails are installed.

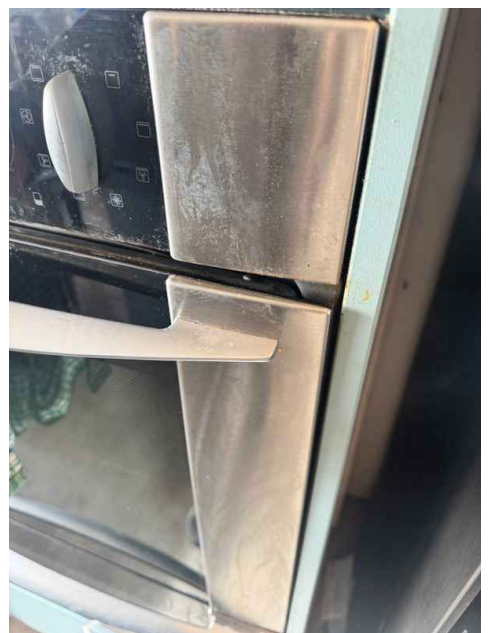
OVEN NOT SECURED TO CABINET

secure as per manufactures recommendations

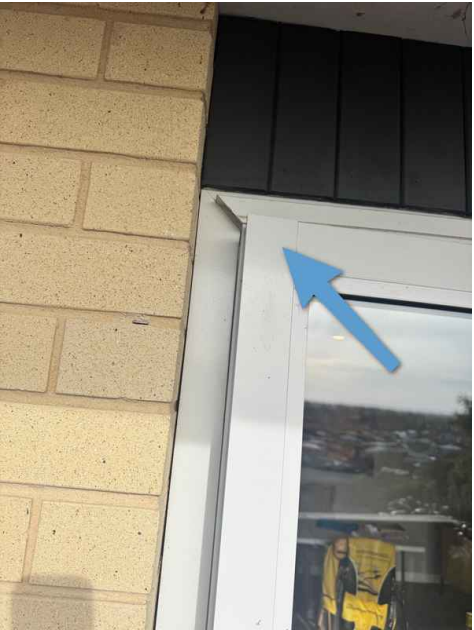
DOOR REQUIRES ADJUSTMENT

adjustment of the door is recommended to prevent damage to hinges.

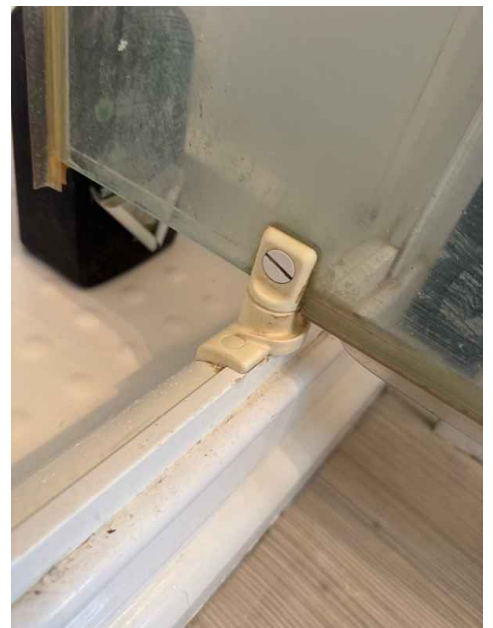
SHOWER SEALS DAMAGED

Replace as required.

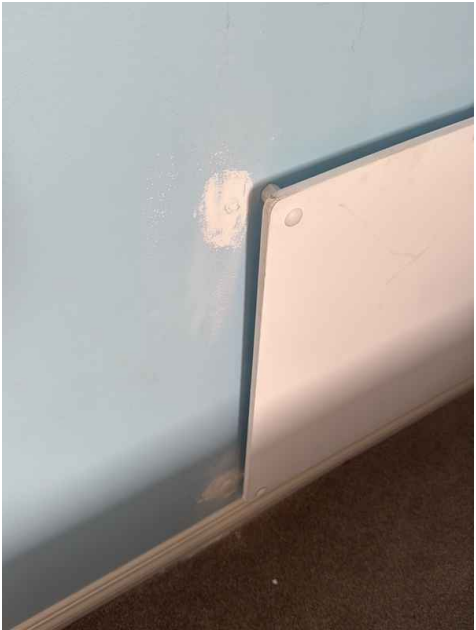
24.1.1 Internal Linings
WEAR & TEAR TO WALLS NOTED
BEDROOM

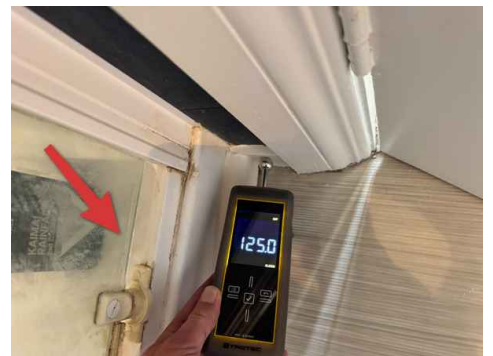
Elevated moisture was located to the following areas.

right hand side of the shower door, shower seal us missing and is teh likely cause of the elevated moisture

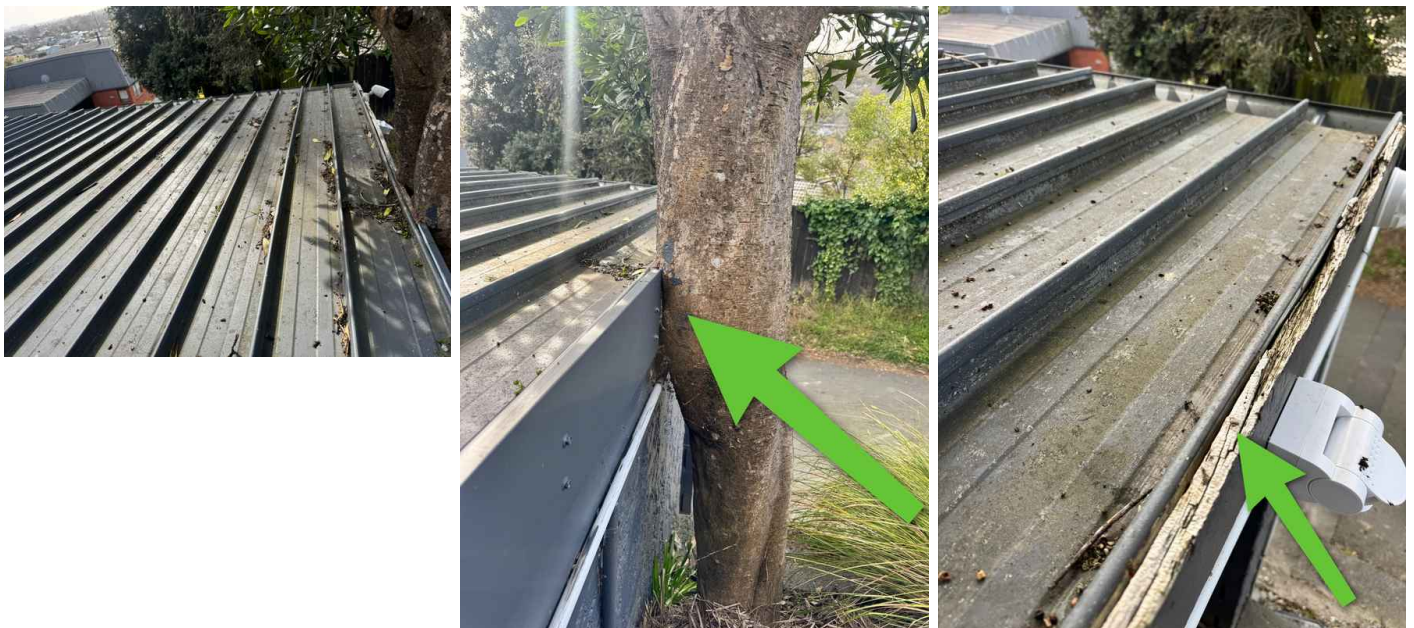
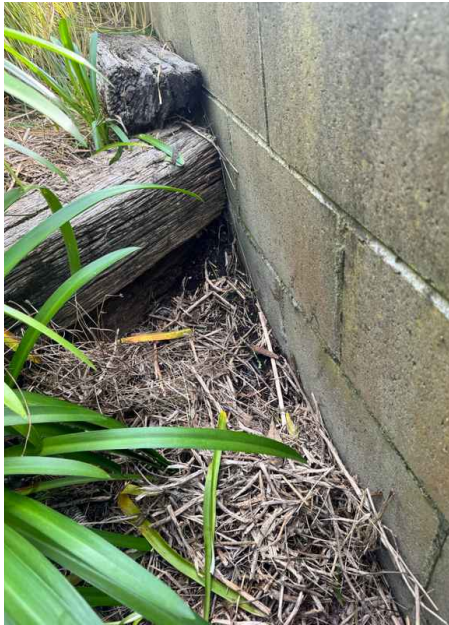
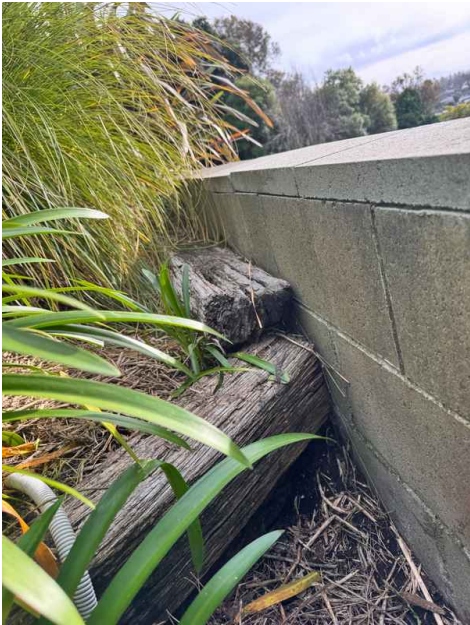
Timber barge has decay with the tree causing damage.

We are unable to verify any water proofing to the garage, moisture through block does occur as paint is loose to wall.

Door requires easing.
