2025 | COMPREHENSIVE WEATHERTIGHTNESS REPORT H/V

42 Harry Shaw Way
Paraparaumu, Wellington 5032

JULY 9, 2025

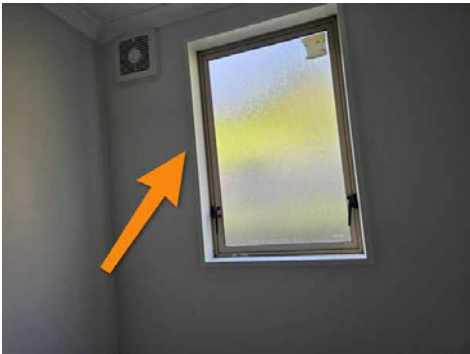
NOTES: Slightly elevated moisture detected on rear wall of bathroom.

Bathroom - 20.0%

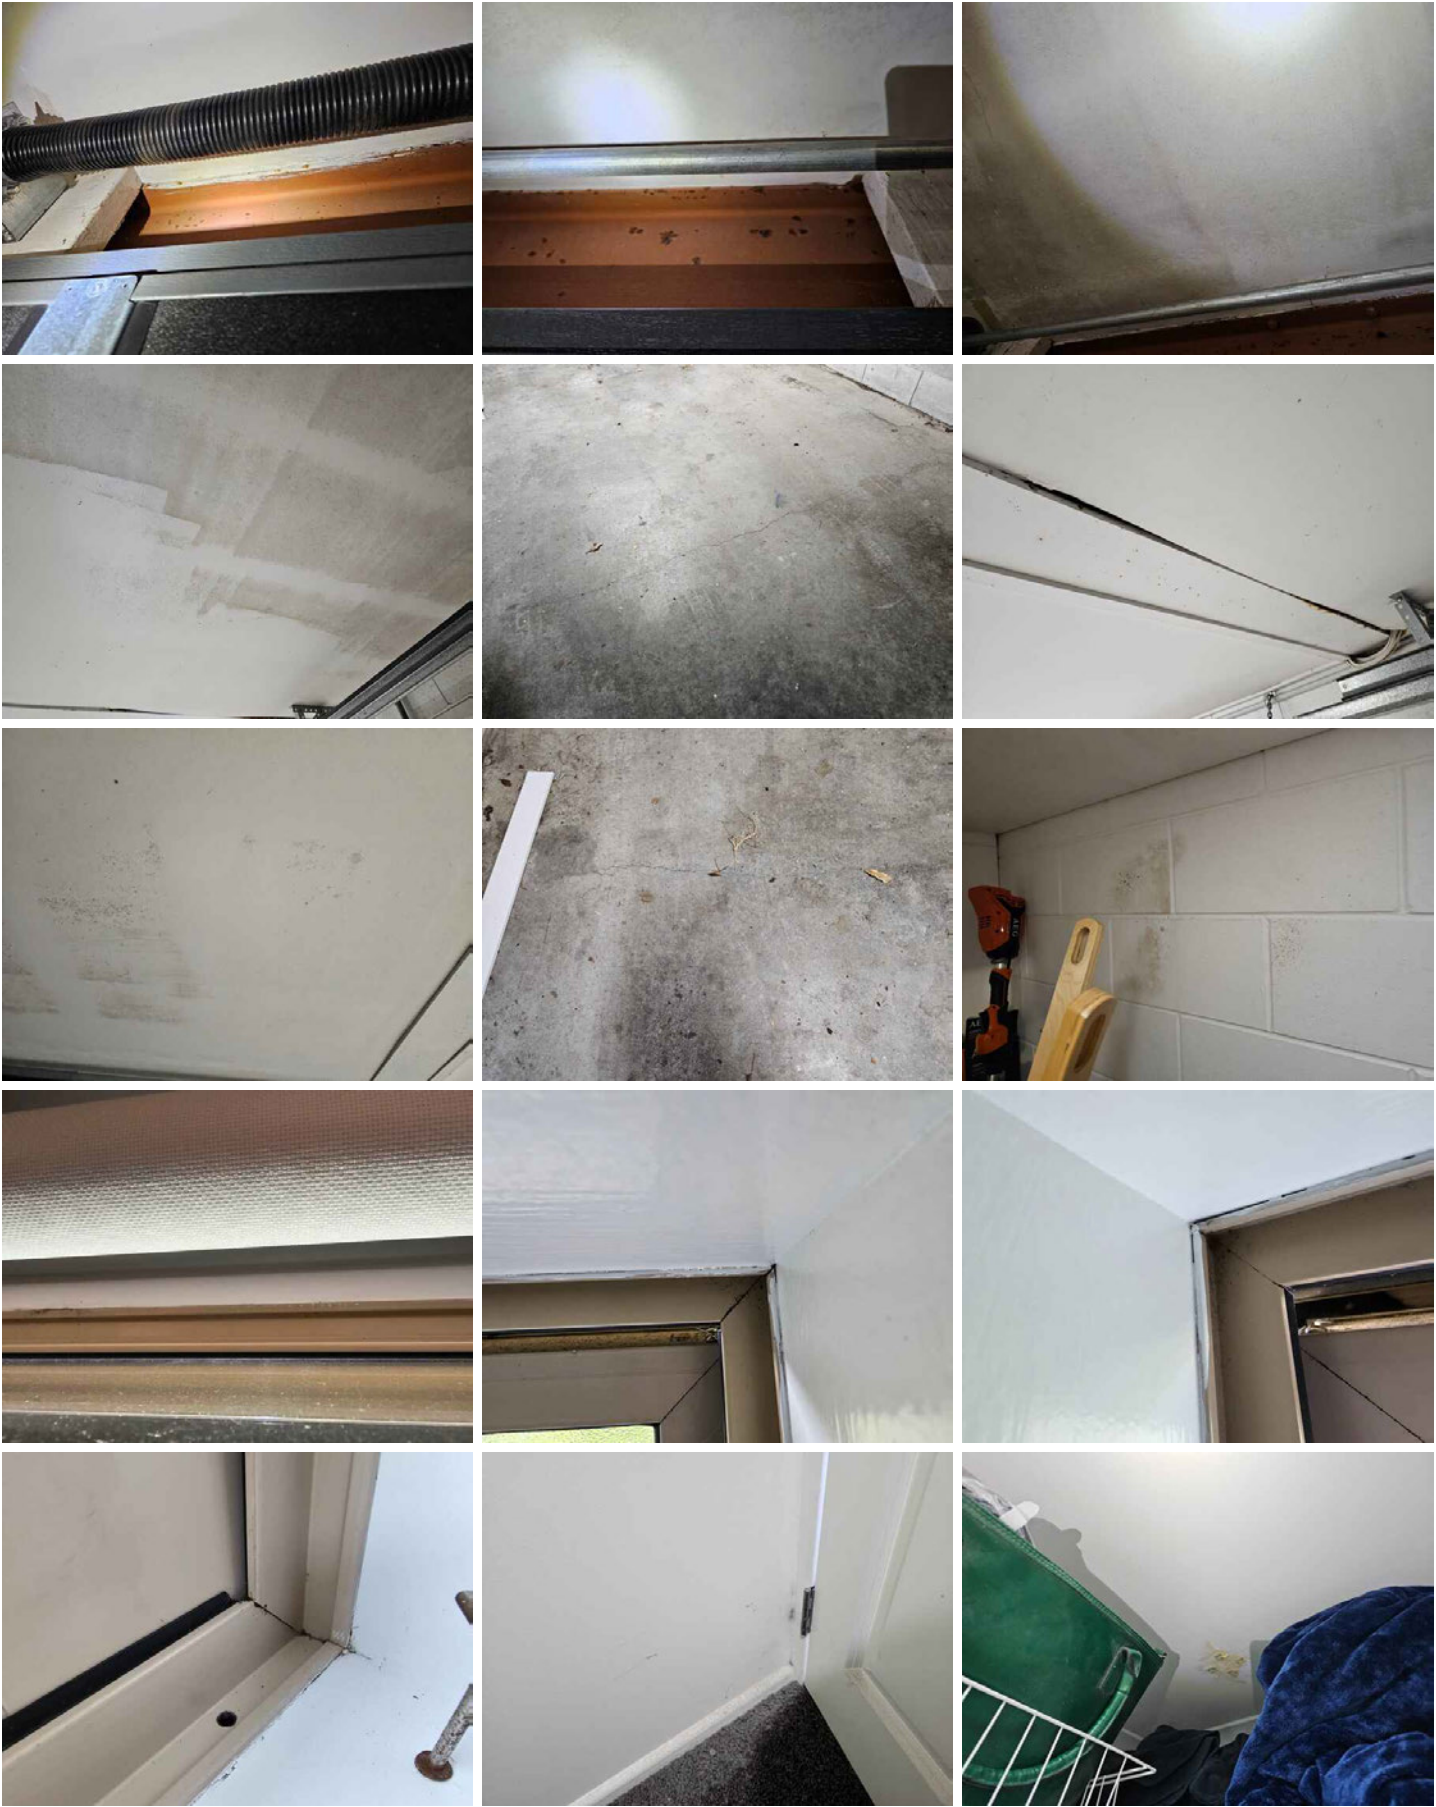
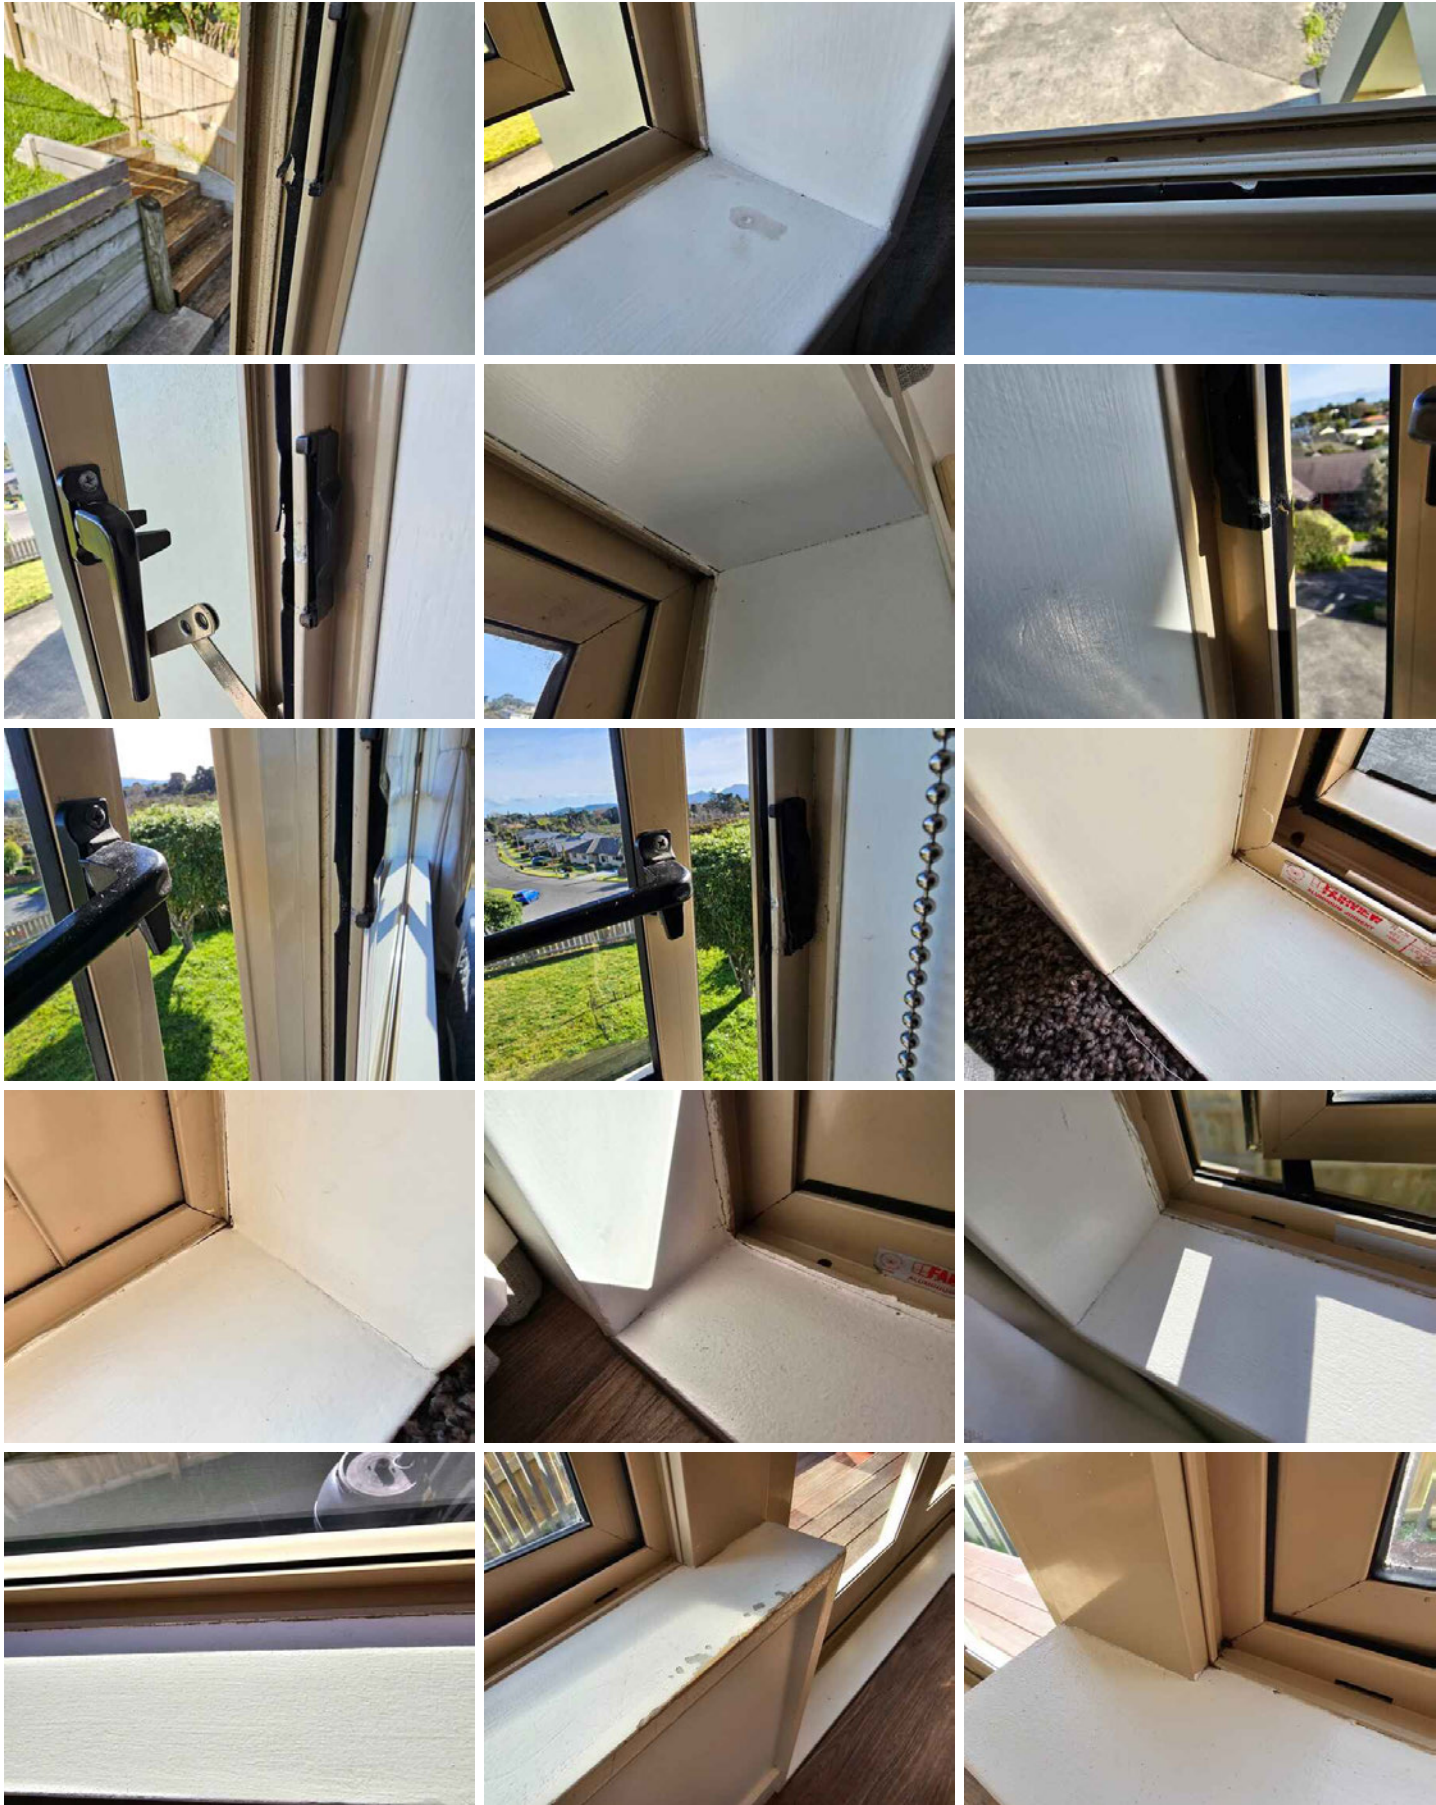
CONDENSATION DAMAGE AT JOINERY

These joinery observations may appear or be quite minor. However, we include them all because of how often we see moderate to major damage within wall cavities from condensation caused defects.

We recommend gap filler where required for the more minor touch ups and replacing any Gib that shows signs of mold and or moisture damage.

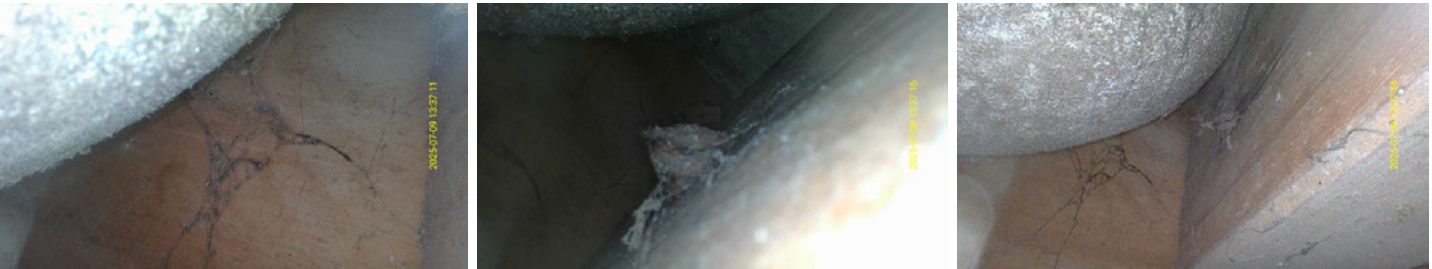
Inside cavity beneath front deck (via downpipe exit)

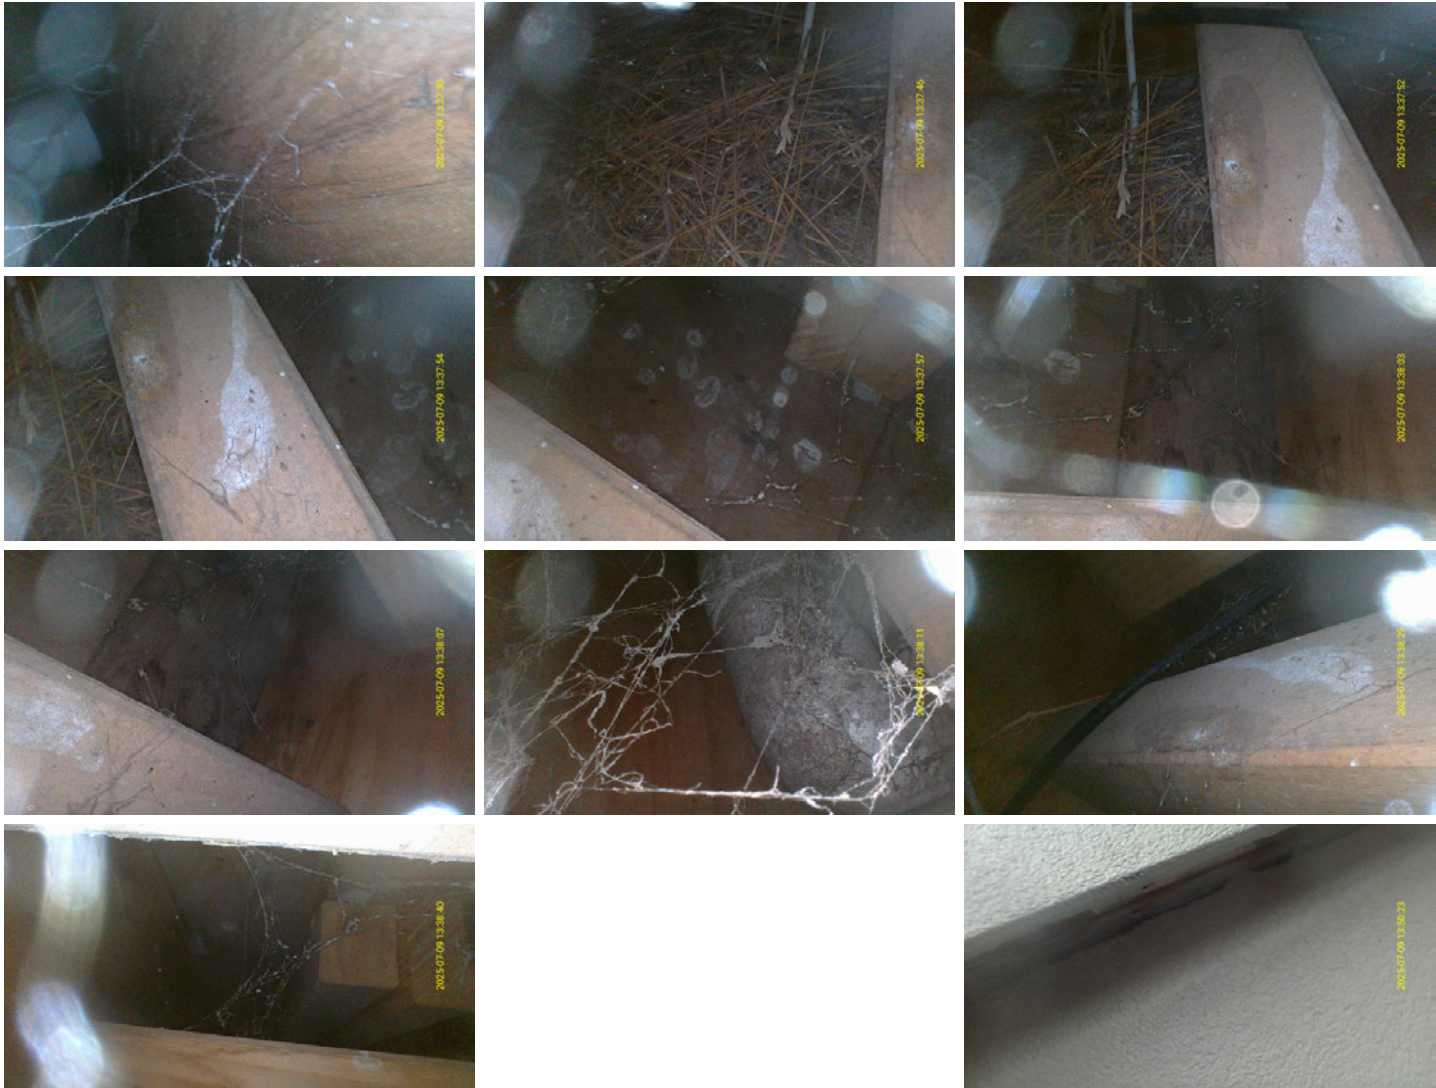
Behind cladding at rear of house

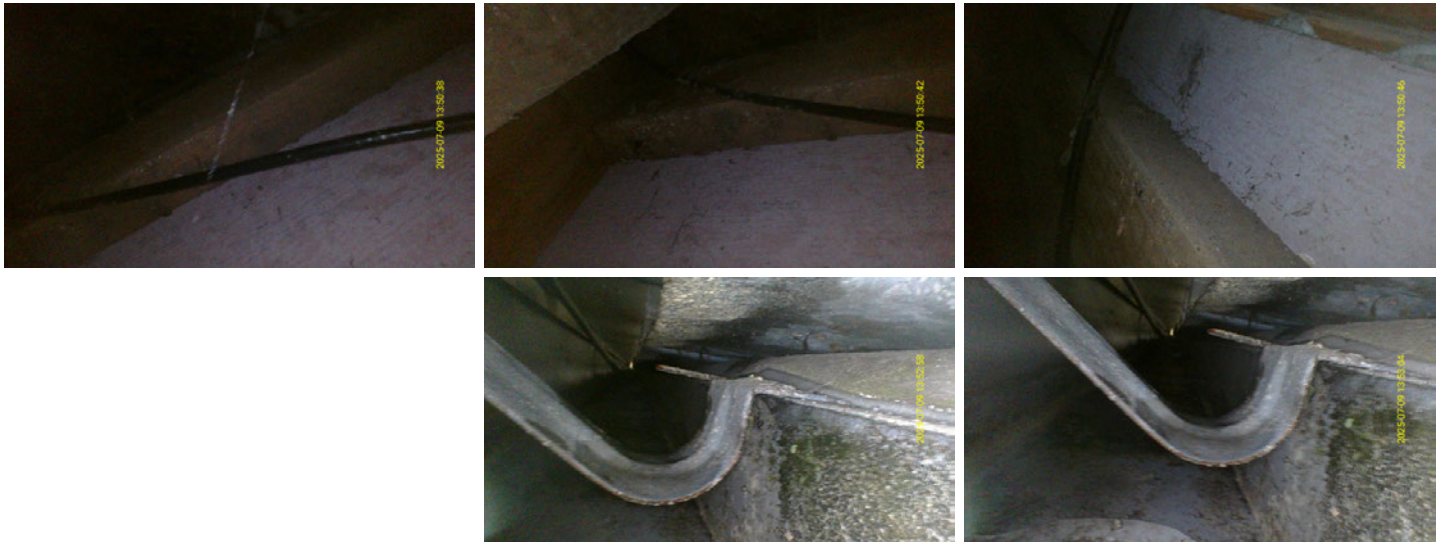
Inside gutter at rear of house

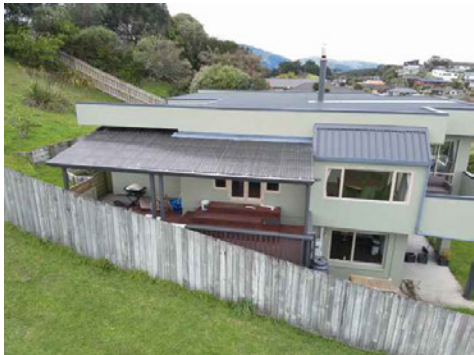
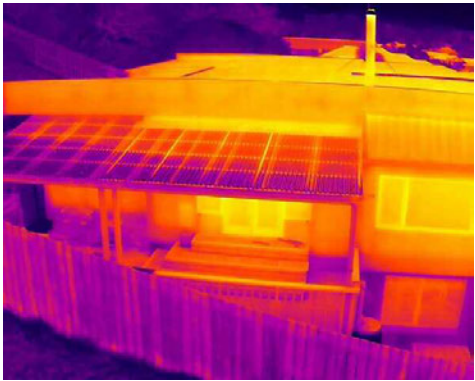
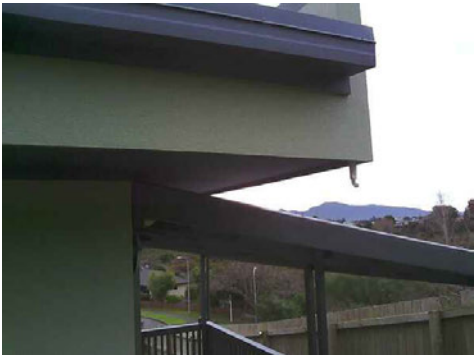
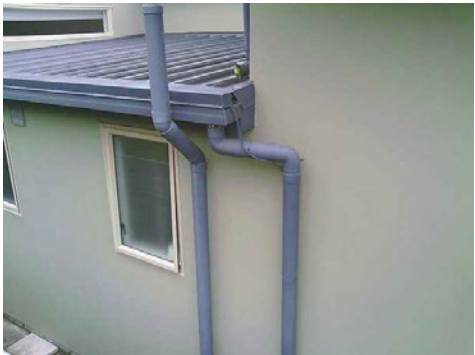
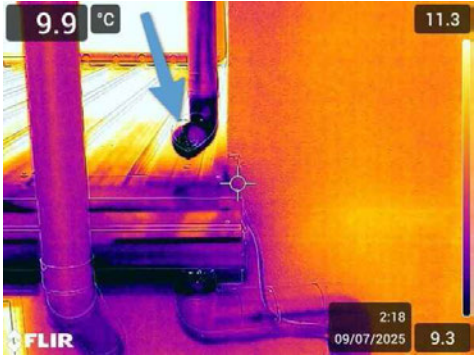
Modification to downpipe has now been made
