EARTHQUAKE RECOVERY (EQR) DOCUMENTATION

Released Under the Official Information Act 1982
EQR Property Overview Report

EQC Property ID	Property Address	Vulnerable?	Property F Status	Property Finalisation Indicator		
2010019059	125 HARRIS CRESCENT, PAPANUI		F3 - Complete & Finalised	Some Finalisation has taken place		
Main Contractor:	CLOSED OUT-Lets Roll Limited ***** (S681)		Property F2'd By:	System Generated Finalisation	F2 Completed Date:	23-04-2015
Cont Managing Hub:	Blenheim	Not Vulnerable	Property F3'd By:	System Generated Finalisation	F3 Completed Date:	23-04-2015

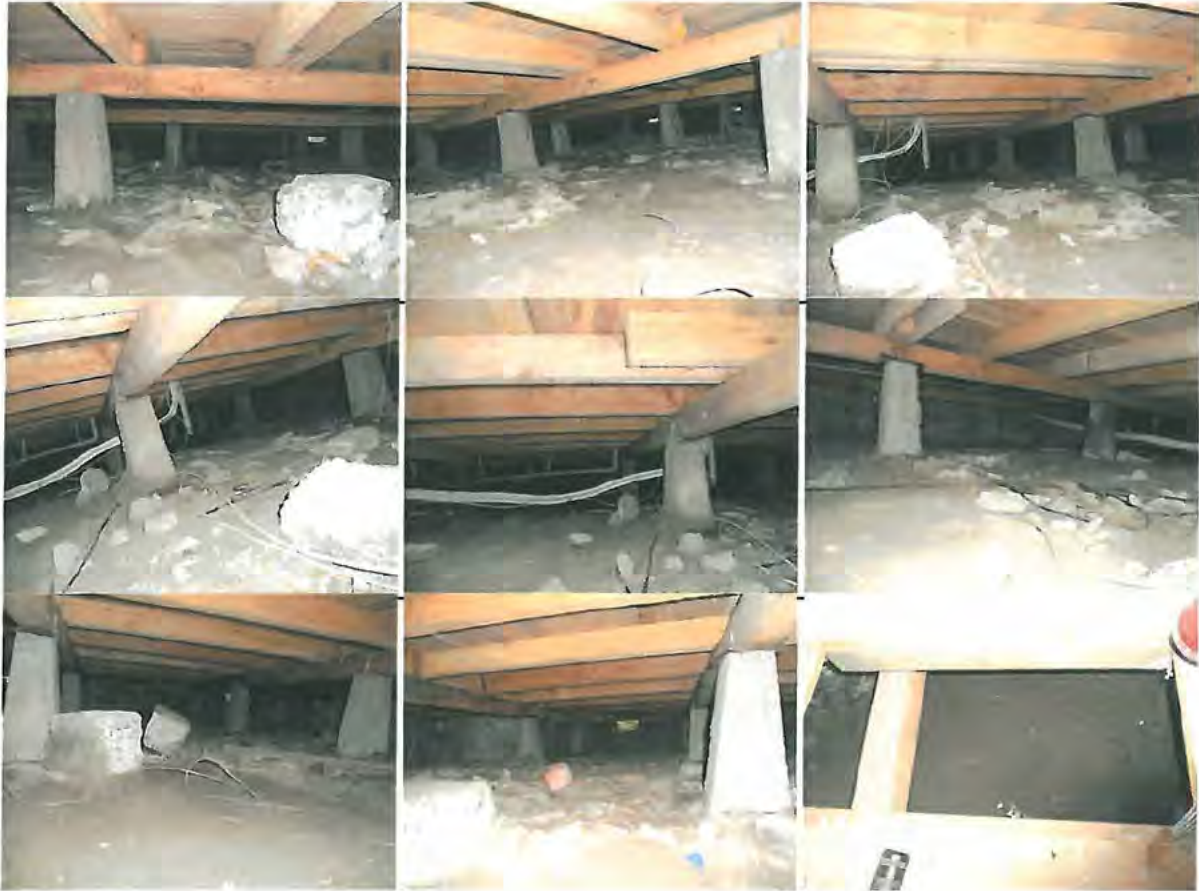
UNDER STRUCTURE PICTURES

- The owner suffers from respiratory issues, this is the reason we are planning to extract the little amount of liquefaction remaining under the house using vacuum extraction to eliminate the chance of silt/dust in the house as may happen if we used manual extraction technique.

Building work	\$95.00
Liquefaction removal process	\$1,691.81
Disposal estimate 2 cubic metres @ 1.6 tonne/m3	\$64.00
Administration costs (2 hours @ \$45.00/hr)	\$90.00

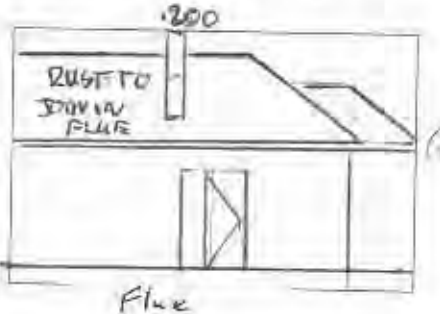
NO OBVIOUS DAMAGE TO ROOF / APPROX 2L/M RIDGE CAP LAP POINTING LOOSE (NOT EQ)
ROOF FRAMING TIMBER (RAFTERS + UNDER PURLINS BOLED WITH AGE / SOME NOT VISIBLE)

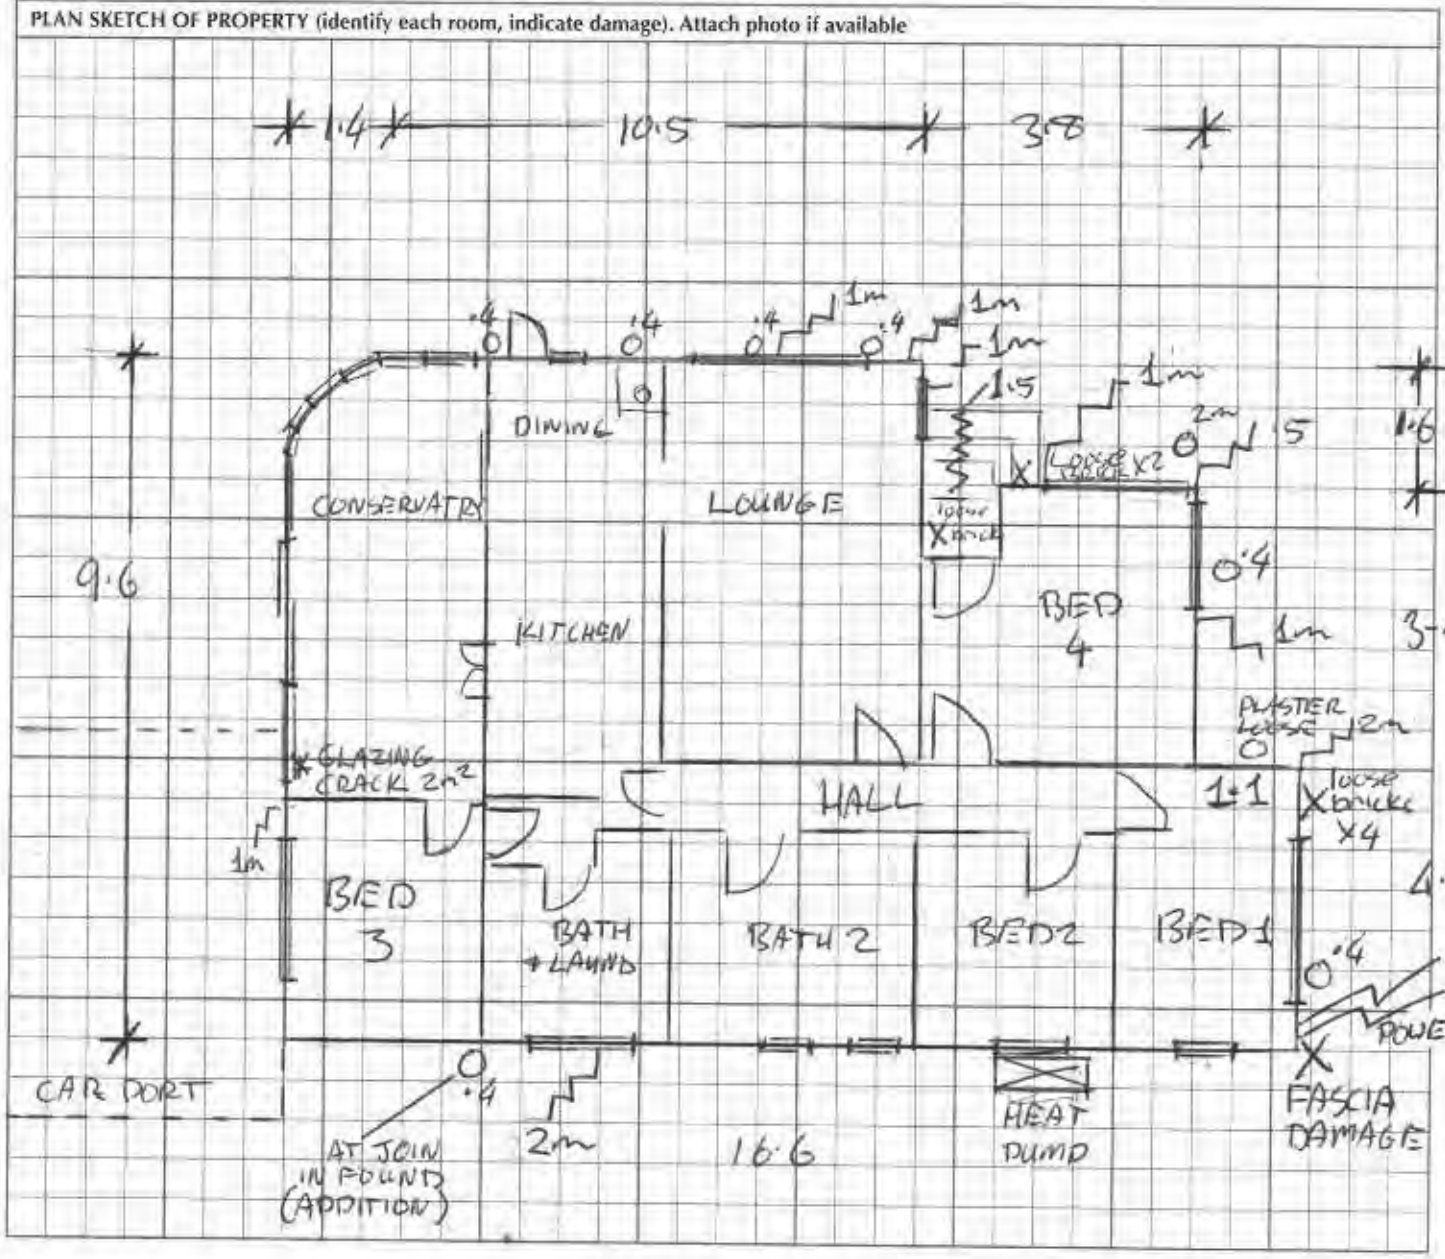
**Additional Information**

RETRO FIT DOUBLE GLAZING / BROKEN GLASS TO WOOD BURNER DOOR (NOT EQ) HEAT PUMP INSTALLED  
 • 600 ml CLEAR SPACE UNDER HOUSE / LIQUIPACTION AT NORTH & SOUTH FOUND WALLS APPROX 15m³
