# RESIDENTIAL PROPERTY INSPECTION

**Inspection Address:** 3/161 Hoon Hay Road, Christchurch

**Inspection Date:** Wednesday, 27 August 2025

**BuildQual NZ Ltd**

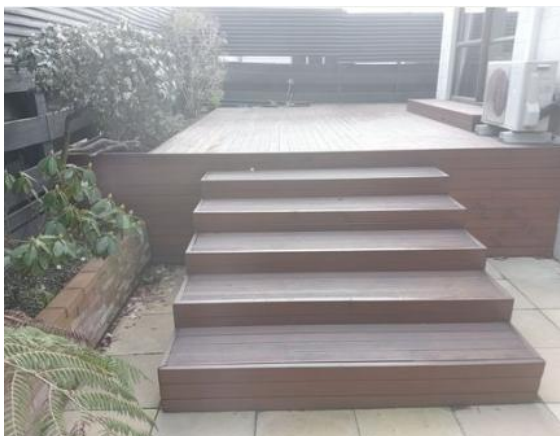
Deck - without a balustrade

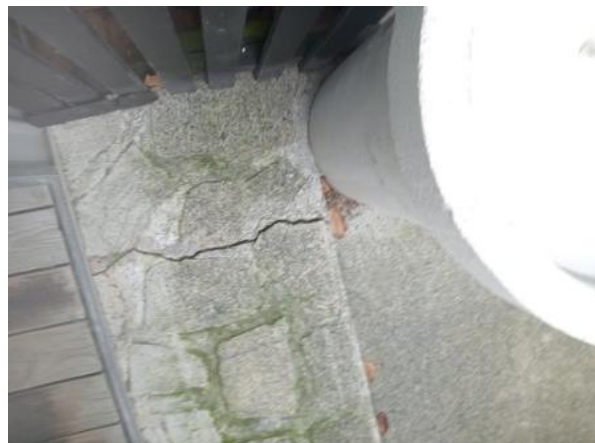
Crack in the concrete step in the east corner of the property

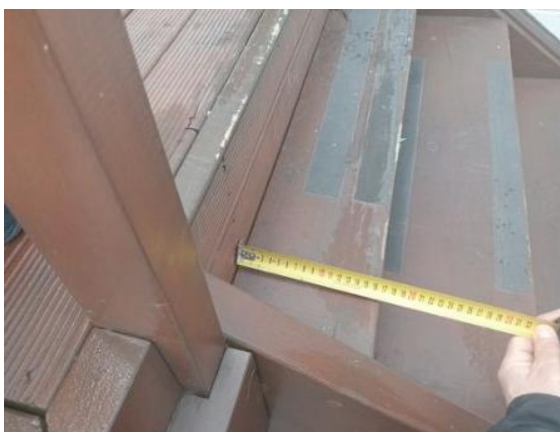
Top step is too shallow

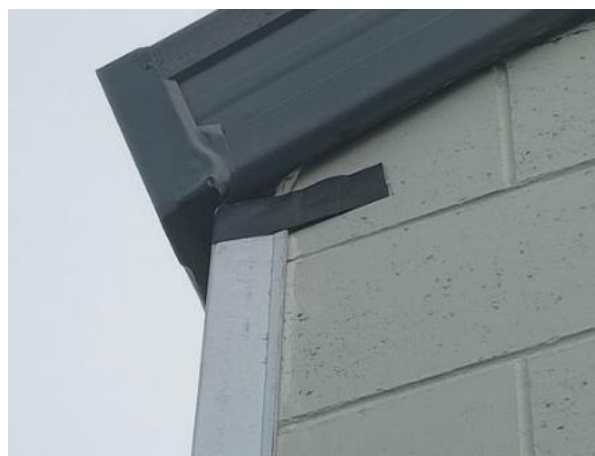
*Please note that the vendor has indicated a willingness to address minor defects following discussion. Additionally, the vendor has clarified that the tape observed on the corner flashing—specifically between the block and weatherboard cladding—was a temporary measure used while the fixings and silicone were drying, and the hot water cylinder has been repaired.*

Corner flashing between the block and weatherboard cladding is secured with tape

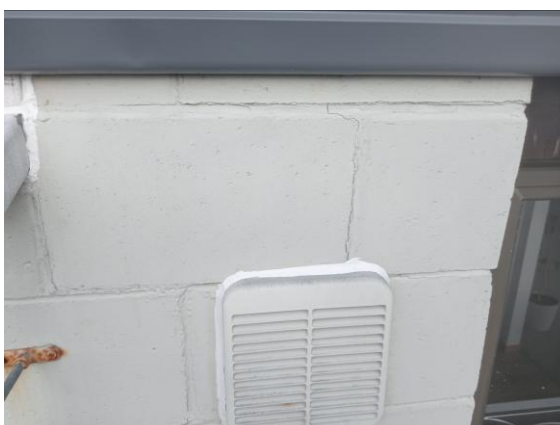
Minor cracking to blocks

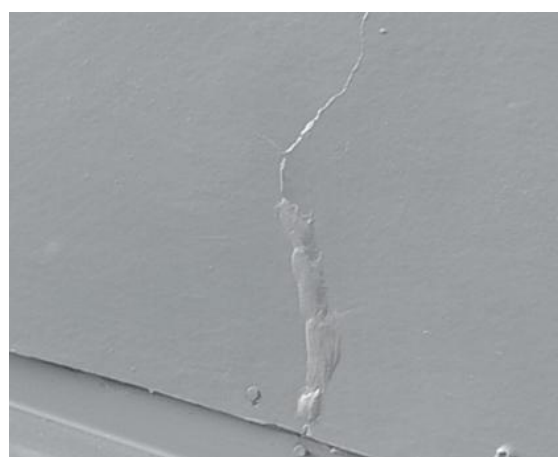
Crack in the sheet cladding on wall above the lower roof

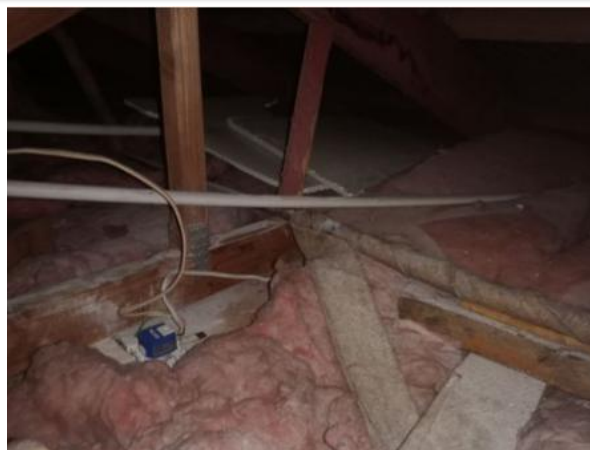
Roof space – insulation. PVC pipes

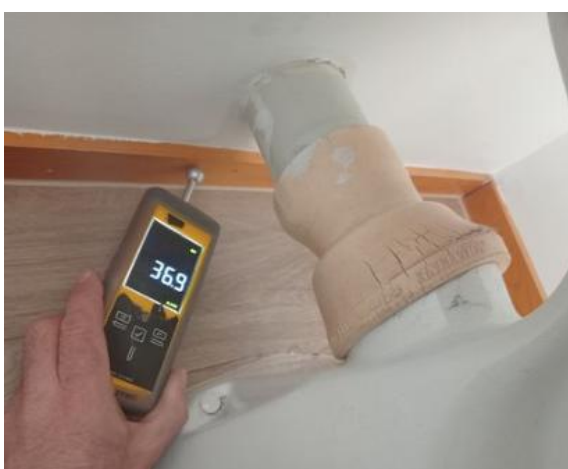
Deteriorating toilet connector

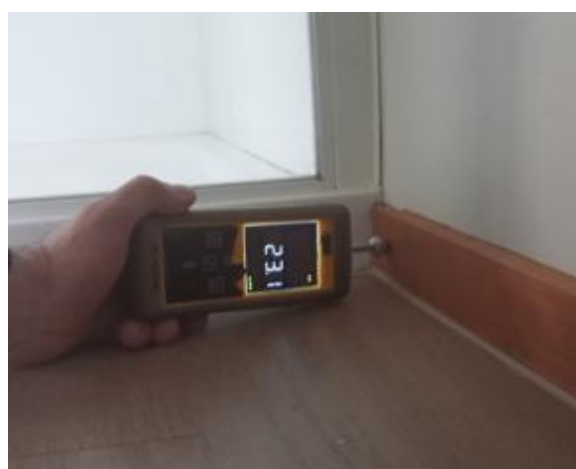
Moisture testing in the house – dry range

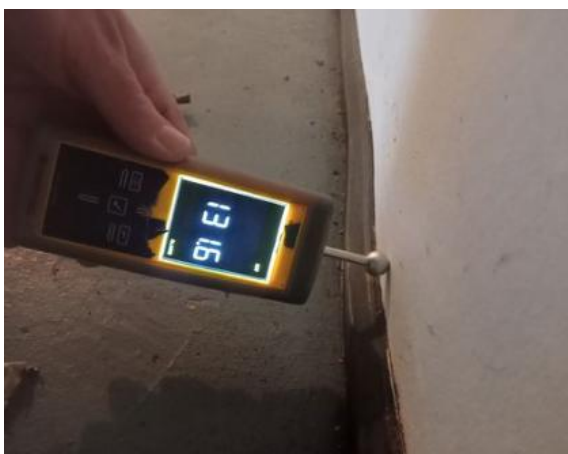
Swelling, warping of the skirting boards noted in the garage with wet moisture readings. Crack in the plasterboard ceiling

Damaged skirting in the garage – wet moisture readings

Further investigation should be undertaken to determine the cause of the wet moisture readings and any remedies in the garage.

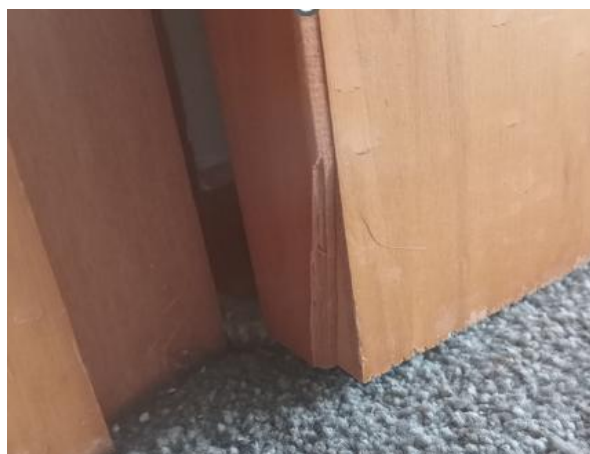
Chip in the bottom corner of the bedroom door
