EQC CLAIM DOCUMENTATION

EARTHQUAKE RECOVERY (EQR) DOCUMENTATION

Released Under the Official Information Act 1982
EQR Property Overview Report

EQC Property ID	Property Address	Vulnerable?	Property F Status	Property Finalisation Indicator		
2010023158	65 COOPERS ROAD, DALLINGTON		F3 - Complete & Finalised	Some Finalisation has taken place		
Main Contractor:	CLOSED OUT-Arbroath Group Limited ***** (SE91)		Property F2'd By:	Blair Jones	F2 Completed Date:	08-08-2016
Cont Managing Hub:	Riccarton	Not Vulnerable	Property F3'd By:	Blair Jones	F3 Completed Date:	08-08-2016

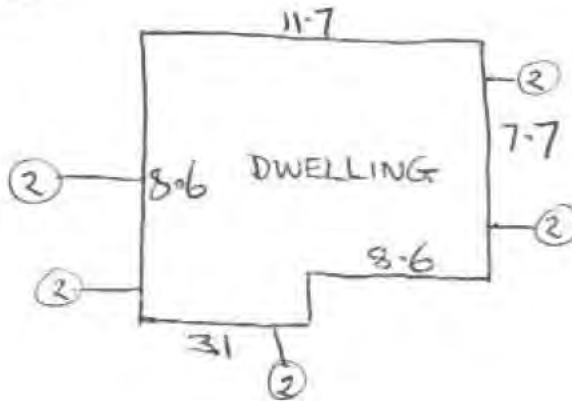
SR Tempero
65 COOPERS ROAD
DALLINGTON
CHRISTCHURCHEstimators Name: ALAN DOWNANGARAGE
5.4
3.6NOTE ALL
SOFFIT JOINTS
HAVE OPENED.

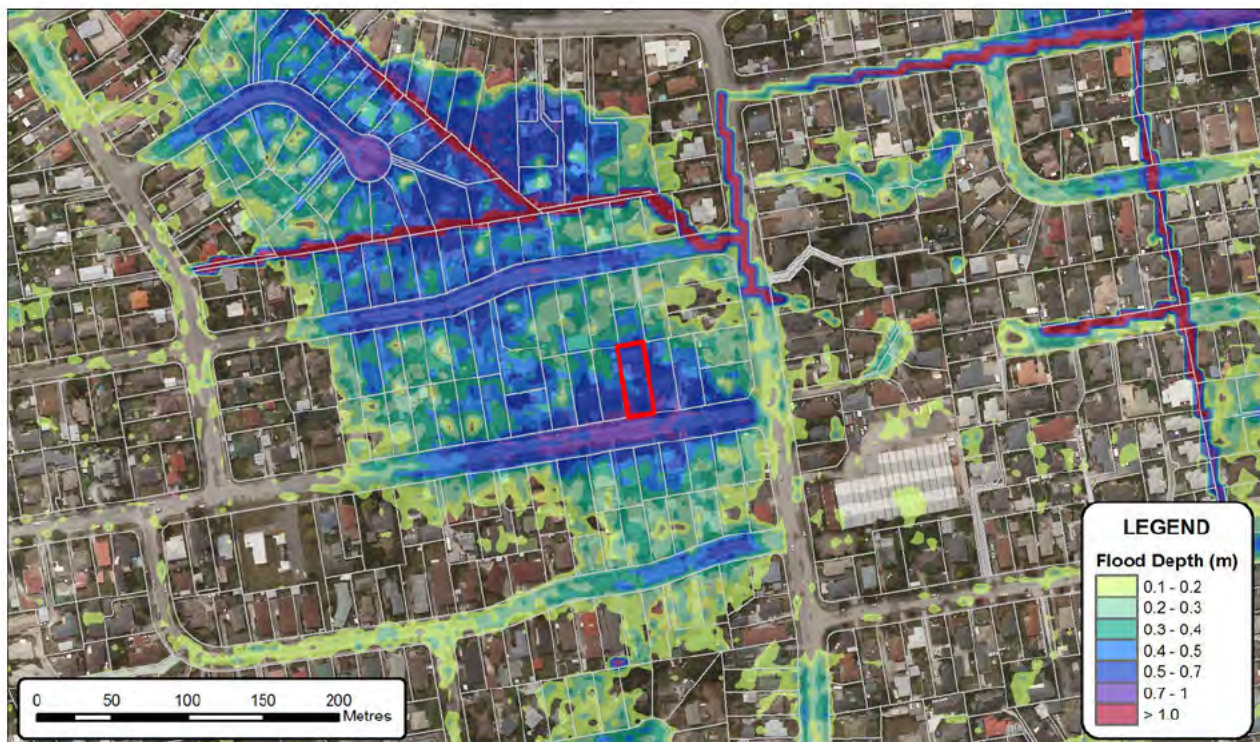
Map 2: Modelled flood depths for a 1 in 100 year flood event before Canterbury earthquake sequence

Map 2 shows flooding for the 1 in 100 year flood event before the Canterbury earthquake sequence.

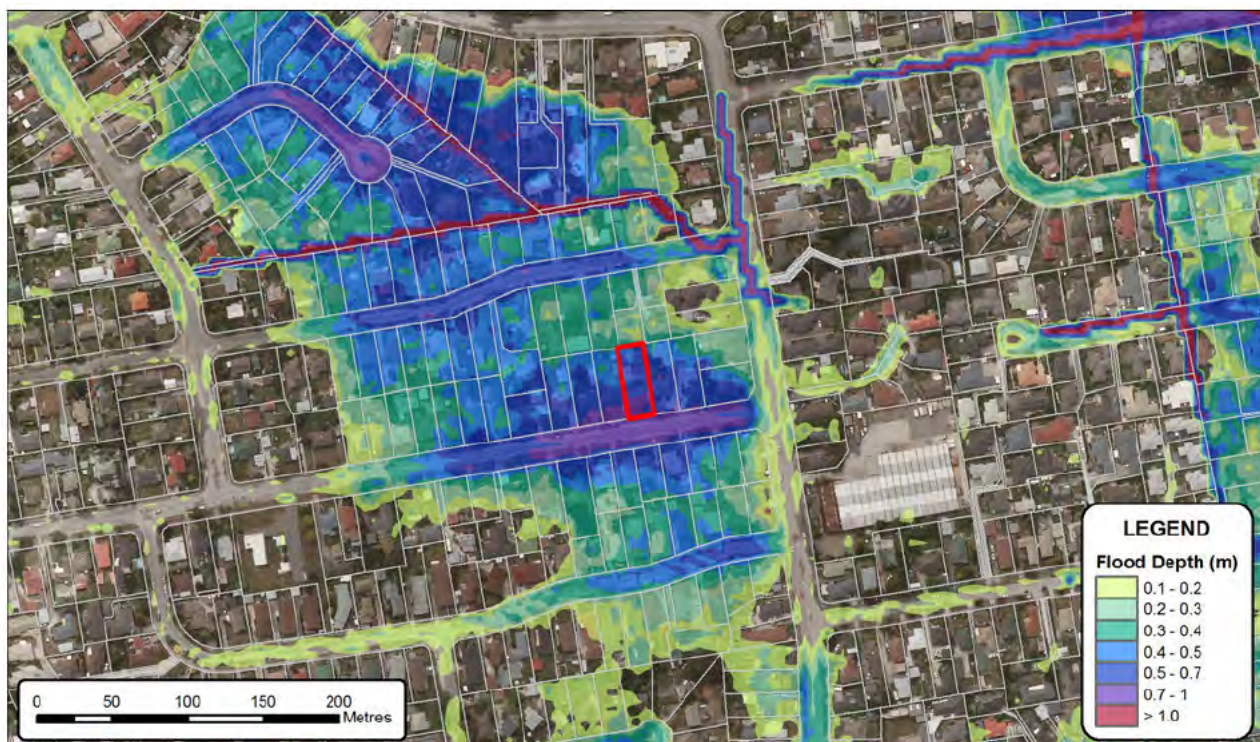
Map 3: Modelled flood depths for a 1 in 100 year flood event after the Canterbury earthquake sequence

Map 3 shows flooding for the 1 in 100 year flood event after the Canterbury earthquake sequence.

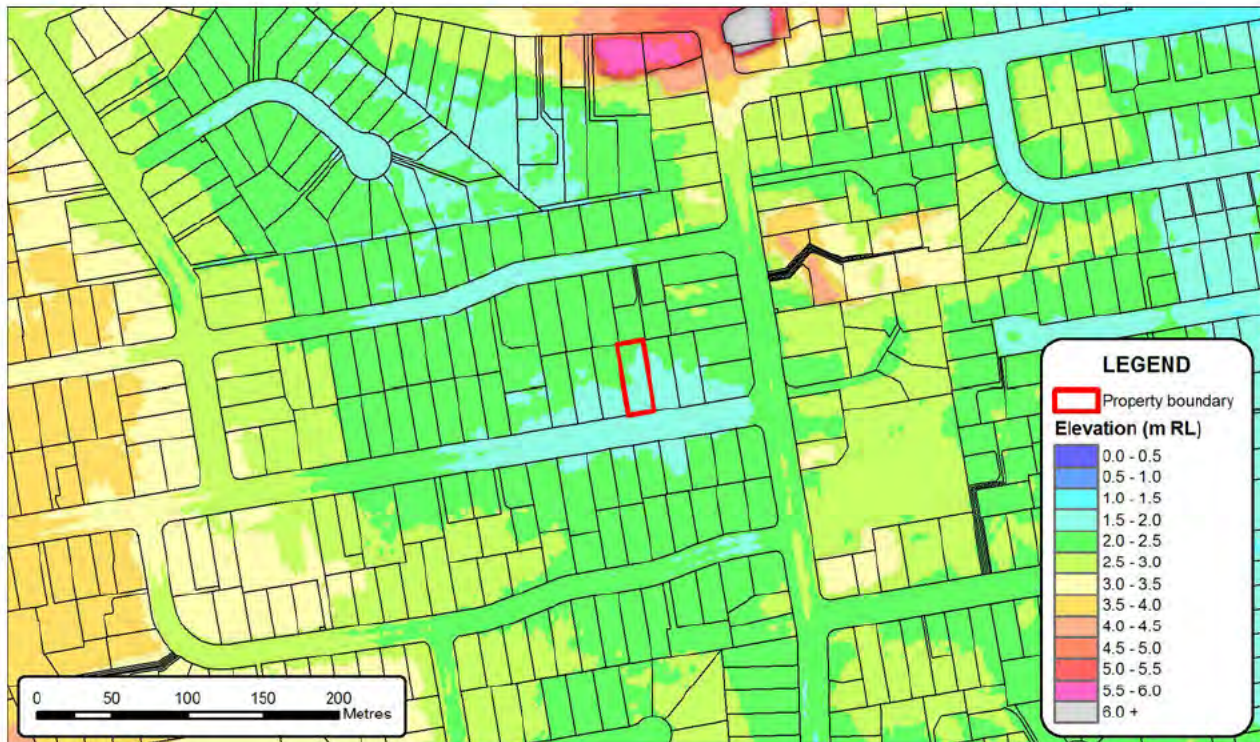
Map 4: Ground surface elevation post December 2011

Map 4 shows the ground elevation (i.e. the height of the land) following the Canterbury earthquake sequence. The ground surface elevation was measured using an aerial LiDAR survey (which involved scanning the ground surface
