Healthy Homes Assessment Report

AC EA No.: 01957 Date: 11/08/2021

First Name:	Bright Property Management
Last Name:	
Street Number	65
Street Name:	Coopers
Street type	Road
Suburb:	Dallington
Post Code	8061
Council Region	CCC
Phone:	
Property Manager:	Bright Property Management

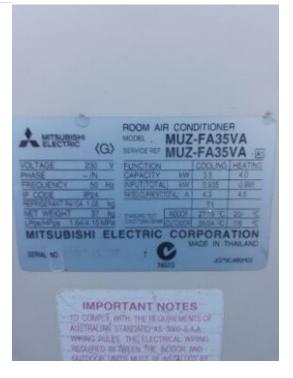
Outdoor unit and label

Heat Pump No 1 (living area) brand, size(KW) and model

MITSUBISHI MSZFA35VA 4.0KW + Panel heater 1.5kW
