## Building and Timber Pest Inspection Report

Inspection Date: Tue, 2 Sep 2025

Property Address: 40A Shields St, Redcliffe QLD 4020,  
Australia

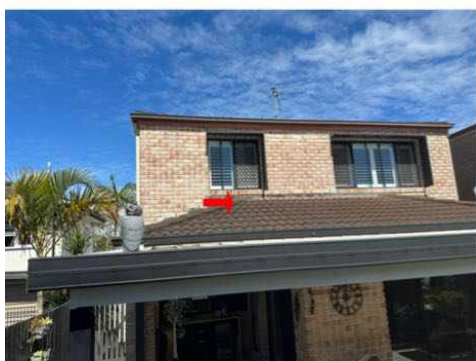
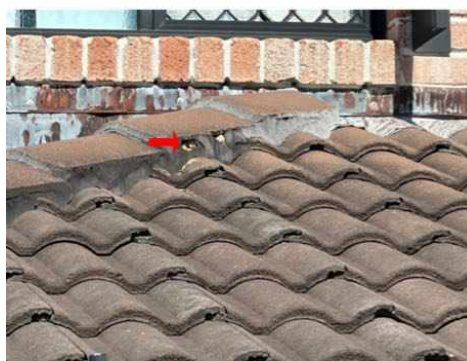
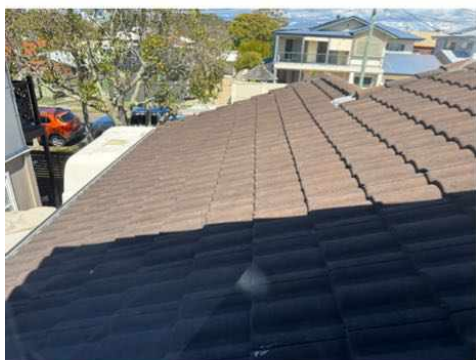
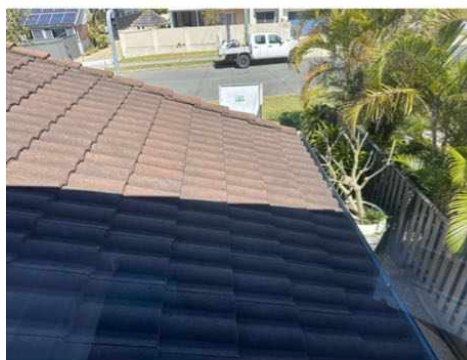
#### Finding 3.01

Building: Main Building  
Location: Roof Exterior  
Finding: Roof tiles - Weathered  
Information: Upon inspection of the exterior roofing, the majority of roof tiles were considered to be in a fair condition. While weathering of the tiles is consistent with the age of the property, maintenance works are required.

Where left unmanaged, deteriorating roof tiles are likely to lead to a number of secondary defects, including minor water leaks and weather exposure to internal roofing structures.

Re-pointing and re-sealing the may be considered as an interim solution by the client to help preserve and extend the life span of the tiles.

Consultation with a roofing contractor is highly advised to gain advice on cost of remedial works that may be required in the short to medium term. Remedial works are likely to increase the longevity of the exterior roofing structure.

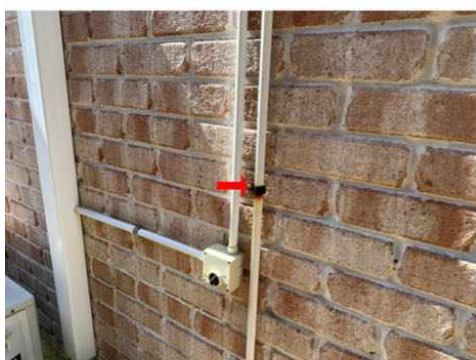
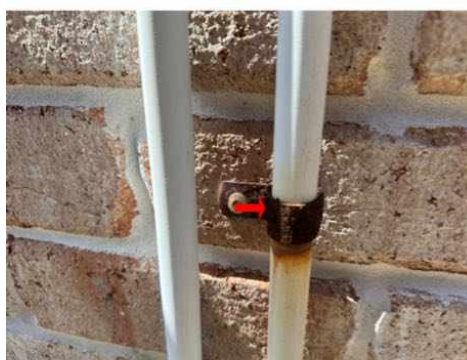
### Finding 3.02

| Building: | Main Building |
| Location: | Exterior walls - left side |
| Finding: | Conduit Clips- Rusted or corroded |
| Information: | This building element shows evidence of rusting and corrosion, which is likely to have developed as a result of excessive exposure to moisture and or inadequate coatings. |

As surface rust provides no protection to the underlying iron, the deteriorating condition is likely to worsen if not addressed in the short-term future.

Where possible, the use of galvanized (treated) metals or aluminium coated metals aid in rust prevention, as does regular general maintenance. Rust formation can be controlled with coatings, such as paint, that isolate the iron from the environment.

Rusting and corrosion should be managed by ideally removing or limiting the affected surface from exposure to moisture. A registered builder may be appointed to replace any building elements that have been severely affected by rust or water damage.

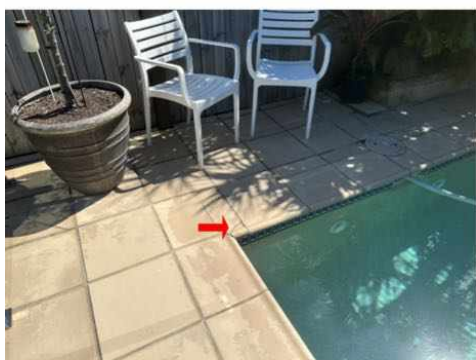
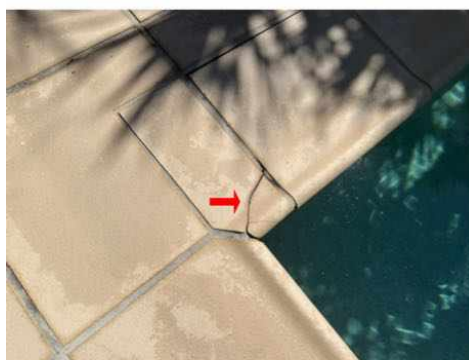
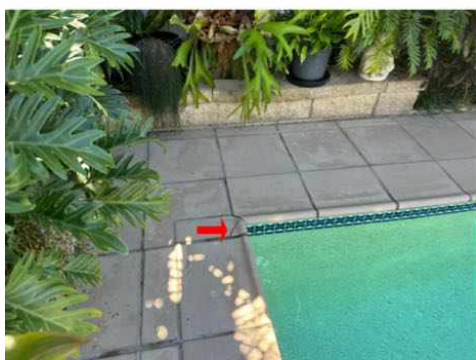
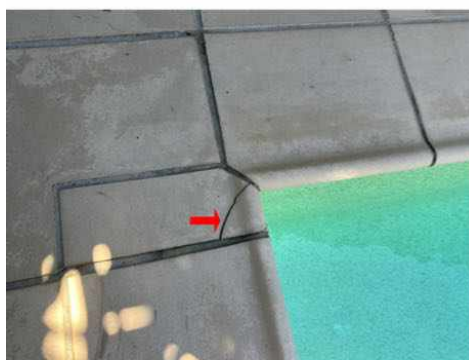
### Finding 3.03

| Building: | Main Building |
| Location: | Pool Area |
| Finding: | Cracked floor tiles |

Information: Cracking in the floor tiles was evident in this area at the time of inspection. It is suspected that this cracking has occurred as a result of minor settlement or shrinkage of the slab.

Cracked tiles throughout the household detract from the overall appearance of the affected areas however it is unlikely to create or lead to any secondary defects.

While not considered a matter of urgency, replacement of cracked floor tiles is recommended at the clients discretion. A tiling contractor may be appointed to perform these works. Where cracks become more numerous, contact a licensed building inspector for further investigation.

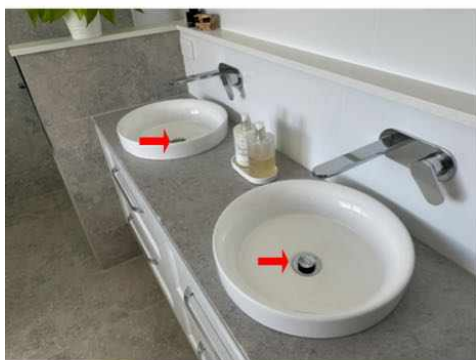
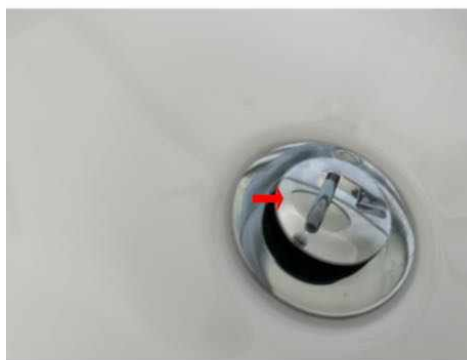
### Finding 3.04

Building: Main Building  
 Location: Ensuite  
 Finding: Vanity Waste plugs  
 Information: The vanity basins were fitted with pop-up waste which appeared to be faulty to some degree. A licensed plumber will need to be engaged to service these wastes to ensure their functionality.

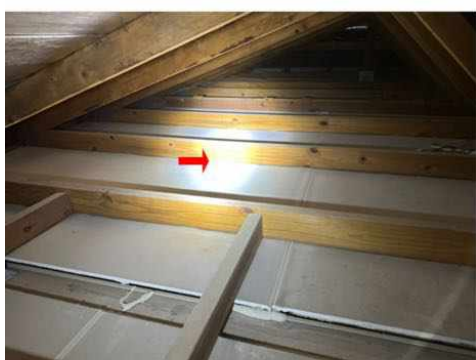
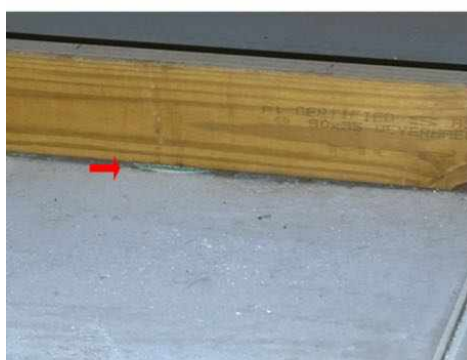
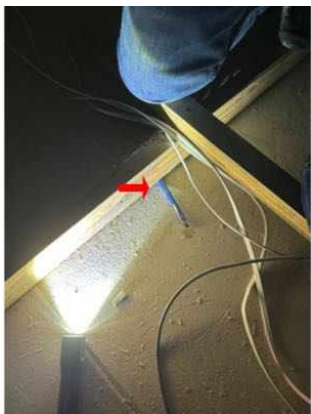
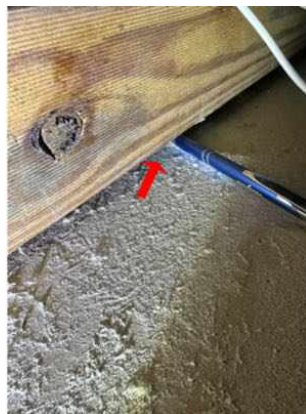
### Finding 3.05

Building: Main Building

Location: Roof Void

Finding: Ceiling - Sagging

Information: Sections of the ceiling were found to be sagging at the time of inspection. Sagging to the fixed ceiling structure generally indicates that the building materials have swollen, due to contact with high humidity, or that fixings (e.g. nails or glue) have become loose and require reattachment.

Where minor sagging is evident, comparatively minor works, such as re-gluing of ceiling sheets, may be required. Such works may be performed by relevant tradespeople, such as plasterers and painters. Where excessive moisture has caused the roofing structure to swell and sag, the source of the water leak should primarily be identified prior to any remedial works being performed.

The appropriate action should be taken by the client as soon as possible to ensure that any potential further damage is limited.

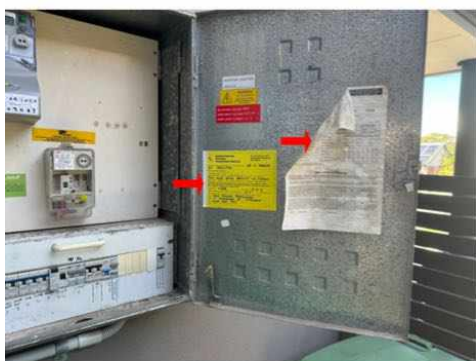
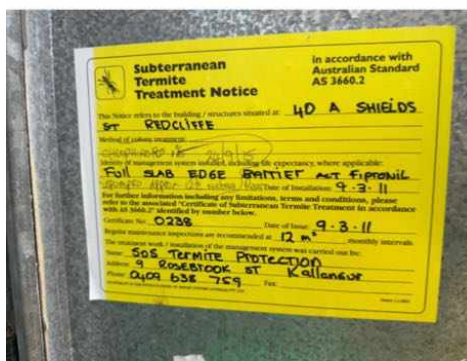
| Building: | Main Building |
| Location: | Meter Box |
| Finding: | Evidence of a previous termite management system was identified |
| Information: | There are a number of factors which indicate the presence of a previously installed or applied termite barrier. The most common are a durable notice (to the inside of your meter box) observable physical barriers installed to building perimeter and in ground reticulation systems. |

Where a Termite Management System has been identified you should refer to the type of barrier date of installation warranty conditions and any documentation provided by a builder or past owner. Consult the company who installed the barrier to confirm whether the system is still under warranty.

Most chemical termite management systems expire and require replenishment and all physical systems are primarily designed to prevent concealed entry.
