# CASH SETTLED CLAIM(S)

## Statement of Claim Checklist / Repair Strategy

H Pearey  
29 NEVILLE STREET  
SPREYDON  
CHRISTCHURCH

## EQC Full Assessment Report

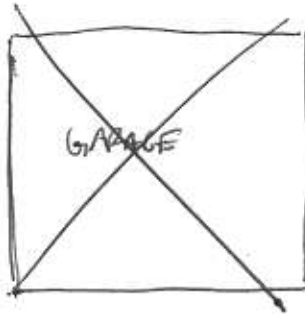
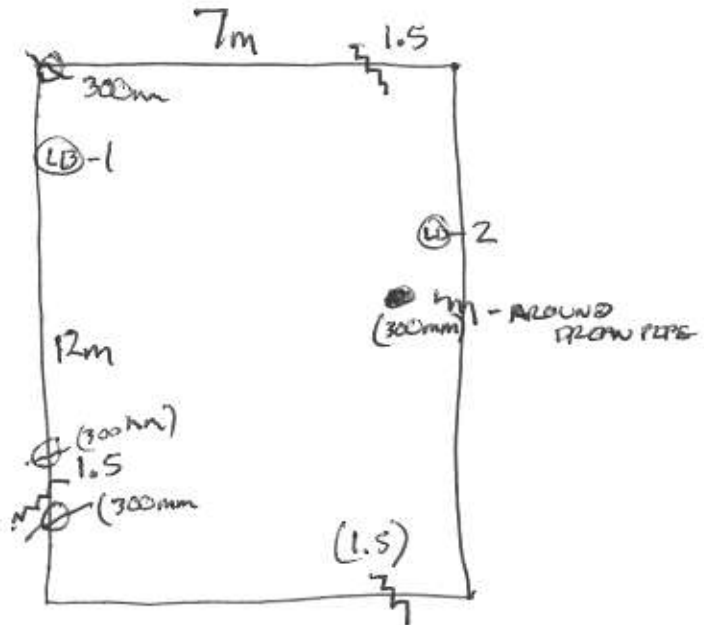
HOUSE FOOTPRINT

| Item | | Event<br>Damage<br>Y / N | |
|---|---|---|---|
| EXTERNAL WALLS | North | Y | 1.5 Crack in hard plaster.<br>Grind out - re hard plaster & mortar<br>Crack small brick East front door<br>Re-lay and mortar. |
| | South | Y | Rear door steps - moved away from house foundations<br>• 6 C.I bricks outside laundry window.<br>• 2 Loose brick around external sewer pipe.<br>Grind out and re mortar joints.<br>Foundation: N/E corner - Cracked away.<br>Grind out foundation - render & hard plaster |
| | East | Y | 1.5m Step cracks - Grind out and re-mortar joints.<br>in bricks |
| | West | Y | 1.5m Step cracks on S/West corner bricks.<br>Grind out and re-mortar joints. |

| Item | Event<br>Damage | |
|---|---|---|
| Foundations | Y | North skirt foundation - Crack in foundation.<br>• 3x2 Grind out and hard plaster |

LB - LOOSE BRICK

⊖ CRACK ON EXTERIOR PLASTER

⚡ - CRACKING IN MORTAR

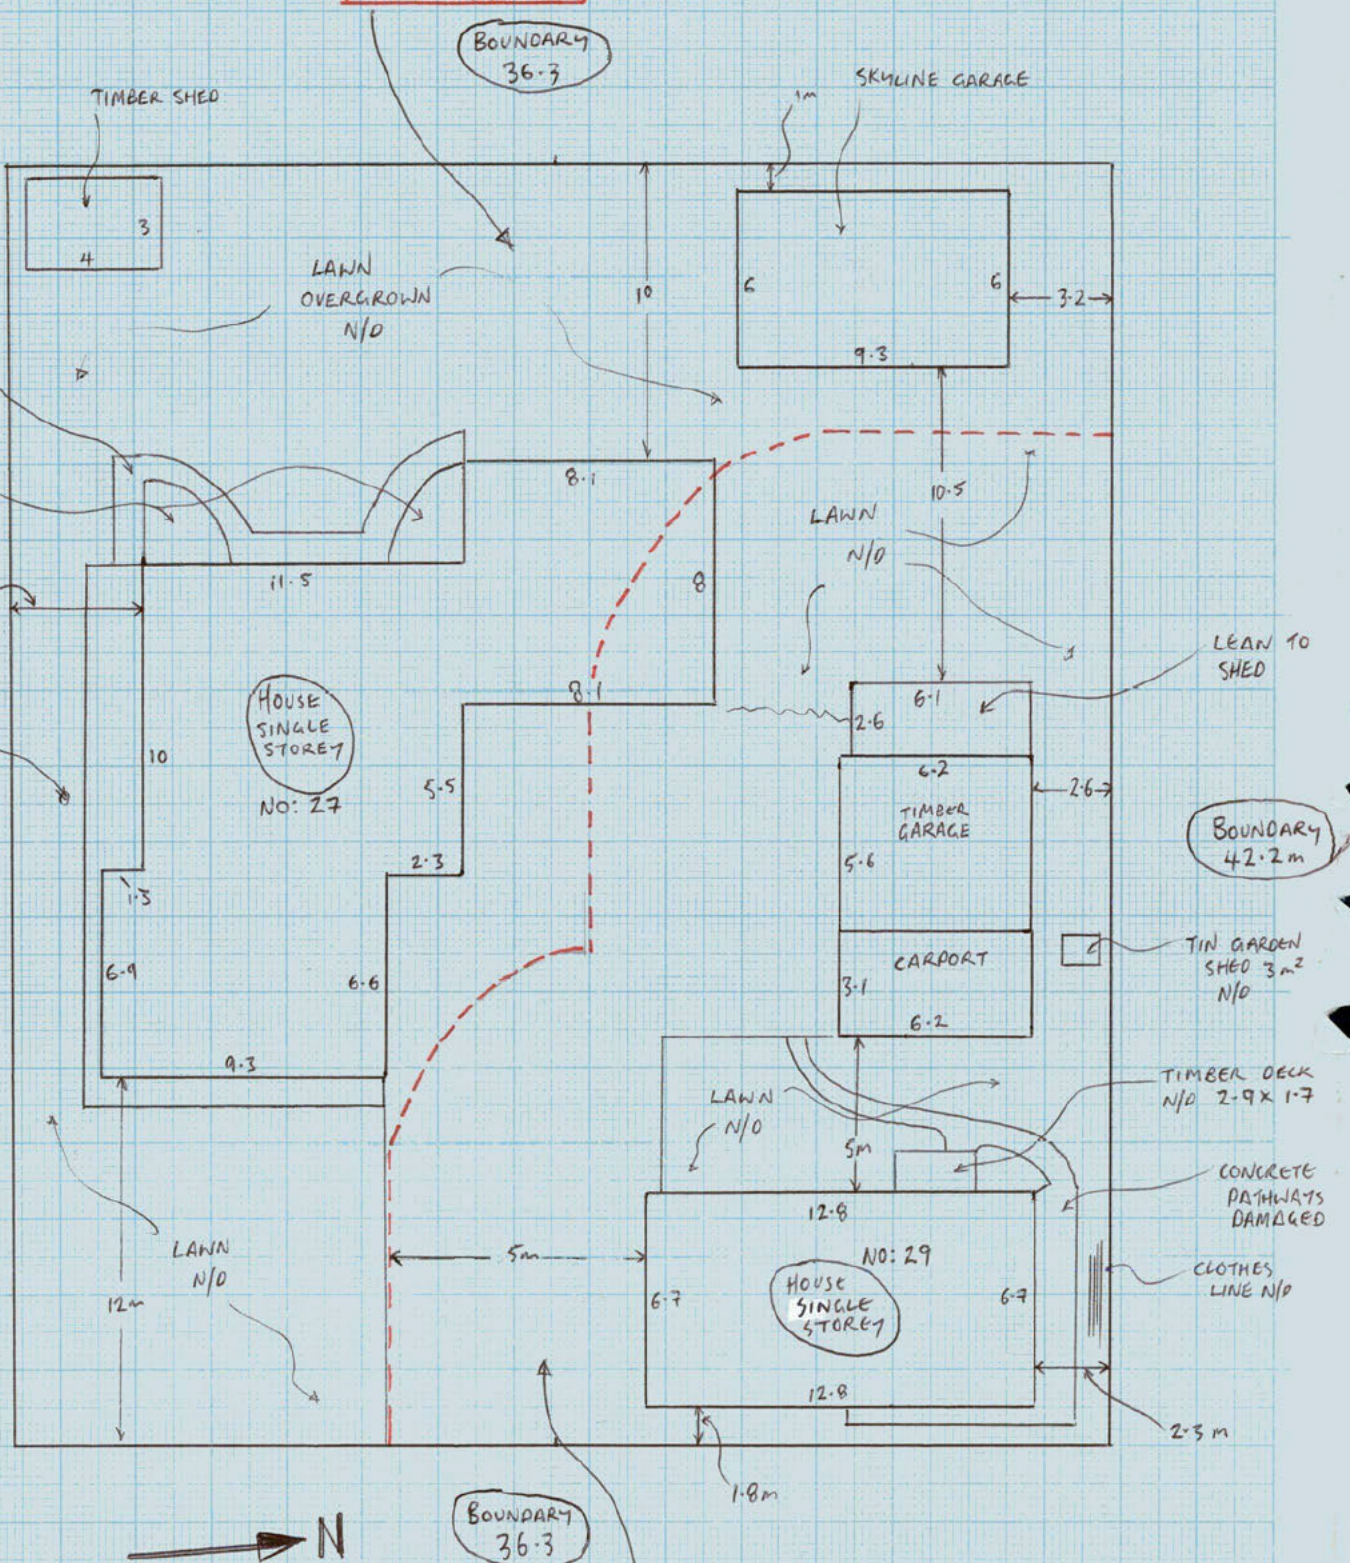
## SHARED MAIN ACCESS PLAN

NO LAND DAMAGE

CONCRETE  
PATIOS  
DAMAGED

CONCRETE  
PATHWAYS  
DAMAGED

SHARED MAIN ACCESS  
NO EQ DAMAGED  
LOOSE STONE CHIP

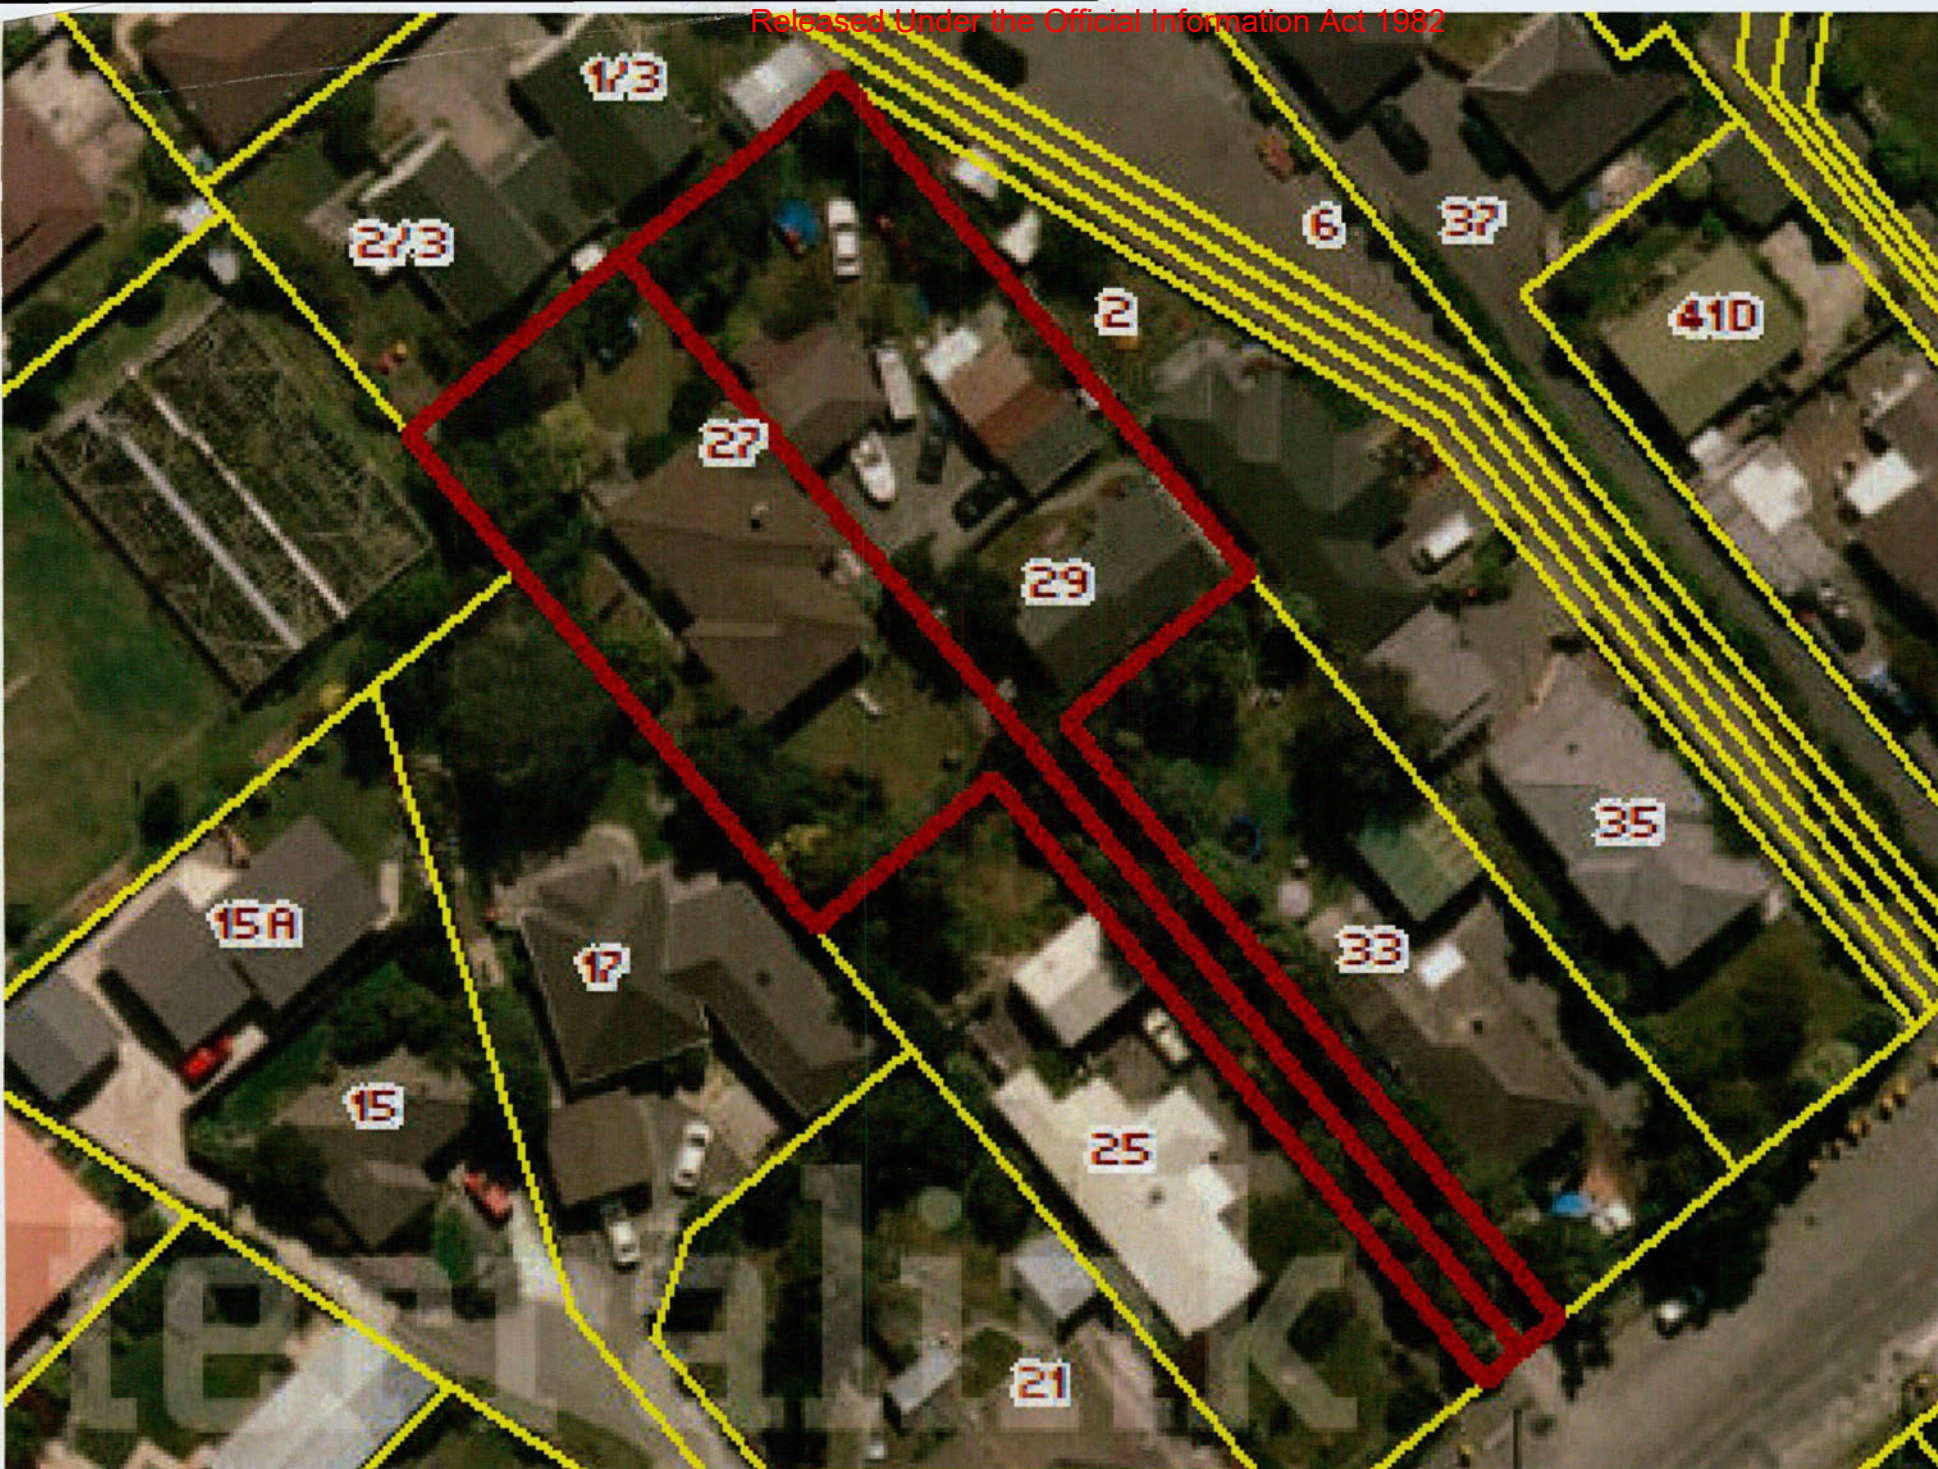
NO LAND DAMAGE

LOOSE STONE CHIP DRIVEWAY  
DAMAGED (NON EQ)
