# RESIDENTIAL PROPERTY INSPECTION

**Inspection Address:** 32 Nicholls Street, Christchurch

**Inspection Date:** Monday, 25 August 2025

**BuildQual NZ Ltd**

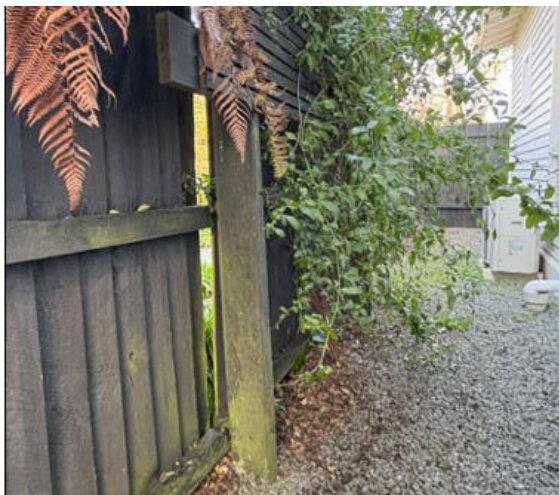
| ITEM ASSESSED | DEFECT | COMMENTS/NOTES |
|---|---|---|
| Fencing <ul style="list-style-type: none"><li>Material Type</li><li>Height</li><li>Condition</li></ul> | Minor | Mixture of profiled metal sheets and timber palings. 1.8m high - fair condition, Some sections are detached and need refixing. |

Section of fence detached

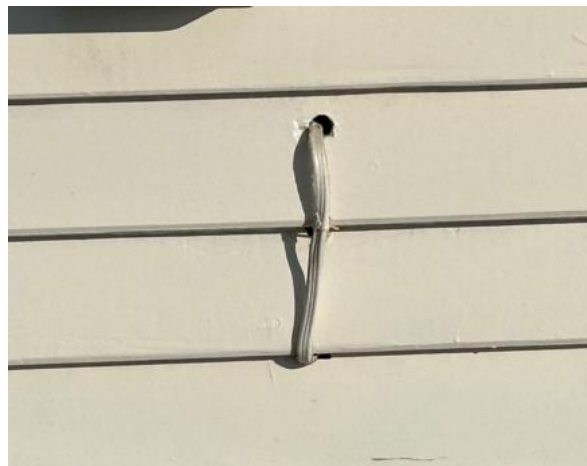
| ITEM ASSESSED | DEFECT | COMMENTS/NOTES |
|---|---|---|
| Wall Cladding (condition, tied to frame, weep holes.) | Minor | Vent penetrations not sufficiently sealed with head flashings or sealant. Electrical wire penetration through cladding not sealed, no conduit covering wiring. |

Electrical wire penetration through cladding not sealed

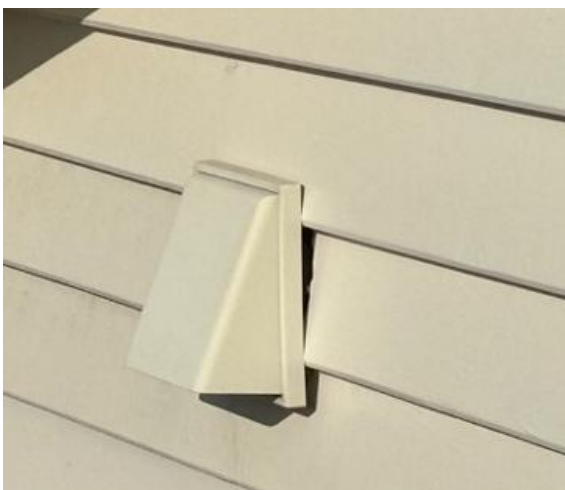
No sealant or flashings around vent penetrations

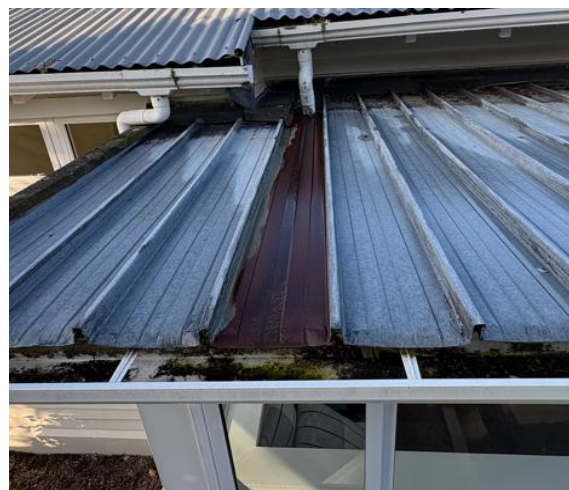
| ITEM ASSESSED | DEFECT | COMMENTS/NOTES |
|---|---|---|
| Roof condition | Minor | Some lichen build-up on roof, needs treating. Tray roofing over entrance area has a dip in the middle which holds water, one section of tray which the main roof drains onto has rusted. |

Rusted section of tray roof over entrance

- Some lichen build-up on roof, needs treating
- Tray roofing over entrance area has a dip in the middle which holds water, one section of tray which the main roof drains onto has rusted and will need replacing

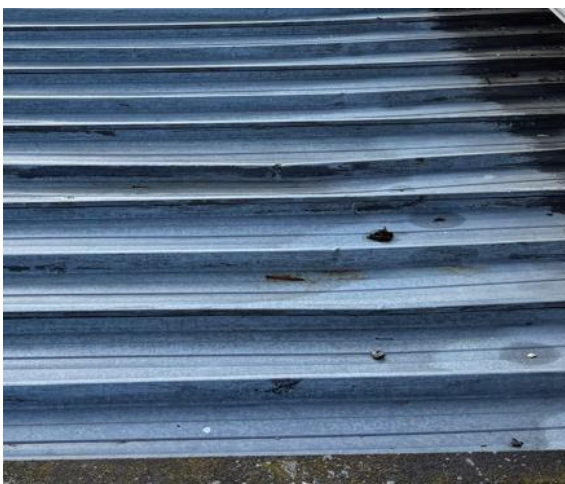
Low spot in tray roof holds water

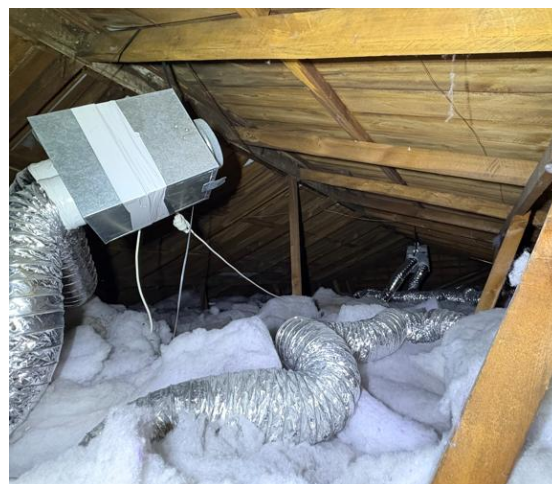
Roof space.

| ITEM ASSESSED | DEFECT | COMMENTS/NOTES |
|---|---|---|
| Thermal Insulation – Type, clearances, approximate thickness, and coverage. | None | Polyester blanket, R3.2 approximately 120mm thick, good coverage |

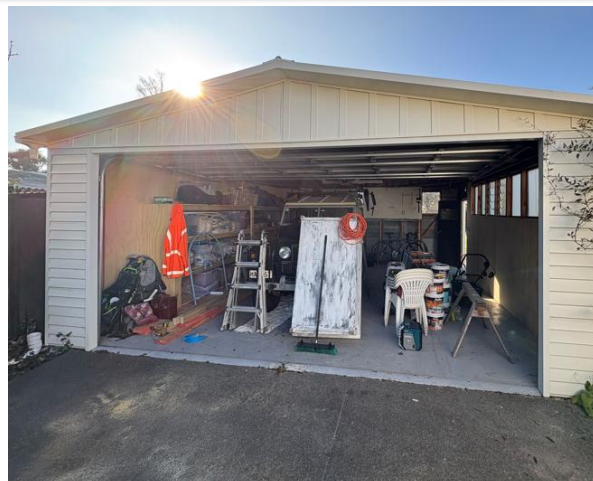
| Garage – opener, doors. | Minor | Good condition, some deterioration of the roofing underlay paper. |

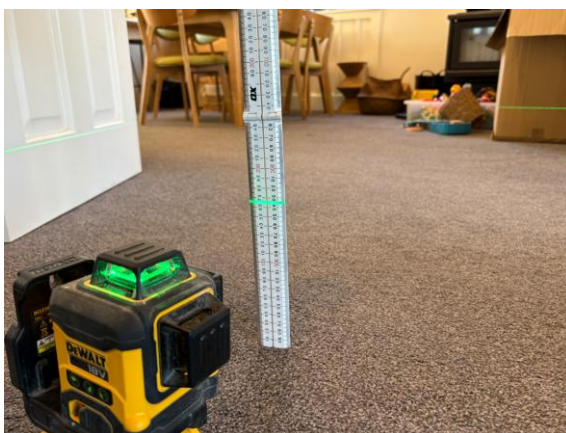
| ITEM ASSESSED | DEFECT | COMMENTS/NOTES |
|---|---|---|
| Timber Floors | None | Measurements were taken with a laser level device across the floor plan, and the variation was around 15mm. The MBIE Guidelines for the level variations of the floor plan have set the limit at 50mm. |

Laser floor level assessment.

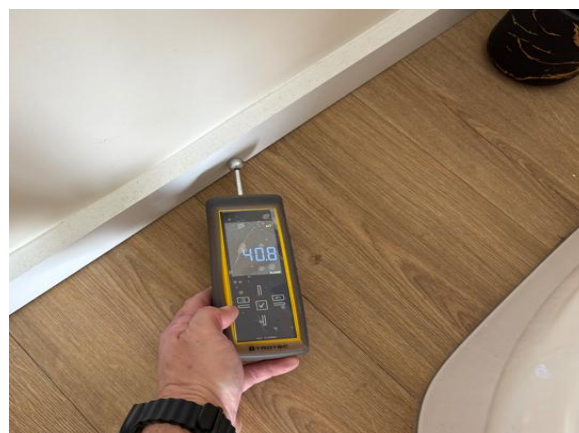
The moisture readings were between 21.6 and 40.8 – these are in the dry range.

Moisture testing – dry range
